**PRELIMINARY ACCIDENT REPORT**

**Accident and Incident Investigations Division**

Accident  
- Preliminary Report -  
AIID Ref No: CA18/2/3/10595

| Aircraft Make and Model | : Extra Flugzeugbau GmbH/EA 300L |

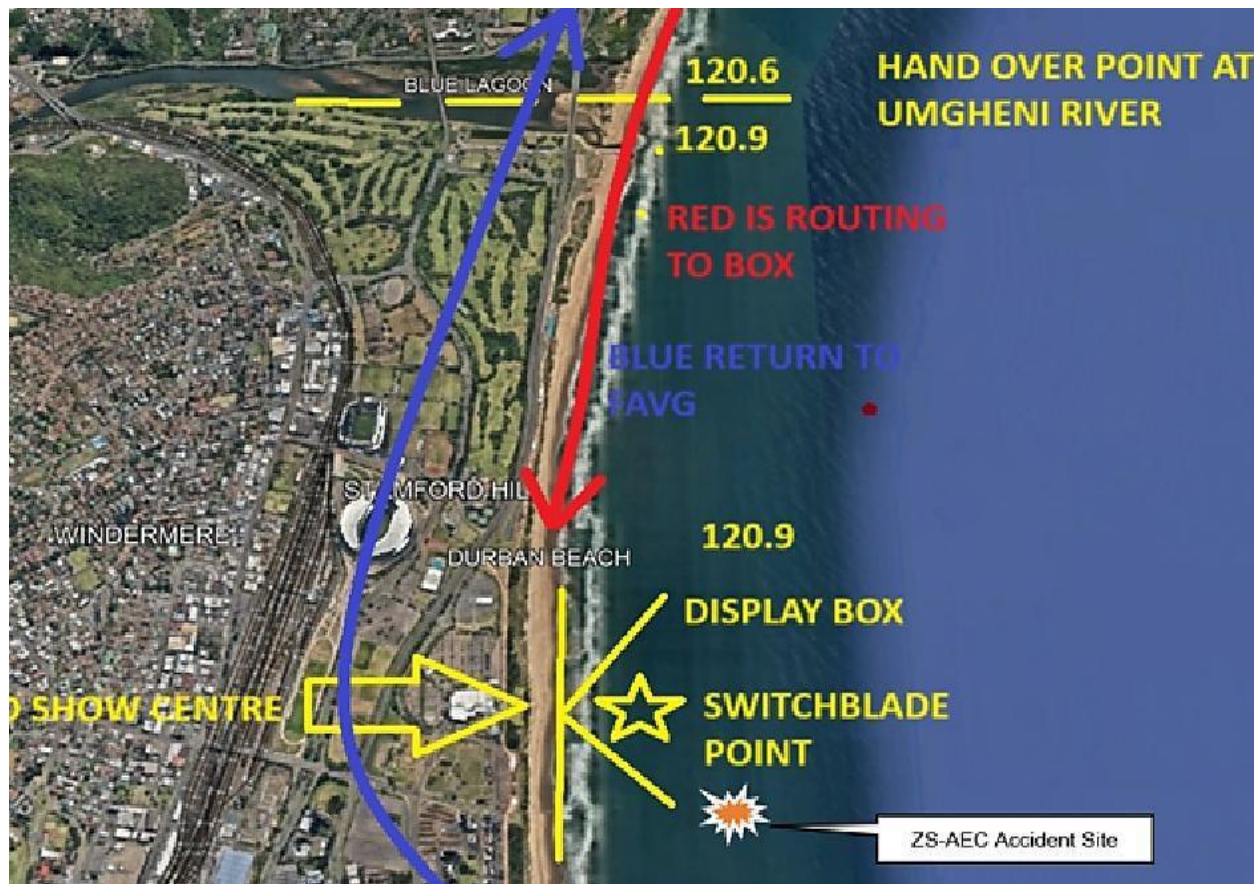
**Figure 2:** The allocated airspace layout for the airshow display. (Source: ATNS-FALE)

- 1.1.2. This event was organised by Smoke on Go Foundation on behalf of the South African Civil Aviation Authority (SACAA). According to the flight display director (FDD) and flight safety officer (FSO), an airshow display area was viewed on 13 August 2025; the ZS-AEC pilot was also present during the viewing. The airshow commenced from 1000Z on 14 August 2025; it culminated after the accident. The operational parameters included a 2 nautical miles (nm) radius entered at North Beach near the Casino, with a vertical limit of 3000 feet (ft) above mean sea level (AMSL). All aircraft took off from FAVG. Each aircraft was issued an airshow squawk code (unique aircraft identifying code) by King Shaka International Airport (FALE) air traffic control (ATC). The aircraft operating in the display box were assigned frequency 120.9-Megahertz (MHz). Upon completion of the aerobatic display and after leaving the display box, all aircraft had to switch to FAVG ATC frequency 120.6-MHz. The aircraft that were routing to the display box were required to fly along the beach line, and those routing back to FAVG were required to fly overland, as indicated in Figure 2.

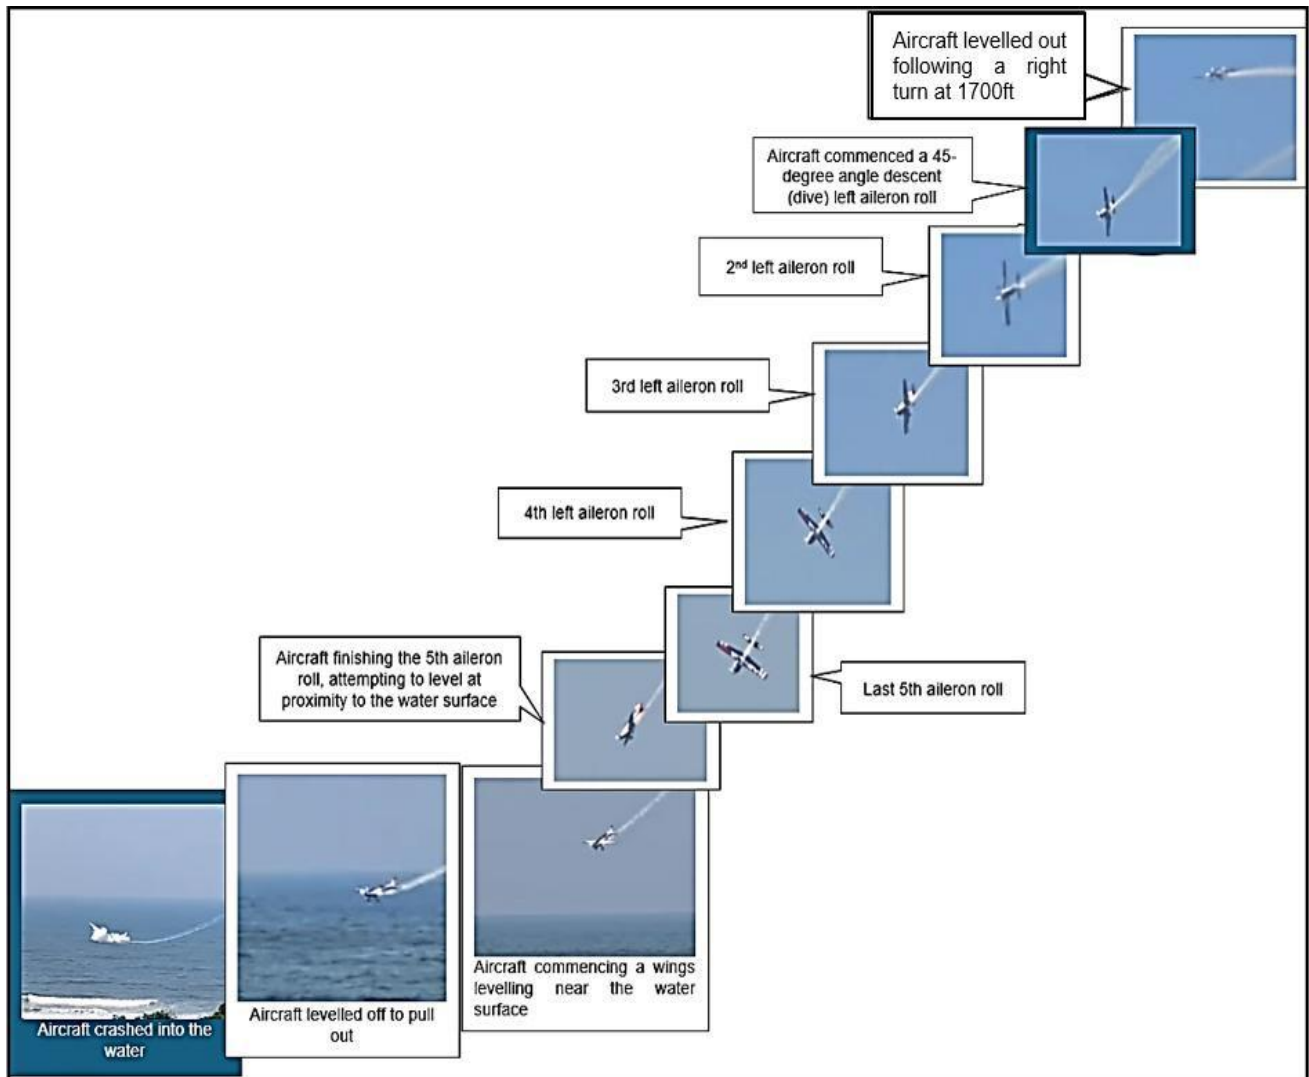
**Figure 3:** The accident sequence captured on the video footage.

1.1.5. At around 1151Z, the aircraft entered the aerobatic box and commenced the display sequence in an inverted low-level manoeuvre. The pilot then pulled up and made a left turn over the ocean, followed by a low-level pass to the left. Shortly afterwards, the aircraft climbed again and made a right turn further east over the ocean and, thereafter, turned south at an altitude of approximately 1700 ft AMSL. The pilot initiated another right turn towards the west, aligning the aircraft with the viewing area whilst flying northbound. At this point, the aircraft performed five consecutive left aileron rolls whilst descending from 1700 ft AMSL (instead of 2200ft AMSL) at a 45-degree angle. The video footage showed the aircraft in a left aileron roll (rolling to the left) before it levelled off and impacted the water (see Figure 3).

1.12.1. The aircraft performed five consecutive left aileron rolls whilst descending from 1700 ft AMSL (instead of 2200 ft AMSL) at a 45-degree angle. The video footage submitted as evidence showed the aircraft in a left aileron roll (rolling to the left) before it levelled off and impacted the water (see Figure 3).

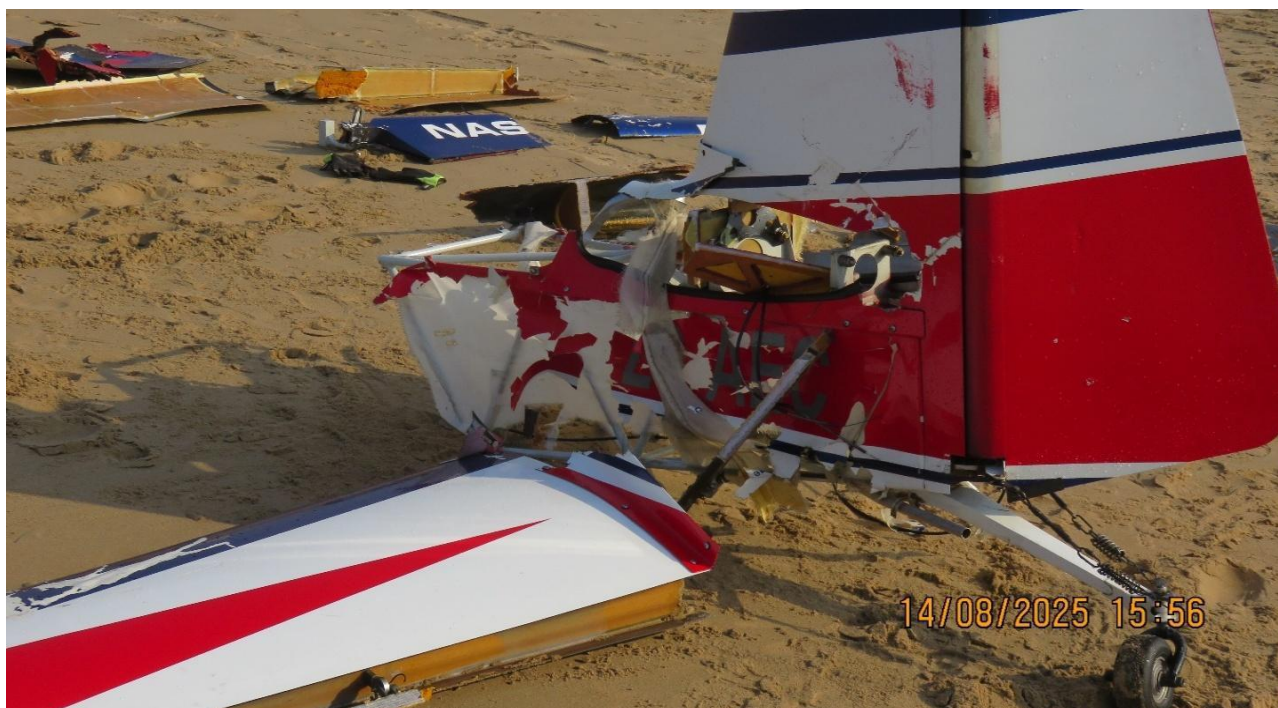
**Figure 5:** Reconstruction of the aircraft with elements that were recovered on the day of the accident.

1.3.1. The aircraft was destroyed during impact with the water.

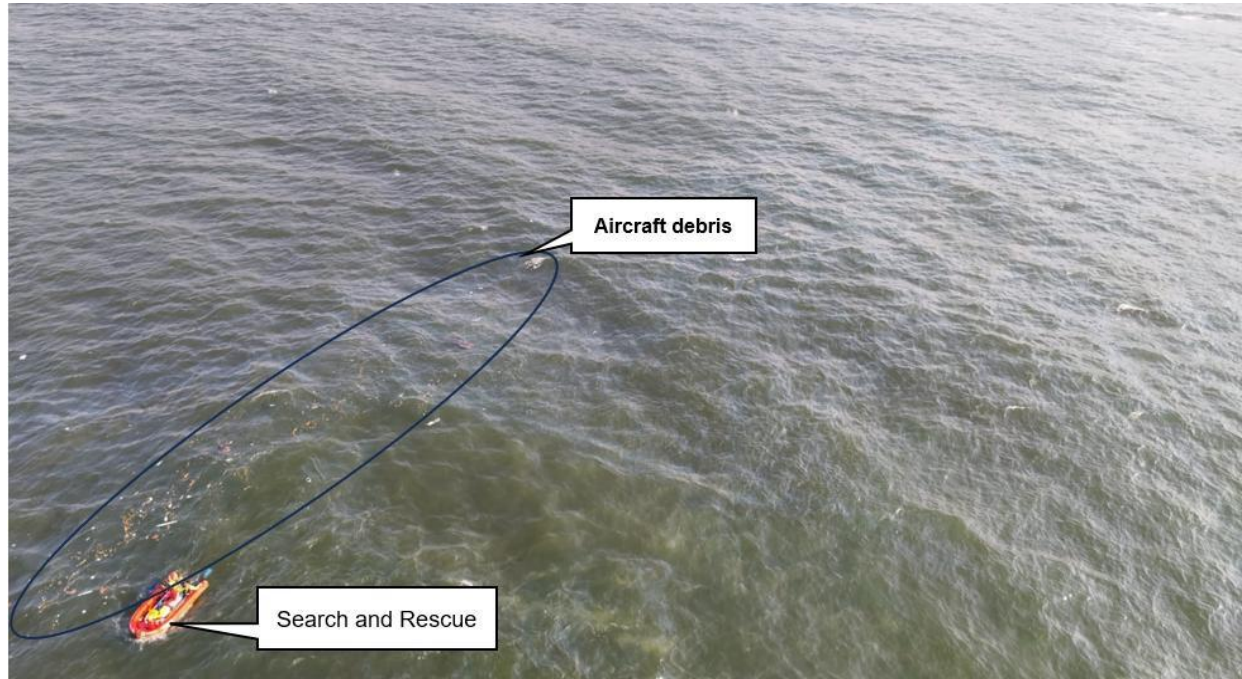
**Figure 6:** Aerial view of the accident site. (Source: SAPS Air-Wing)

1.12.2. The aircraft impacted the water at GPS co-ordinates determined to be 29°50'18.91"S, 031°02'29.40"E and the wreckage was sinking to a depth of 9-11m. The aircraft disintegrated during the impact sequence; parts of the aircraft, including sections of the outer skin, engine cowling and sections of the wings were later recovered from the water. Some of the debris was found floating near the impact site whilst other fragments drifted and washed up along the coastline near FAVG.

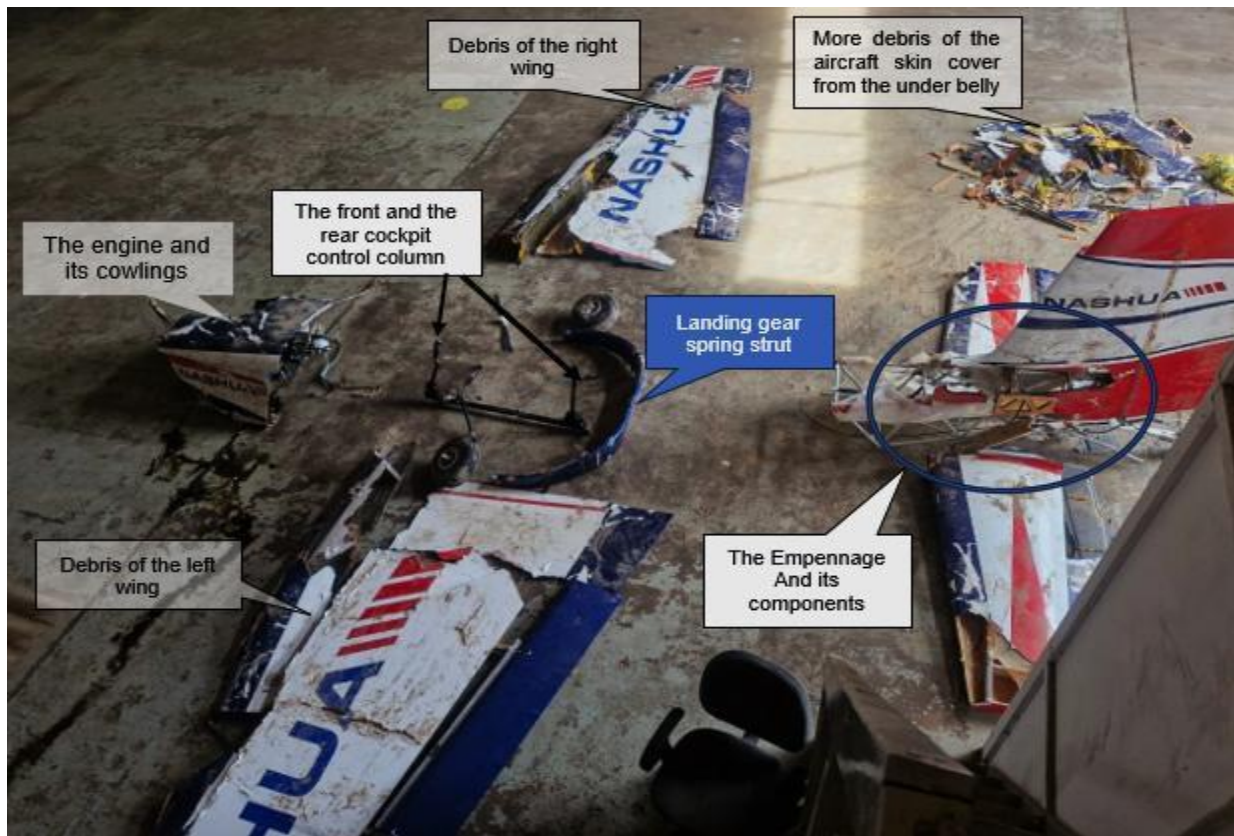
**Figure 7:** A reconstruction of the aircraft using recovered debris.

1.12.3. On 20 August 2025, the engine and the aircraft control columns from both cockpits were successfully recovered from a depth of approximately 11m below the surface of the water. The engine was largely intact; however, it showed noticeable damage to the mountings and several external accessory components, including the oil filter and electrical wiring.

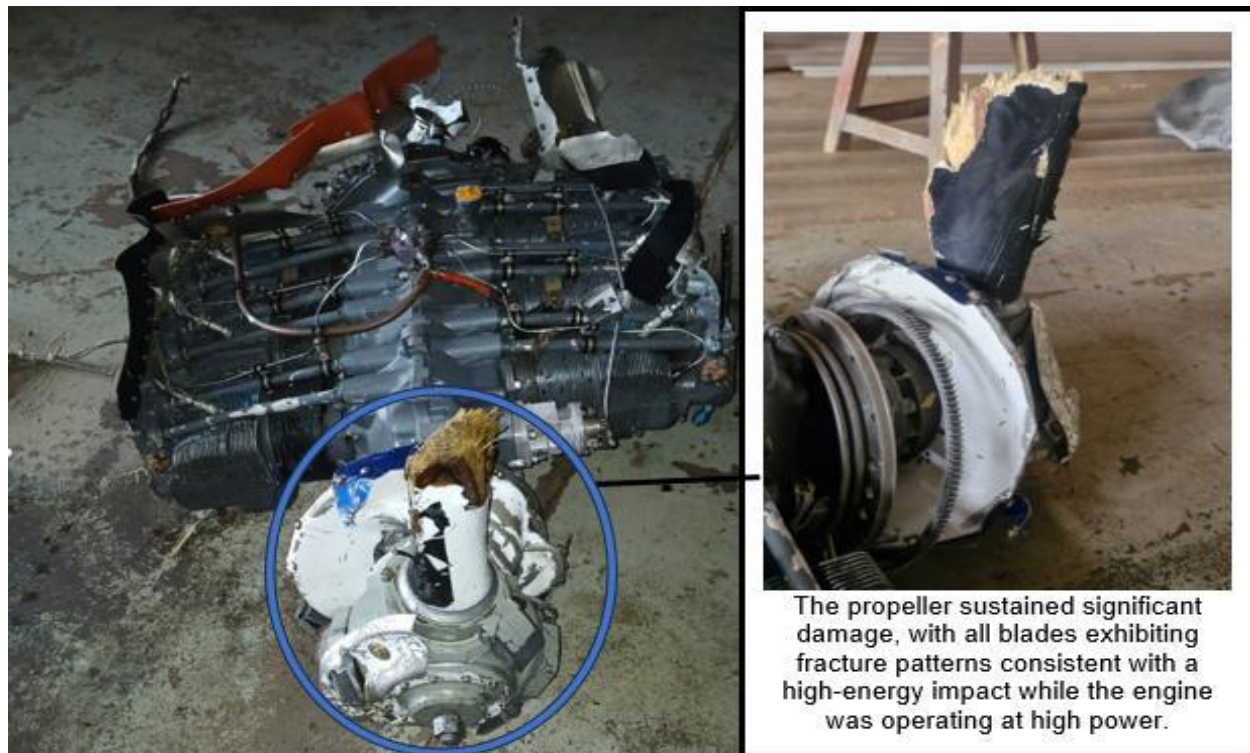
**Figure 8:** The recovered aircraft engine. (Source: SAPS Search and Rescue)

1.12.4. Part of the firewall, the propeller gearbox and one of the propeller blades were still attached to the engine; the (attached) propeller blade was damaged, and the other two blades were missing. The fracture patterns on the wooden blades showed signs of high-energy impact which indicated that the engine was delivering significant power at the time of crash.
