PRELIMINARY ACCIDENT REPORT

Accident
- Preliminary Report -
AIID Ref No: CA18/2/3/10501

Reference Number	: CA18/2/3/10501
Occurrence Category	: Accident Category 1
Type of Operation	: Private (Part 94)
Name of Operator	: JA Earle
Aircraft Registration	: ZS-BGN
Aircraft Make and Model	: De Havilland Aircraft Company, DH-82A
Nationality	: South Africa
Registration Marks	: ZS-BGN
Place	: Dirt road near R42 and R551
Date and Time	: 28 September 2024 at 0815Z
Injuries	: None
Damage	: Substantial

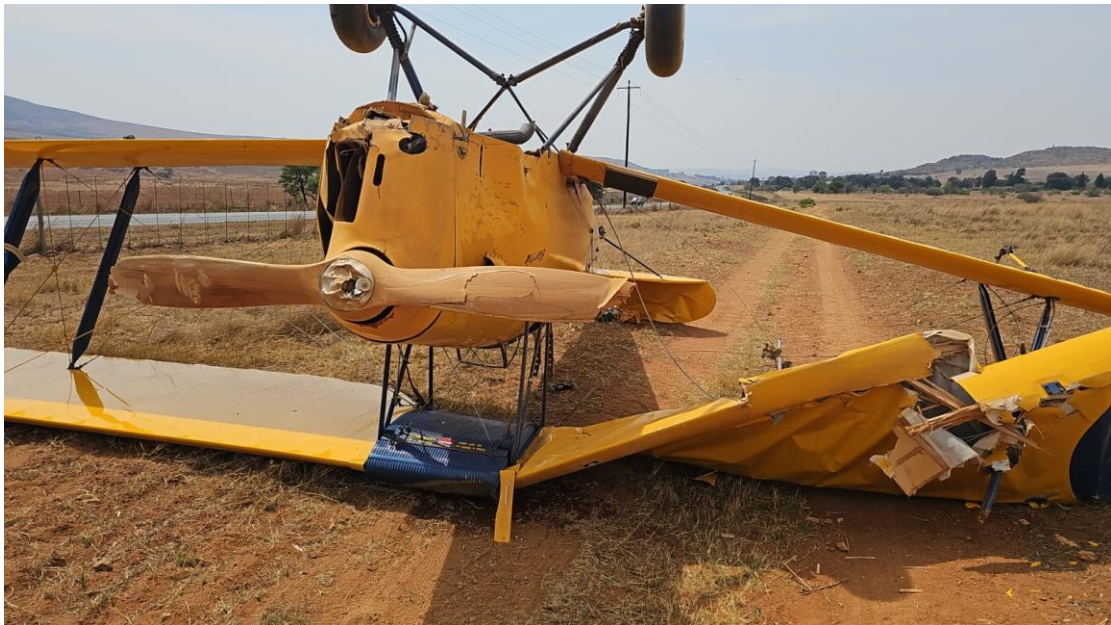
1.3.1. The aircraft's right wing, rudder, fin, propeller and the front engine mount were substantially damaged.

Figure 3: The aircraft post-accident. (Source: Pilot)

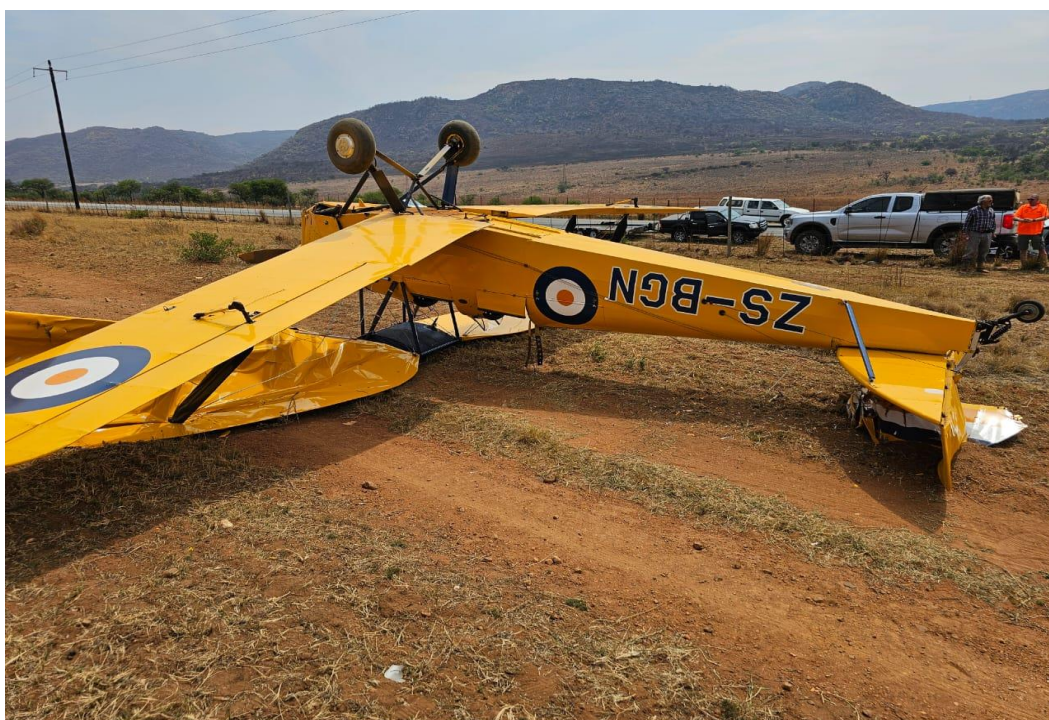
Figure 4: The aircraft in an inverted position post-accident. (Source: Pilot)

1.12.2 The aircraft was found in an inverted attitude; it faced the direction from which it had approached. The dirt road surface was uneven and unfavourable to perform a safe landing.

1.12.3 The bottom side of the nose section was damaged, consistent with impact with the ground (see Figure 2). The propeller was severed, and the engine mountings were bent. The right upper wing was also damaged during the accident sequence, indicative of impact with a solid surface. The tail fin and rudder were substantially damaged due to the hard impact with the ground as the aircraft had flipped over.

2.2.4 The aircraft flipped over during the landing roll after the main wheel had rolled over a trench on an uneven dirt road.
