PRELIMINARY ACCIDENT REPORT

Accident
- Preliminary Report -
AIID Ref No: CA18/2/3/10192

On Sunday afternoon, 17 July 2022, a pilot and three passengers on-board a Cessna 175B aircraft with registration ZS-CPO took off on a commercial flight from Weltevrede Aerodrome (unlicensed aerodrome), near Stanford town with the intention to sightsee around the area. The pilot elected to take-off in an easterly direction. Shortly after rotation, the stall warning horn sounded, whereafter, the aircraft suddenly banked to the left (towards the mountainous terrain). The pilot attempted to push the nose down to gain speed but the aircraft collided with power lines and crashed on the neighbouring farm after plunging through several pine trees.

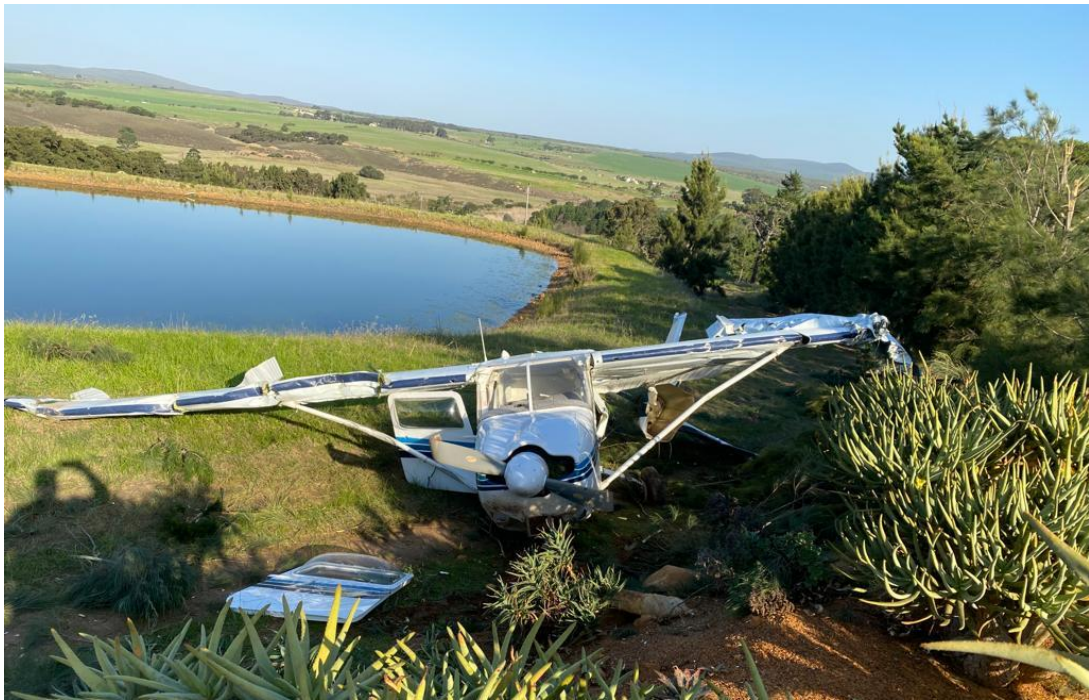
1.3.1 The aircraft was substantially damaged during the accident sequence.

Figure 3: The aircraft as it came to rest.

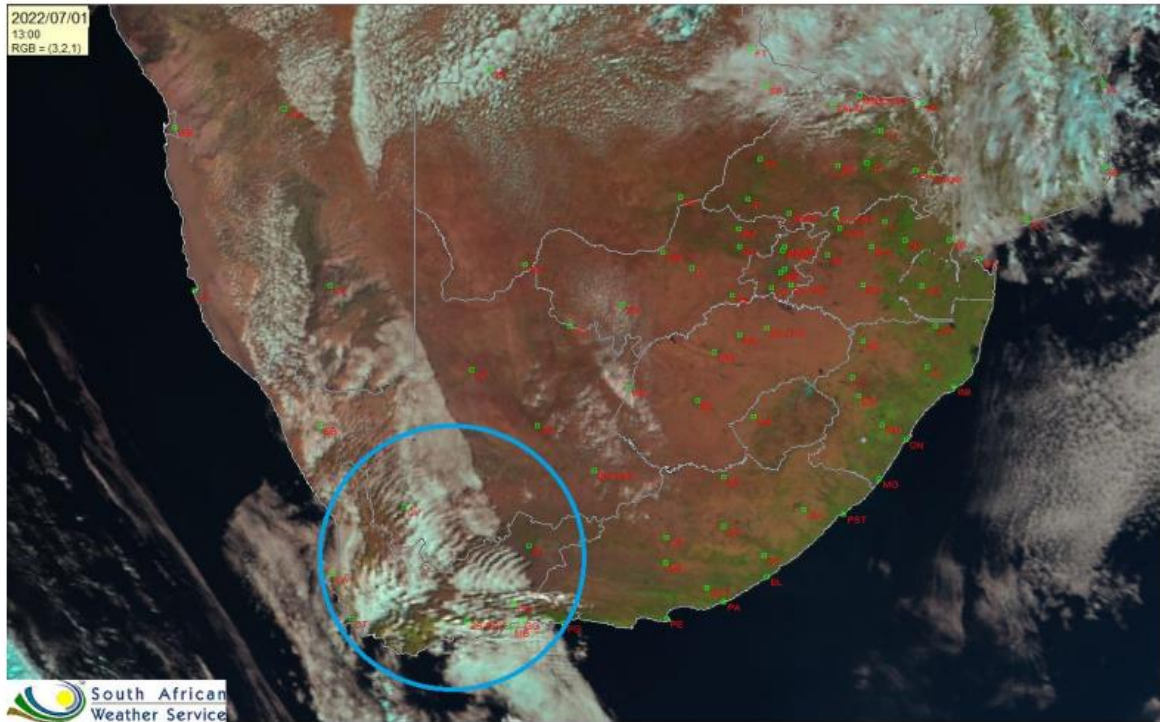
The Day Natural Colour (DNC) satellite imagery of the MeteoSat Second Generation (MSG) indicated the presence of severe mountain wave turbulence (MTW) over the south-western parts of South Africa, including the area of accident between 1300Z and 1315Z, encompassing the time of accident at 1306Z. The wave-like formation of clouds as seen on the satellite images is the physical evidence of the occurrence of MTW, due to strong north-westerly (NW) winds close to the W-E mountain range over the south-western parts of the country. The strong NW winds are intercepted at a perpendicular or acute angle to this mountain range, thus, turbulence. These wave-like cloud formation occur downwind the mountain range over a stable layer for a considerable distance, reaching the south-west coast and offshore. Farther away from the mountain range, these wave-like formations are referred to as gravity waves. The satellite image at 1300Z (Figure 4) indicate the occurrence of MTW in the south-west, including the area of accident (see blue circle). The MTW wave-like phenomena is a tell-tale signal of strong winds close to the mountain range, intercepted at a perpendicular angle.

Figure 4: The Day Natural Colours satellite imagery at 1300Z on 17 July 2022. (Source: SAWS)

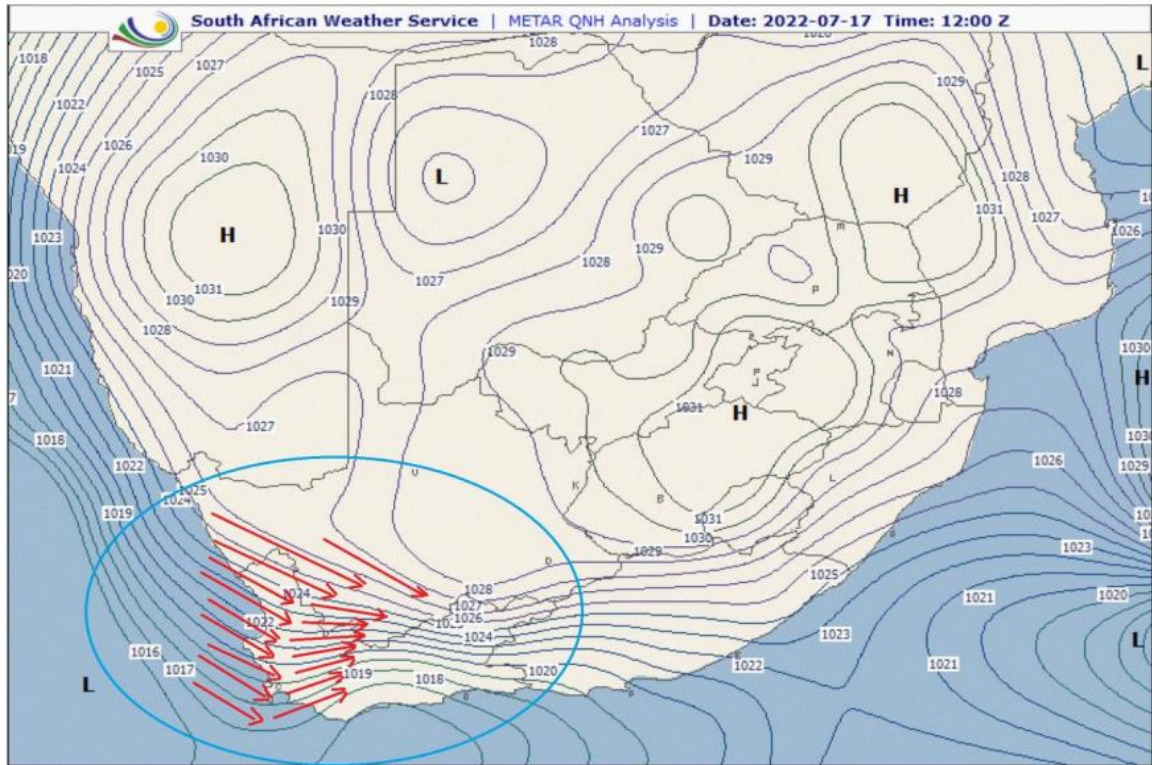
A very strong pressure gradient force was present in the south-western parts of the country as indicated in the QNH chart analysis valid for 1200Z (Figure 5). The pressure gradient force is a result of the presence of high pressure over the central interior and low pressure offshore the west coast of the country, which resulted in strong geostrophic winds. As such, strong geostrophic NW winds were to be expected over this region, including the area of the accident (see blue circle in Figure 5). These are the winds responsible for the MTW as observed by the satellite images as well as surface observation of the Hermanus Automatic Weather Station (AWS), and Cape Town International Airport (FACT) and George Aerodrome (FAGG) meteorological aerodrome reports (METARs) in and around the time of the accident. These strong winds on their own were likely a hazard for moderate to severe turbulence.

Figure 5: The QNH chart analysis valid for 17 July 2022 at 1200Z. (Source: SAWS)

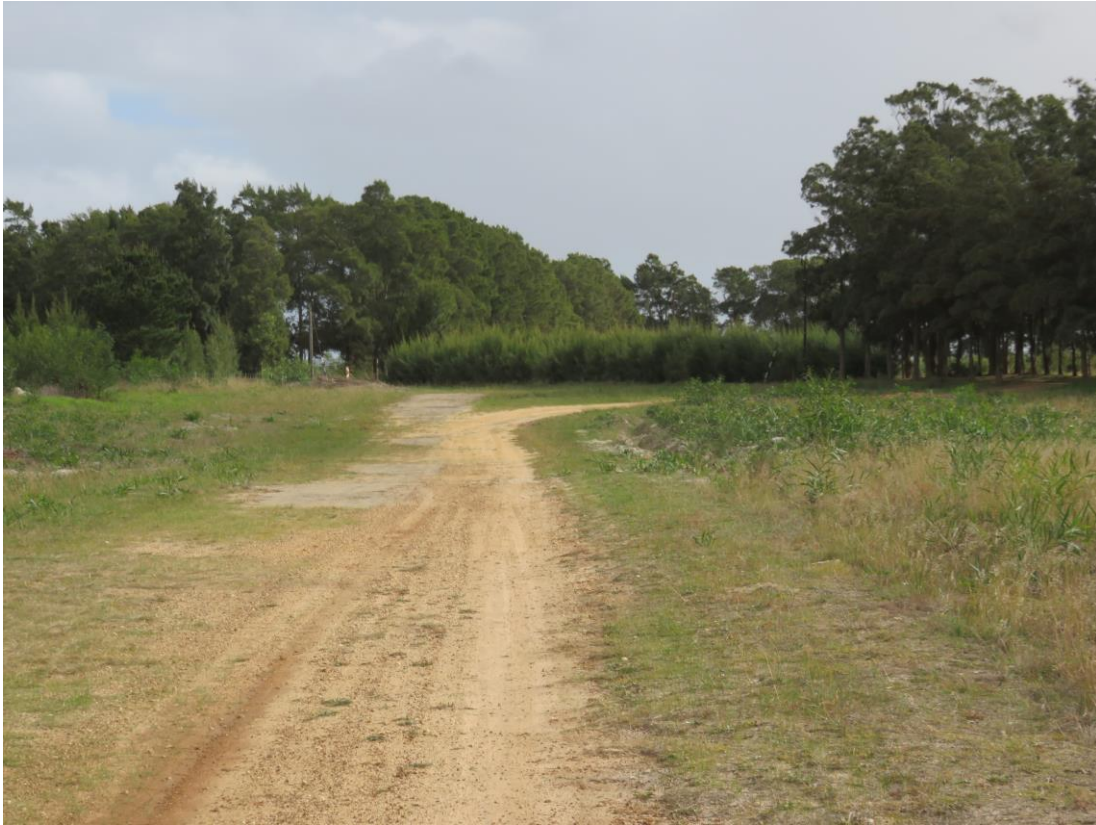
Figure 9: Runway 11 view taken facing the approach path.

2.2.19 The aerodrome was surrounded by hazards such as high trees, especially on the approach for Runway 11, and power lines crossing the approach path of Runway 29.

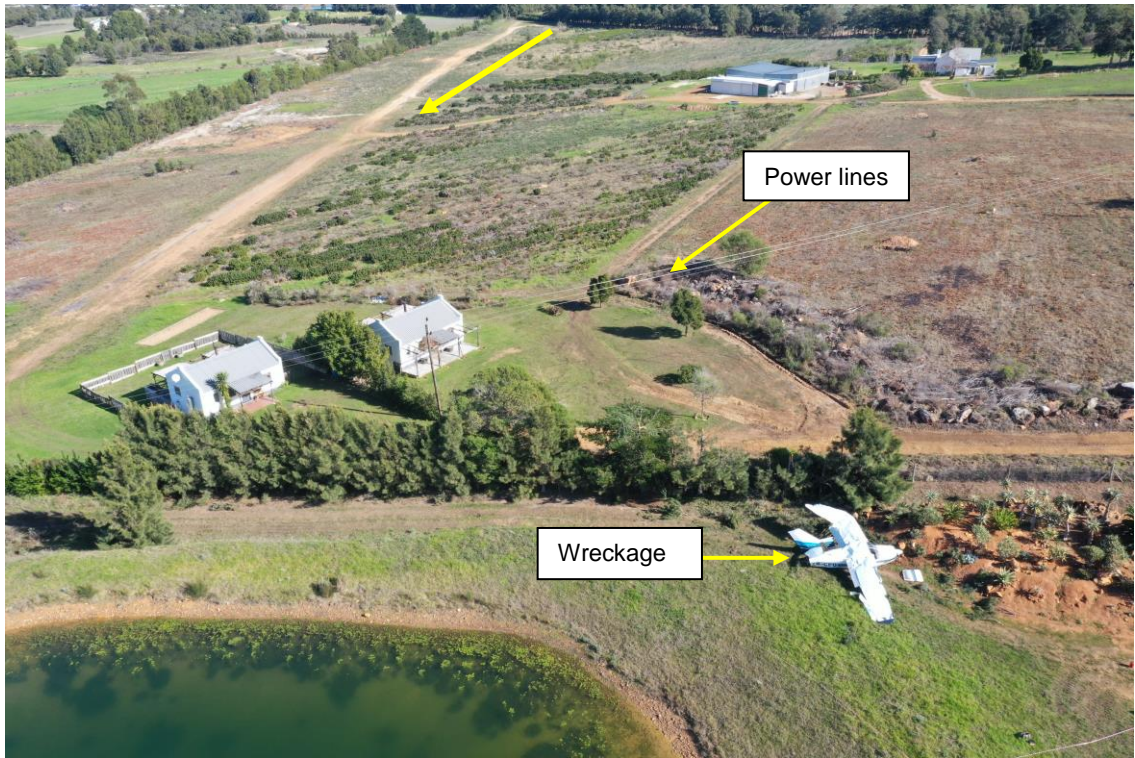
1.4.1 An 11 kilovolt-ampere (kVA) power line (consisting of three lines) was severed during impact, which caused a power outage in the area.

1.12.1 After take-off from Runway 11, the aircraft banked to the left and collided with power lines, approximately 80m to the left of the runway centreline. After the aircraft collided with the power lines, it veered off to the left, then the right wing and the right-side of the fuselage impacted several pine trees, whereafter, ground impact followed. The aircraft came to rest in an upright, right wing-low attitude on the neighbouring farm facing a northerly direction, which was approximately 90° from the direction of take-off. The nose wheel, the right main gear strut assembly and the left door broke off during impact. The entire empennage was severed and was found on the left-side of the fuselage (looking from the aft) as seen in Figure 12. The cockpit/cabin area remained intact. Substantial damage was caused to both wings. The left wing tank had ruptured and fuel leaked from the tank and onto the occupants who were seated on the left-side of the aircraft (see Figure 13).

Figure 10: The runway, power lines and wreckage. (Source: AAS drone footage)

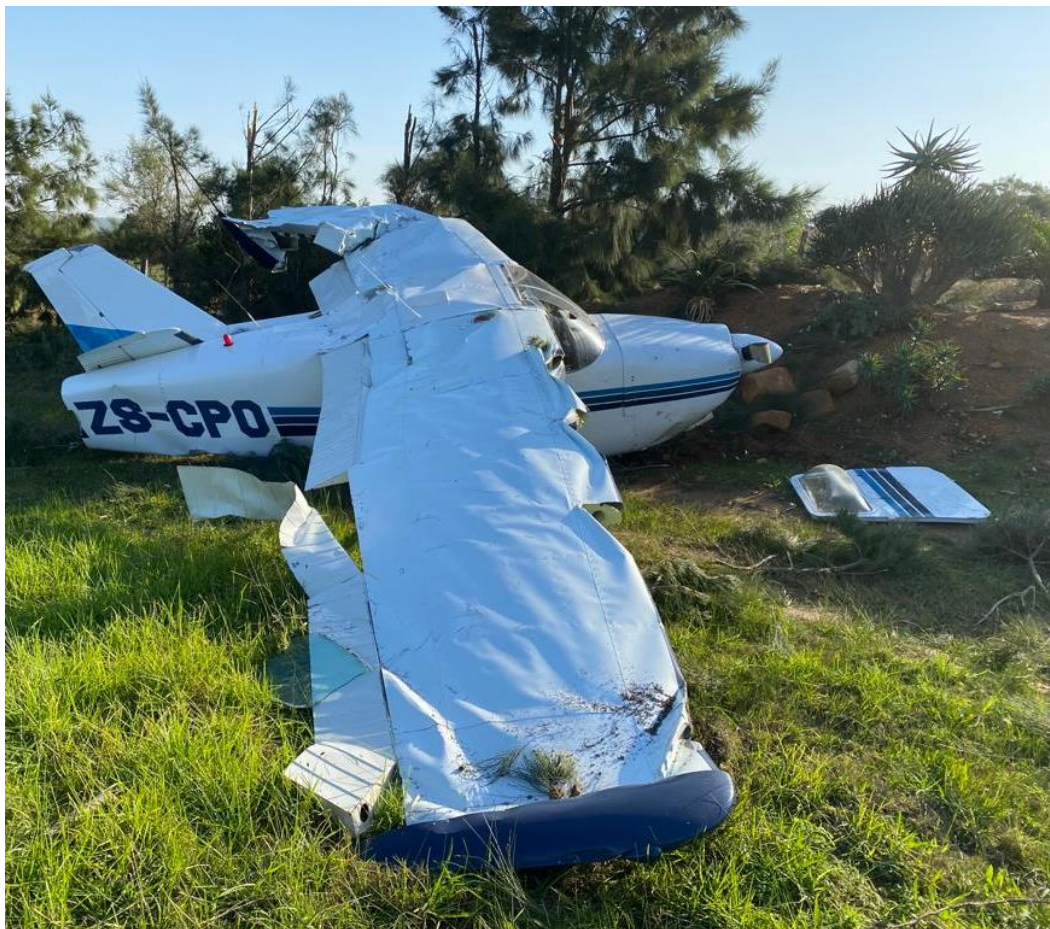
Figure 11: Damage on the leading edge of the right wing following impact with the trees.

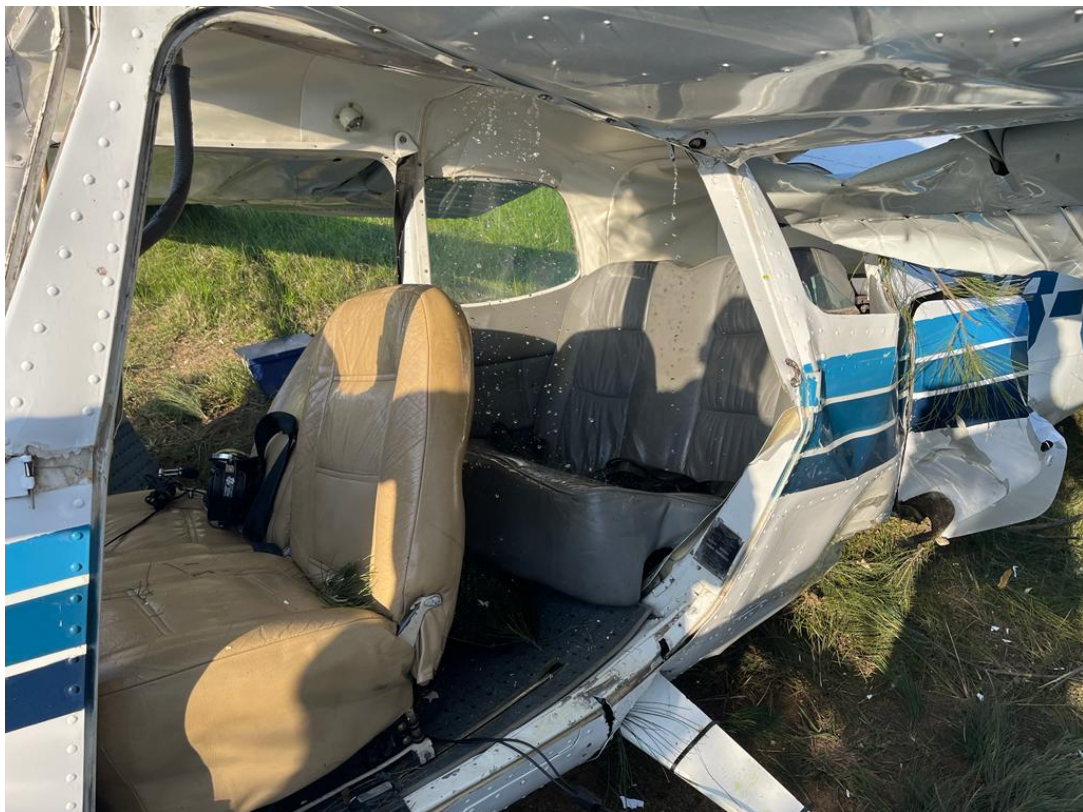
- 1.1.6 Fuel spewed from the left wing into the cabin, drenching the occupants on the left-side as the left door was ripped off during impact. All four occupants managed to evacuate the aircraft unassisted. The farmer and his wife quickly came to assist the occupants. The passenger who was seated next to the pilot had a cut to her head and was bleeding profusely. The farmer's wife took her to the farmhouse where she attended to her wound. The passenger who was seated behind the pilot also had a cut to his right cheek, just below his eye. All three passengers had bruises on their legs; and the passenger who was seated next to the pilot had more bruises on her right arm and shoulder. The pilot brought them a first aid kit that was in the aircraft. Approximately 20 minutes after the accident, three ambulances arrived at the scene as well as the police, a fire truck. The medics attended to the passenger who was seated next to the pilot and was transported to hospital in Hermanus by ambulance. The other two passengers drove to the hospital in their own vehicle where they also received medical attention. All passengers were discharged at approximately 1700Z on the same day.

Figure 13: Fuel leaking from the ruptured left-wing tank. (Source: Passenger)

1.14.3 Although fuel was leaking from the left-wing tank, there was no evidence of fire on the wreckage.

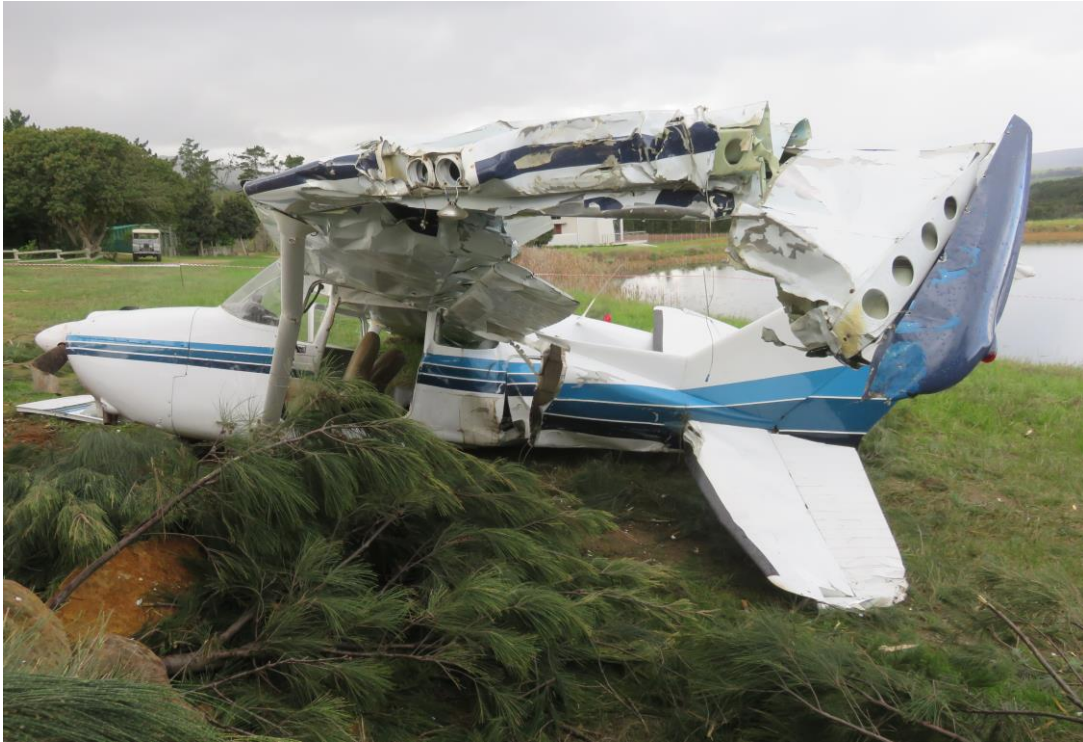
Figure 14: The left-wing was severely deformed during the impact sequence.
