PRELIMINARY ACCIDENT REPORT

Accident
- Preliminary Report -
AIID Ref No: CA18/2/3/10392

Reference Number : CA18/2/3/10392
Occurrence Category : Category 1
Type of Operation : Training (Part 141)
Name of Operator : Unitas Flying School
Aircraft Registration : ZS-CZR
Aircraft Make and Model : Piper, PA-28-180 Cherokee
Nationality : South African
Place : Approximately 1.38nm from Vereeniging Airfield Runway 03
Date and Time : 23 November 2023 at 1430Z
Injuries : None
Damage : Substantial

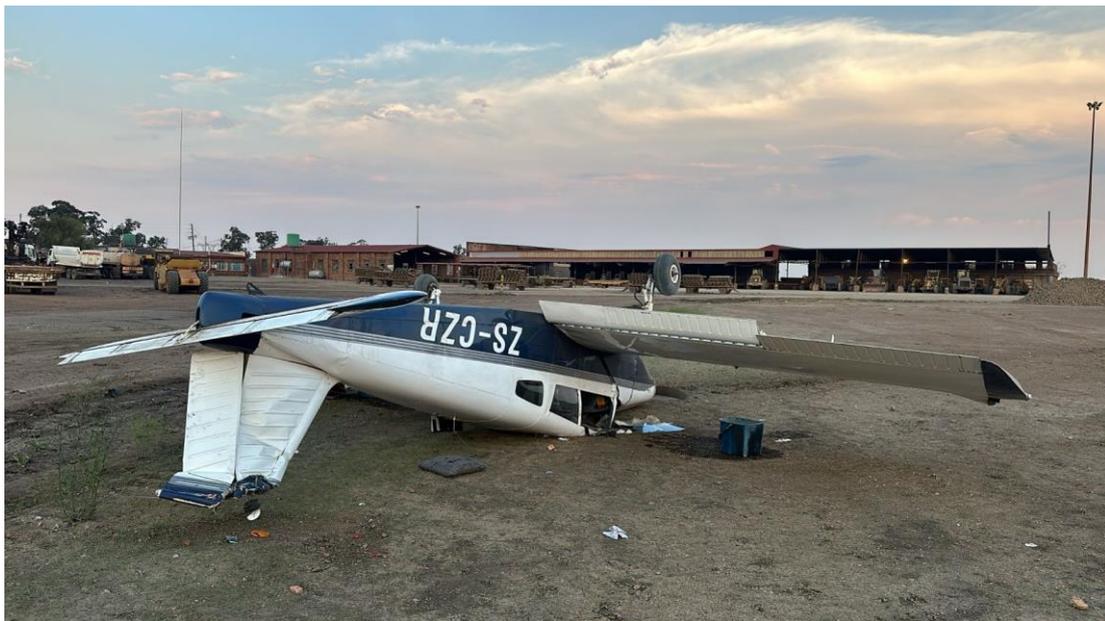
1.3.1 The aircraft sustained substantial damage.

Figure 3: The aircraft post-accident. (Source: Instructor pilot)

1.12.1 The wreckage was found intact in an inverted position at a brick manufacturing plant in Vereeniging. The aircraft sustained damage to the vertical stabiliser, canopy and nose wheel, which had collapsed.
