PRELIMINARY ACCIDENT REPORT

Accident  
- Preliminary Report -  
AIID Ref No: CA18/2/3/10588

<b>Reference Number</b>	: CA18/2/3/10588
<b>Occurrence Category</b>	: Accident (Category 2)
<b>Type of Operation</b>	: Private (Part 91)
<b>Aircraft Registration</b>	: ZS-CZU
<b>Aircraft Make and Model</b>	: Piper Aircraft Corporation, PA-28-180
<b>Nationality</b>	: South African
<b>Place</b>	: Bloemhof Farm near Greytown, KwaZulu-Natal Province
<b>Date and Time</b>	: 8 June 2025 at 1630Z
<b>Injuries</b>	: One of the crew members sustained minor injuries
<b>Damage</b>	: Substantial

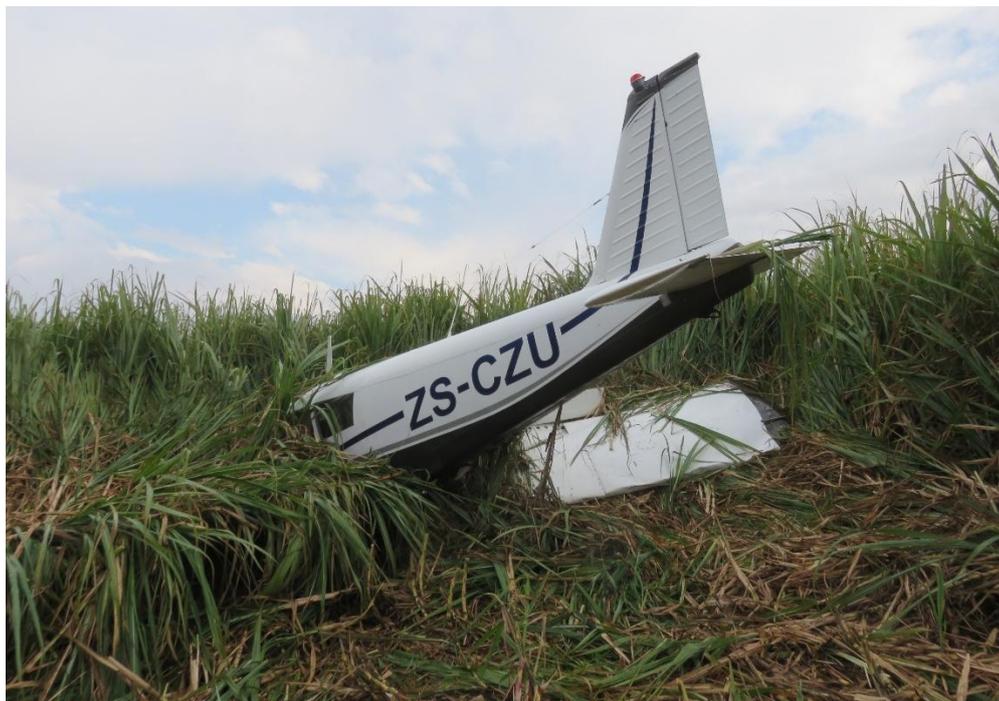
1.12.1 The aircraft impacted the sugarcane crops at Bloemhof Farm which were about to be harvested. The aircraft came to a stop in a nose-down, wings-level attitude, approximately 30 metres (m) from the first contact with the sugarcane crops which acted as an arresting medium. The right wing separated where it attaches to the fuselage and twisted approximately 120°. The access door on the right side of the aircraft could be easily opened after the accident. The left wing, propeller and part of the engine nacelle were covered by the sugarcane crops. It was possible to ascertain that a substantial

**Figure 8:** The aircraft as it came to rest.

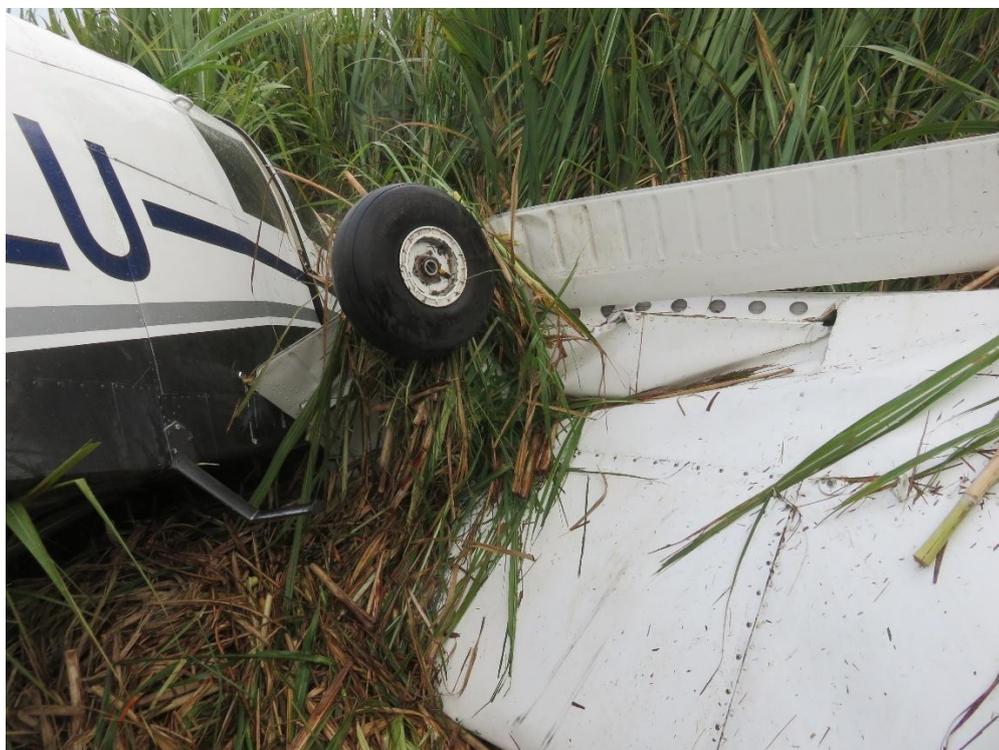
1.3.1 The aircraft sustained substantial damage to the right wing, which twisted approximately 120° and partially separated from the fuselage.

**Figure 9:** The twisted right wing with the main landing gear still attached.

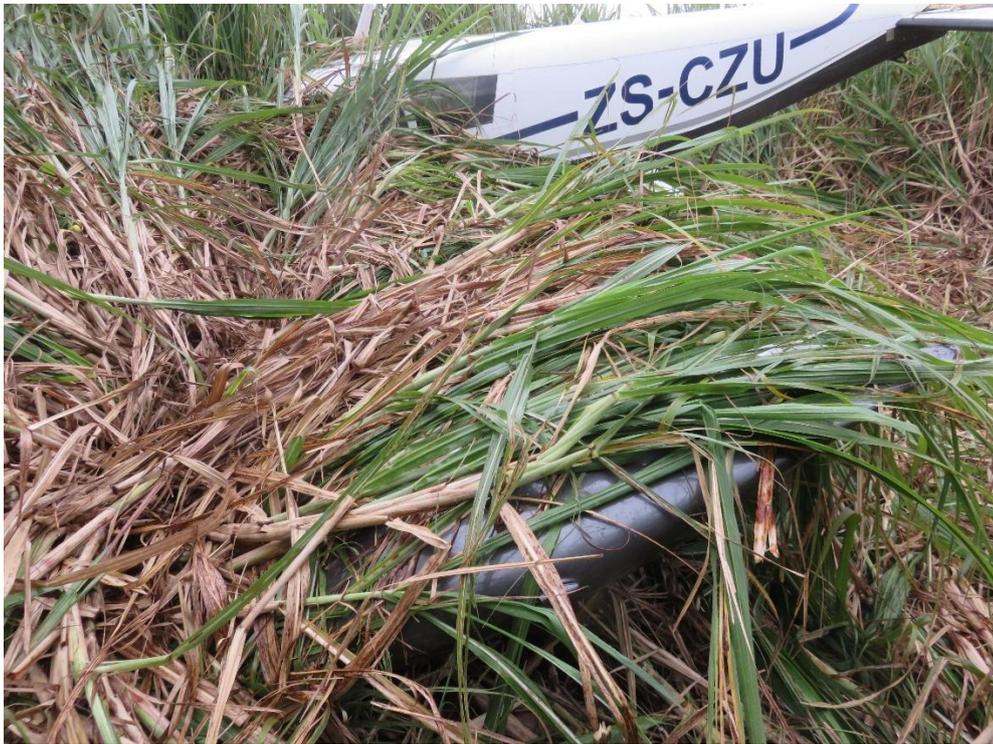
**Figure 10:** The left-wing tip is almost buried underneath the sugarcane crops.

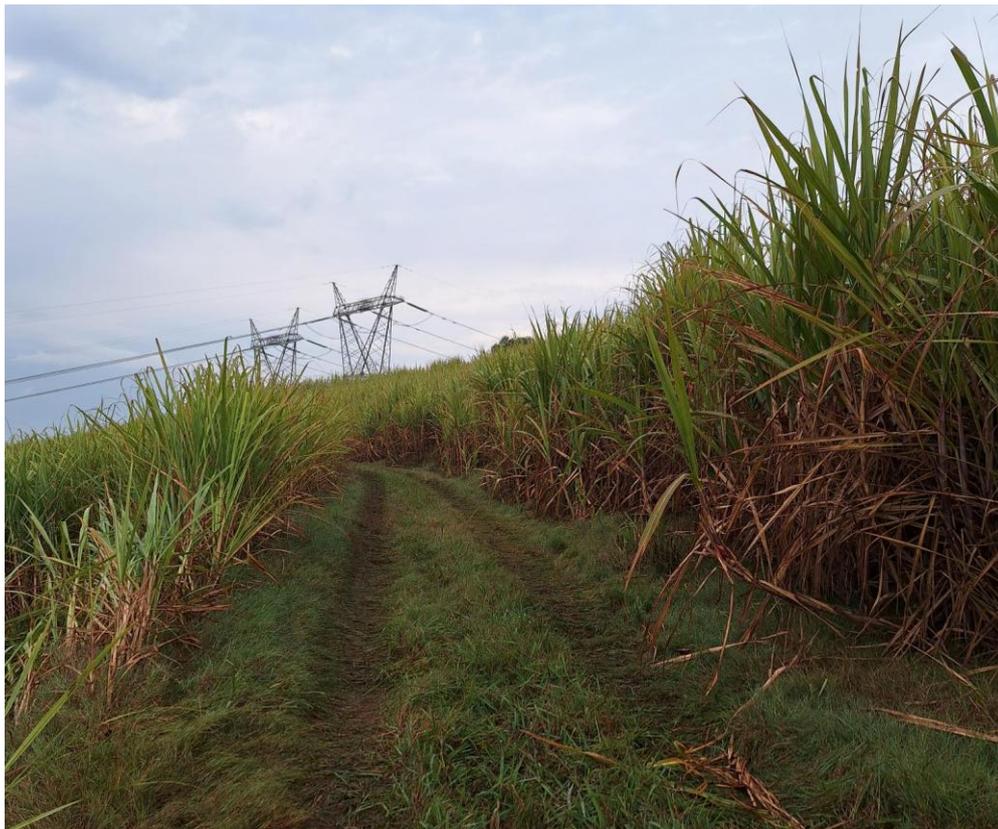
amount of fuel was still in the left-wing tank; the fuel selector in the cockpit was selected to the left tank. The aircraft came to rest 2.8nm west of FAGY and 220m from the high-tension power lines that diagonally crossed the flight path.

**Figure 11:** The high-tension power lines were 220m from the crash site.

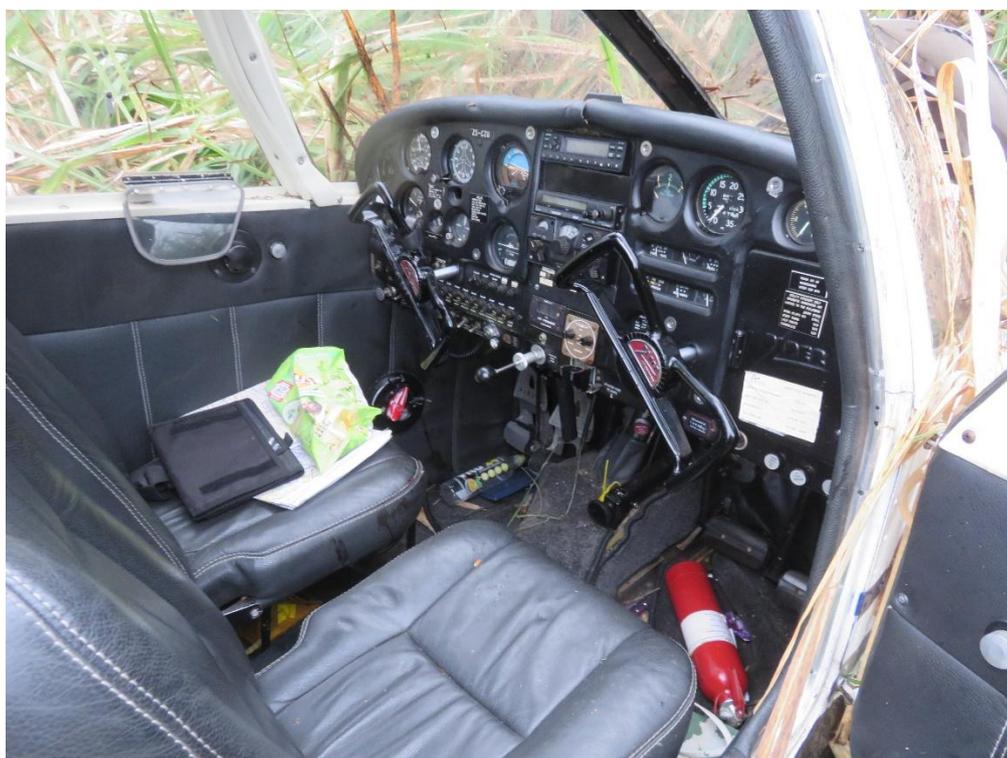
1.15.2 The two occupants made use of the aircraft's equipped safety harnesses. The PIC sustained minor facial injuries as she impacted the instrument panel during the accident. The PF was not injured.

**Figure 12:** The cockpit remained intact.
