PRELIMINARY ACCIDENT REPORT

Accident
- Preliminary Report -
AIID Ref No: CA18/2/3/10614

Reference Number : CA18/2/3/10614
Occurrence Category : Accident (Category 2)
Type of Operation : Agricultural Operations (Part 137)
Name of Operator : Rotorworx Aviation
Aircraft Registration : ZS-DLF
Aircraft Make and Model : Robinson R22 Beta II
Nationality : South African
Place : Roodegrond Citrus Farm near Patensie, Eastern Cape Province
Date and Time : 10 November 2025 at 0545Z
Injuries : One fatal
Damage : Destroyed

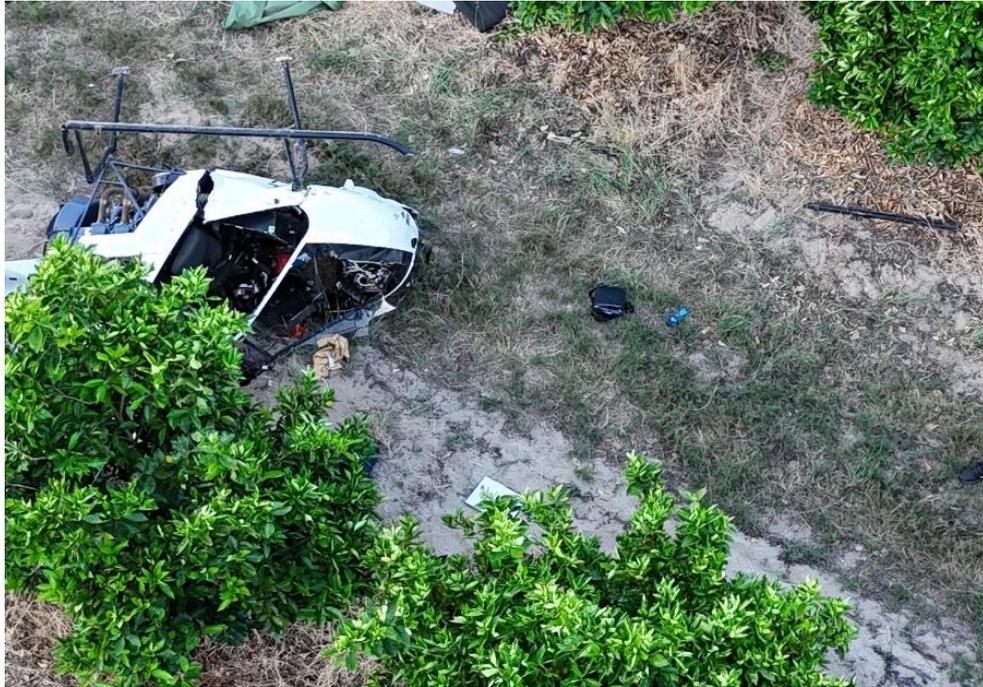
1.3.1. The helicopter was destroyed during the accident sequence.

Figure 3: An elevated view of the helicopter at the accident site.

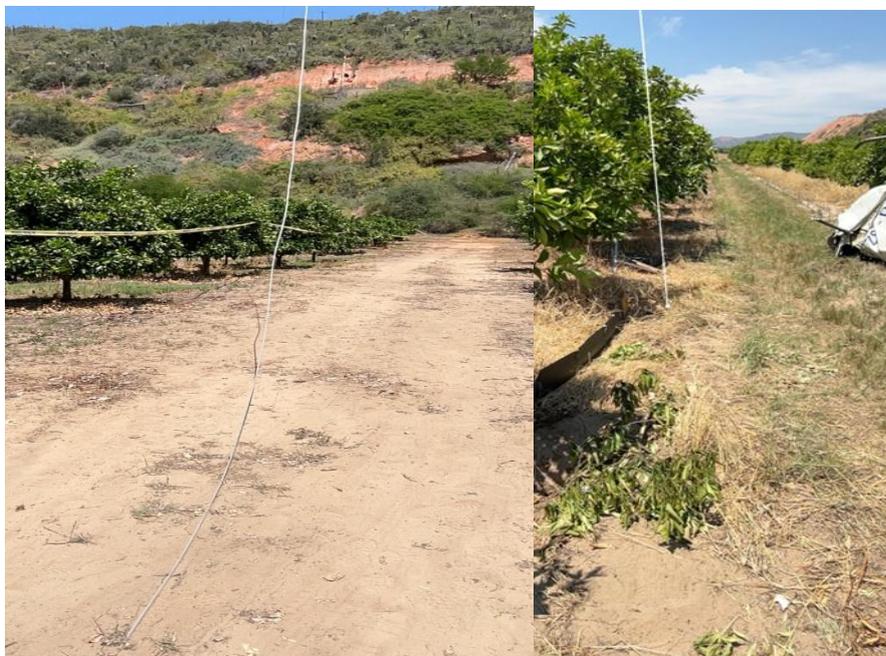
- 1.4.1. The privately owned overhead 1000V electric power line spanning 7.2m above ground level was damaged. The power line supplied electricity to water pumps at Patensie Citrus Farm.

Figures 4 and 5: The damaged power line.

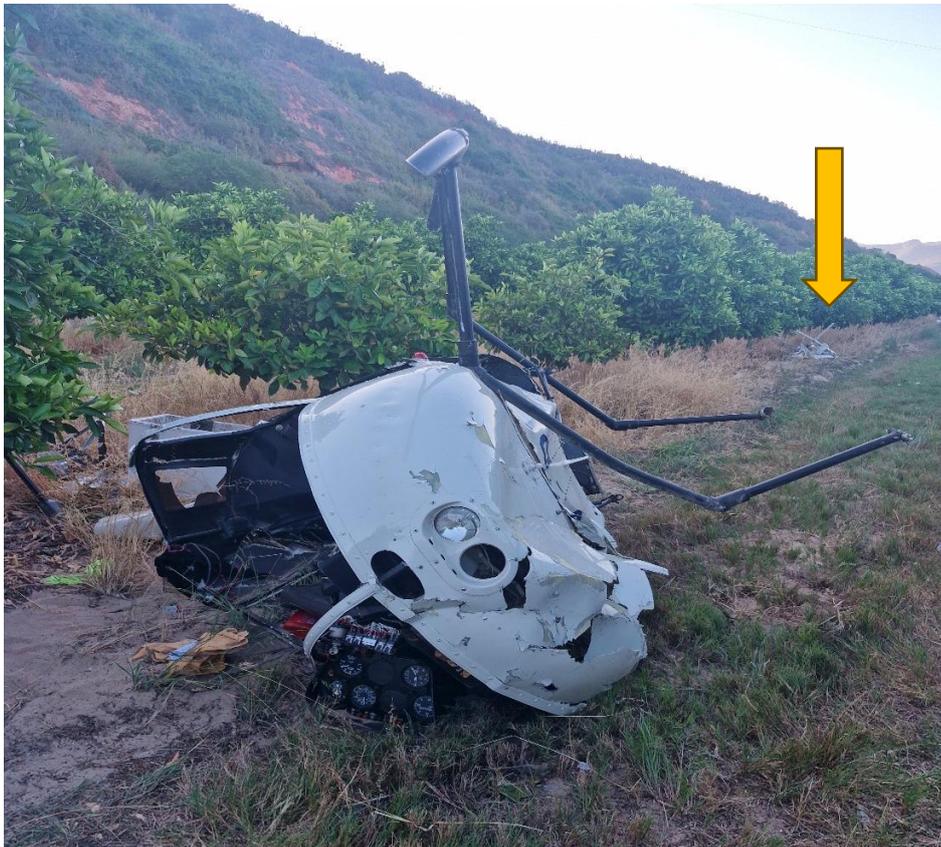
1.12.1. The helicopter's main rotor mast impacted the power line whilst flying in a south-easterly direction. As a result, the main rotor severed the tail boom, and the two main rotor blades detached from the root hub. The helicopter crashed to the ground, left skid first; it came to rest on its right side between rows of citrus bushes, approximately 37m from the point of impact with the electric power line.

1.12.2. The bladder tanks still contained fuel at the accident site although the quantity could not be determined. The fuel was clean and free of contaminants. There were no noted pre-impact anomalies; all fractures were consistent with impact forces. All airframe components and controls were accounted for post-accident.

Figure 6: A frontal view of the helicopter with the tail rotor in the background (yellow arrow).

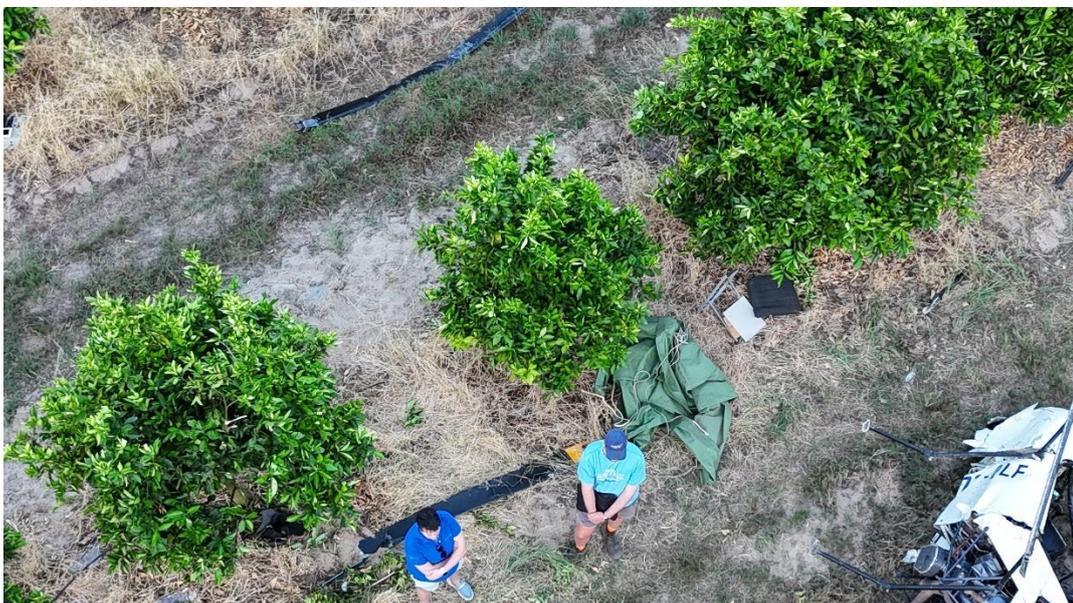
Figure 7: An elevated view of the accident site.
