PRELIMINARY ACCIDENT REPORT

Accident and Incident Investigations Division

Accident
- Preliminary Report -
AIID Ref No: CA18/2/3/10248

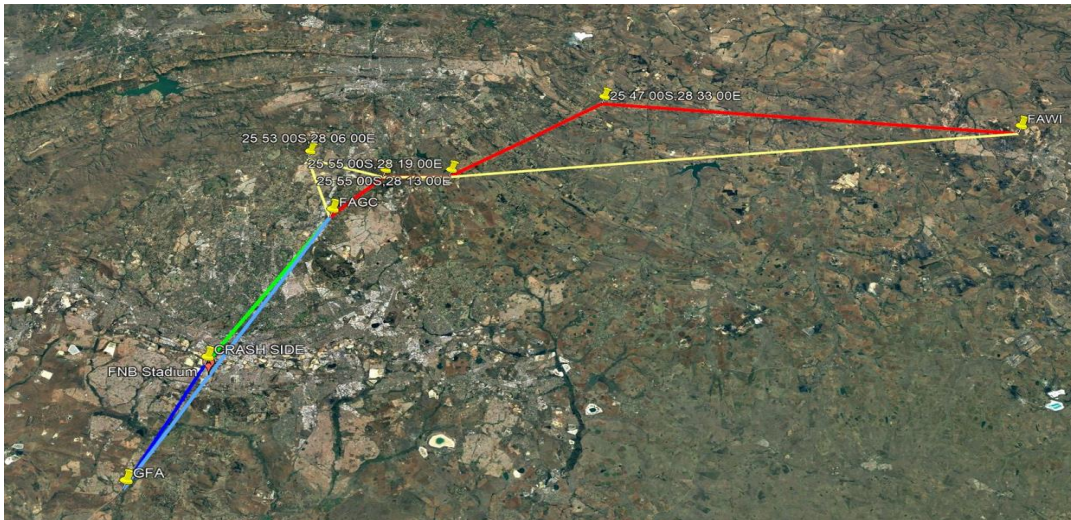
1.1.4 According to their flight path (Figure 2), the crew was supposed to fly east from FAGC as indicated by the red line, however after two circuits (and during the third circuit) they requested to route to Johannesburg South (GFA).

Figure 2: The planned flight path. The red line indicates the filed flight path (departure path), the yellow line indicates the filed planned return path, the green line indicates the path they took, the light blue line indicates the route from FAGC to GFA, and the dark blue line indicates the route from Johannesburg GFA to the crash site. (Source: Google Earth)

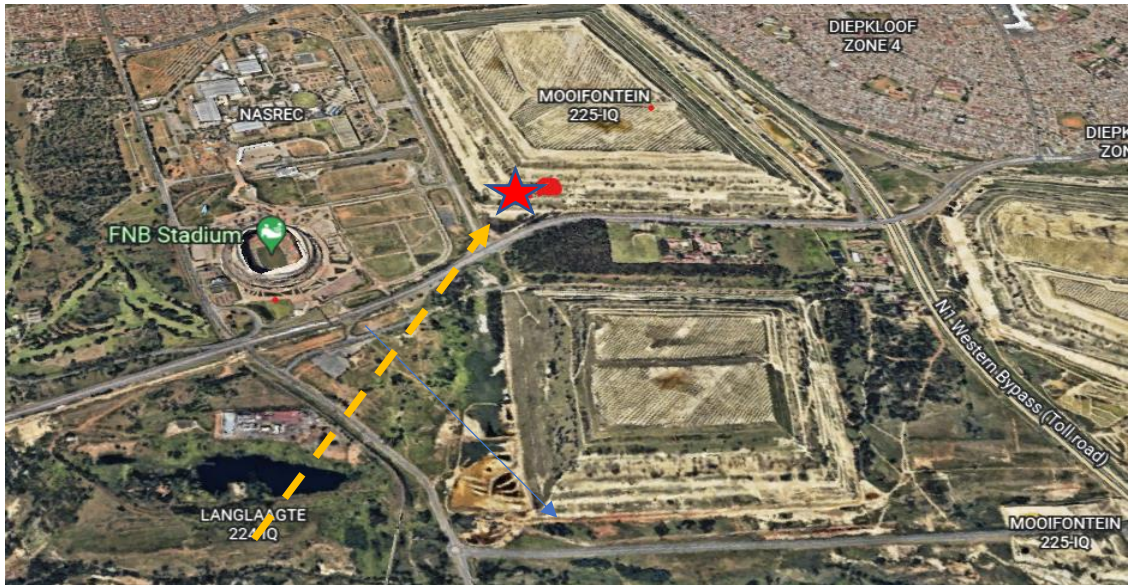
1.1.8 The accident occurred during daylight at the base of Crown Mine dump site at Global Positioning System (GPS) co-ordinates determined to be 26°14'05.5” South and 027°58'24.0” East, at an elevation of 5600 feet (ft).

Figure 3: The yellow line shows the flight path, and the red star indicates the crash site. (Source: Google Earth)

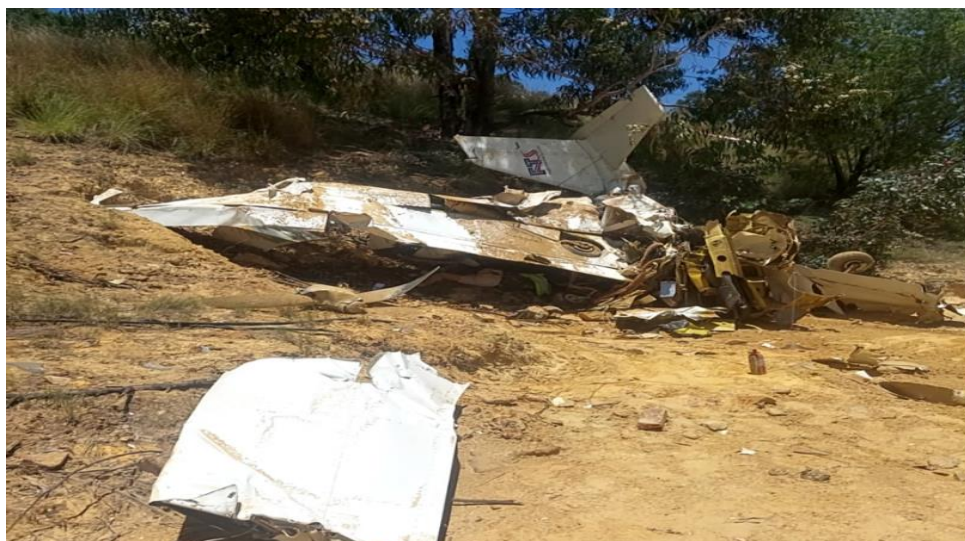
1.3.1 The aircraft was destroyed during the accident sequence.

Figure 4: The ZS-EAW aircraft post-accident.

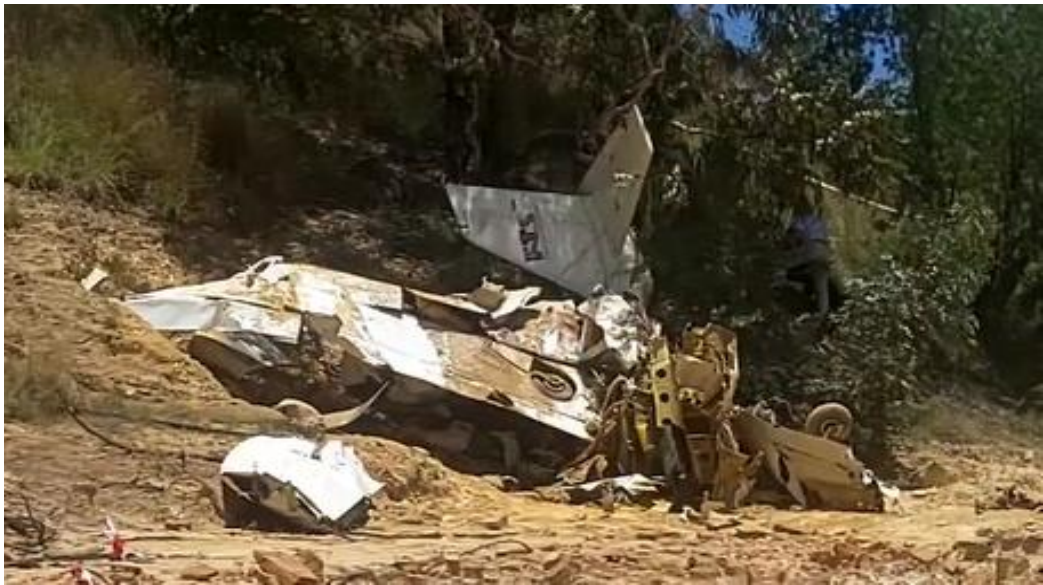
1.12.1 The aircraft struck the ground at a high speed at Crown Mines dump site, located southwest of Johannesburg central business district (CBD). The aircraft first impacted the ground with its left-side and bounced approximately 4 metres, it then hit the ground the second time, and bounced again approximately 6 metres. It finally impacted a hillock and flipped over. Fragments of the left engine were found scattered on the hillock. A piece of the left wing tip was found approximately 4 metres on the left-side of the main wreckage.

1.12.2 The pilot's body was found approximately 2 metres from the wreckage, whilst the flight instructor's body was found under the wreckage. The aircraft was crushed from the mid-section to the nose section.

1.12.3 The left main gear and the nose gear were found in an extended position, whilst the right main gear was in a retracted position. The landing gears were found selected in the "Down" position. The rudder and the right elevator were still intact whilst the left elevator was bent towards the tip. The flight controls (rudder and the elevator) were checked for movement, which was confirmed. Also, the cables were checked for continuity, and they were found to be intact.

Figure 5: The after it flipped over.

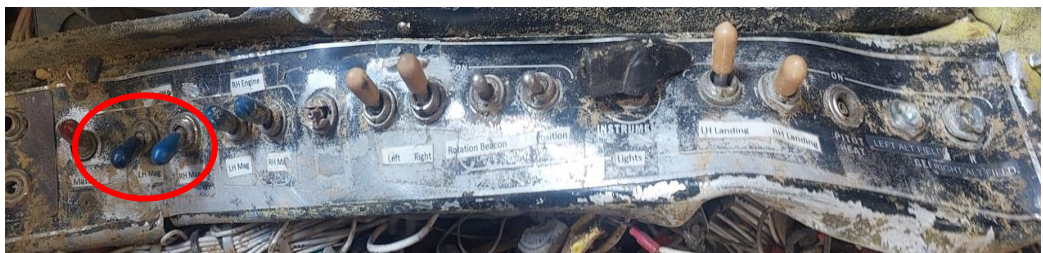
1.12.4 During the on-site inspection of the instrument panels, both the left-side engine magneto switches were in the 'off' position and the instrument indications were damaged by impact forces.

Figure 6: The cockpit instrument with the left-side magneto switch in the 'off' position.

- 2.2.9 The on-site inspection of the instrument panel indicated that both the left-side engine magneto switches were in the 'off' position and the instrument indications were damaged by impact forces.

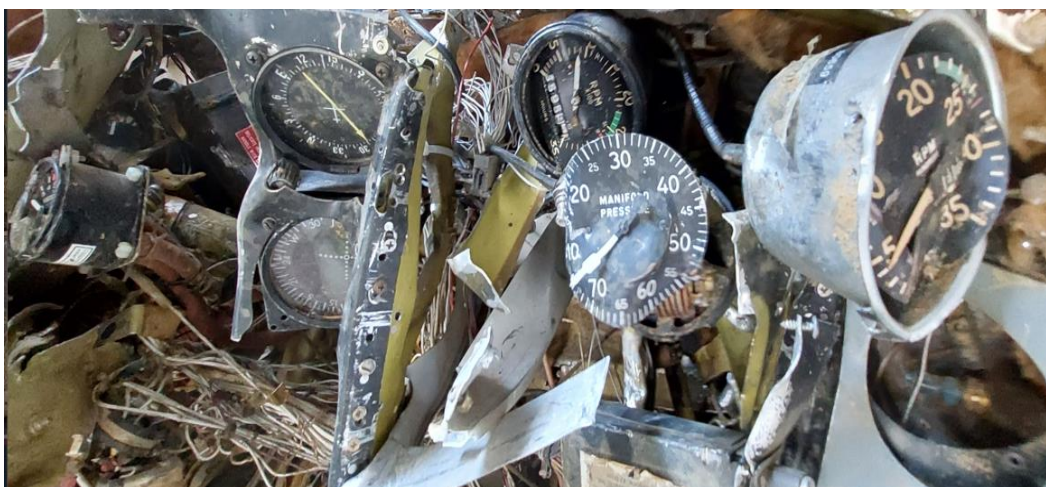
Figure 7: The damaged instruments.

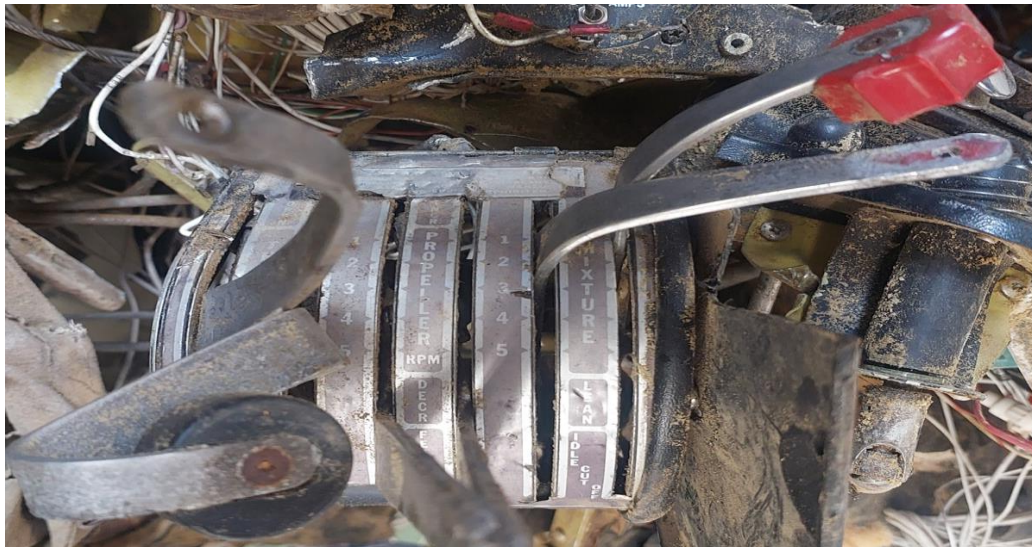
- Left- and right-side engine power levers were towards the “closed” position.
- Left- and right-side propeller levers were feathered.
- Left- and right-side mixture control levers were at full rich.
- Levers were bent and hard to move (forward or backward).

Figure 8: The console showing the position of the power levers.

- 2.2.10 Following the accident, the aircraft console's:
- Left- and right-side engine power levers were towards the "closed" position.
 - Left- and right-side propeller levers were feathered.

- Left- and right-side mixture control levers were at full rich.
 - Levers were bent and hard to move (forward or backward).
- 2.2.11 On-site examination of the engines found that the right-side engine was still intact with no impact damage, whilst the left-side engine was damaged on impact with the ground. Both engines' crankshafts were rotated by hand, and they turned freely with evidence of compression. There was an oil leak from both engines.

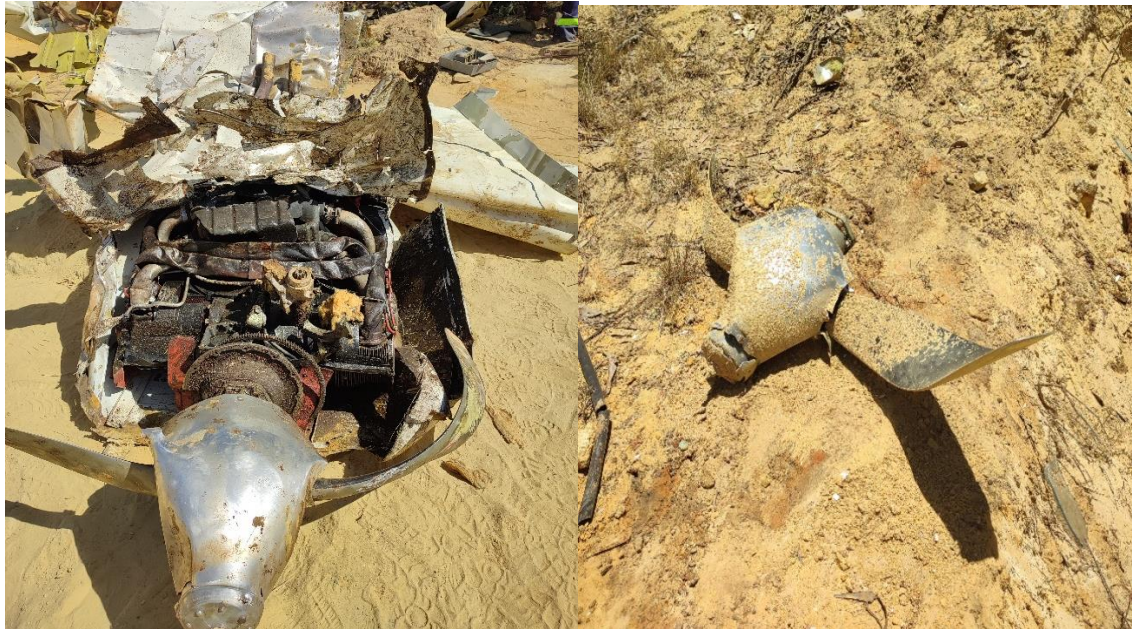
1.12.6 During the on-site examination of the engines, the right-side engine was still intact with no impact damage, whilst the left-side engine was damaged on impact with the ground. Both engines' crankshafts were rotated by hand, and they turned freely with evidence of compression. There was an oil leak from both engines.

1.12.7 The inspection of the airframe, engine and propeller indicated that there was no pre-impact failures, and all damage was attributed to the impact forces. Both engines will be subjected to a teardown inspection.

Figure 9: The bent propellers.

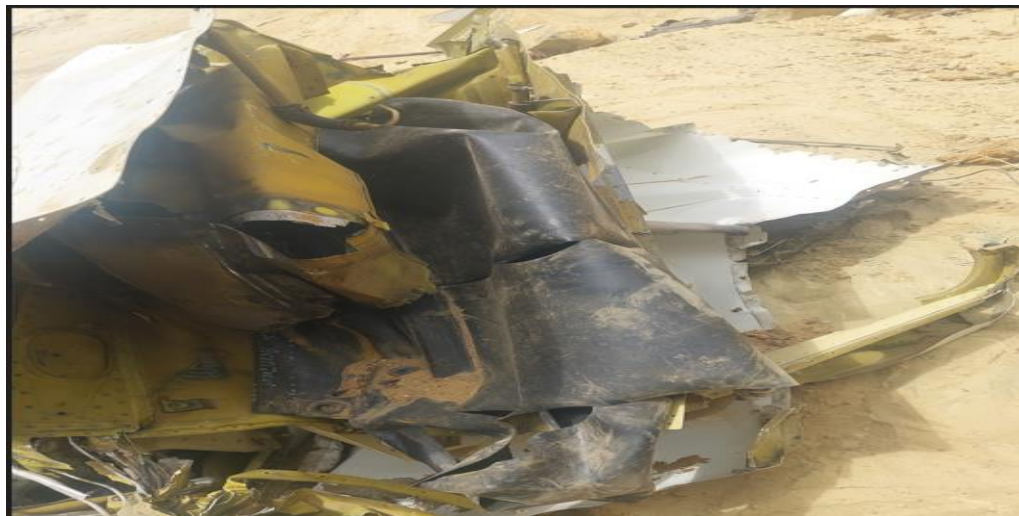
1.12.8 The right tank switch was in the “auxiliary” (Aux) position whilst the left tank switch was in the “off” position. The aircraft’s main and auxiliary fuel bladder tanks had ruptured, and the fuel leaked to the ground.

Figure 10: The ruptured fuel bladder tanks.

- 2.2.13 The right tank switch was in the "auxiliary" (Aux) position whilst the left tank switch was in the "off" position. The aircraft's main and auxiliary fuel bladder tanks were found ruptured, and the fuel leaked to the ground.
