**PRELIMINARY ACCIDENT REPORT**

**Accident and Incident Investigations Division**

Accident  
- Preliminary Report -  
AIID Ref No: CA18/2/3/10664

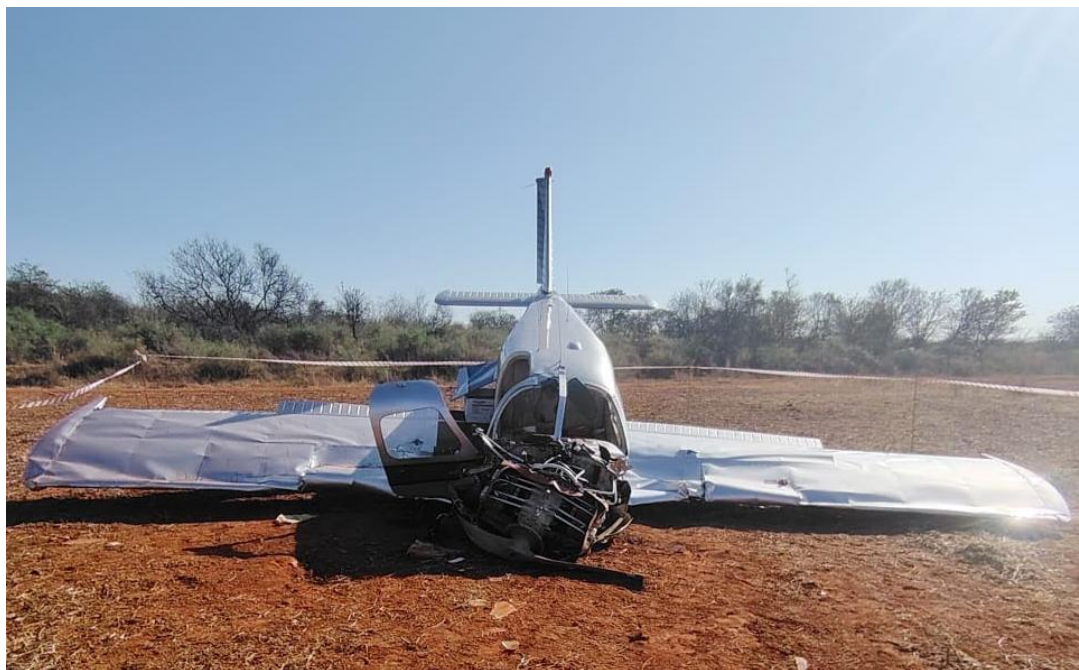
1.3.1. The aircraft was destroyed during the accident.

**Figure 2:** The wreckage at the accident site.

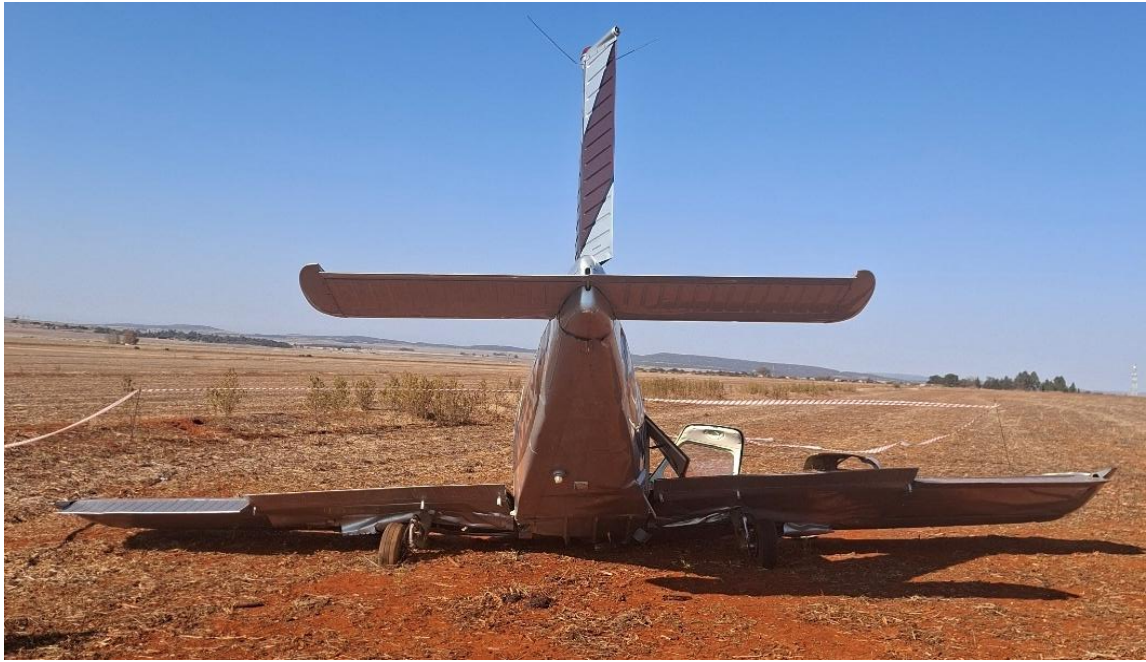
1.12.2. During the examination of the aircraft, all flight controls were confirmed but one, which was the flight control continuity. The ailerons could not be moved and were both in the Down position. The elevator and rudder moved freely (see Figure 3).

1.12.3. The undercarriage broke and collapsed rearwards during the accident (see Figure 3).

**Figure 3:** The rear view of the aircraft after the accident.

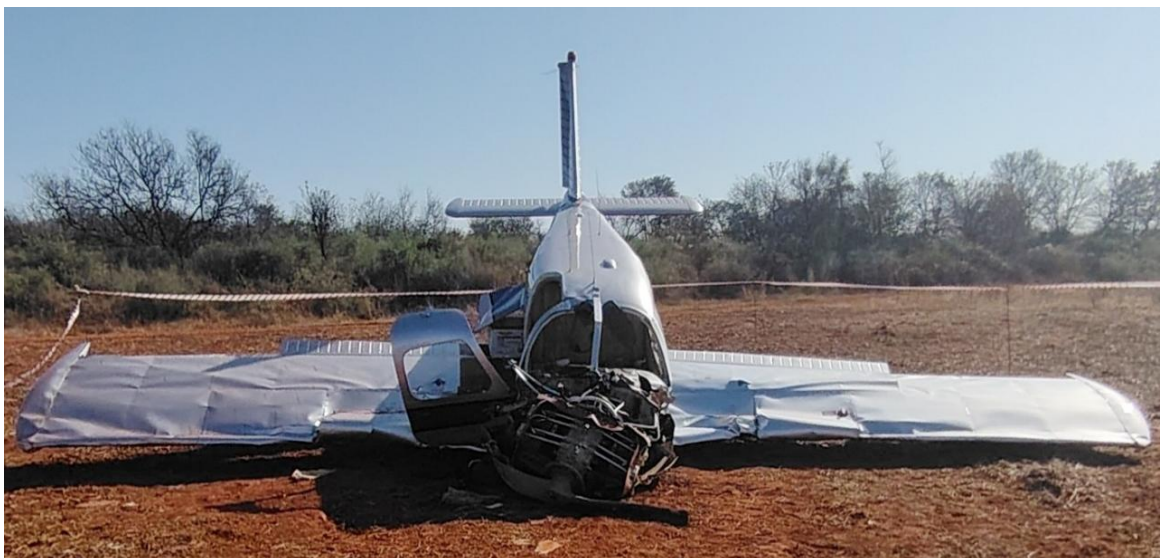
1.12.4. Both wings exhibited severe damage to the leading edges, along with accordion-like wrinkling (deformation) of the skin which ruptured the fuel tanks. The damage was consistent with compressive loading from the front of the wing during rapid deceleration, resulting from the steep nose-down impact (see Figure 4).

**Figure 4:** The damaged propeller and wings.

1.12.5. The top engine cowling had broken off and was found approximately 10 metres forward of the main wreckage. The engine cradle was deformed, and the engine was facing slightly to the right (see Figure 4).

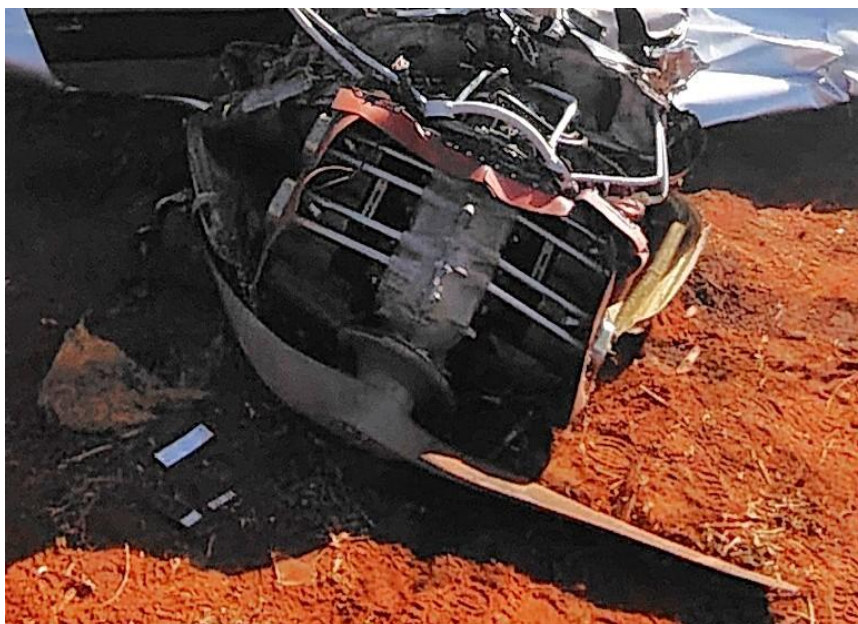
1.12.6. The propeller exhibited asymmetrical damage. One of the two blades was bent rearwards and the other displayed little to no deformation. Neither blade showed evidence of S-curve bending. The damage pattern was consistent with a non-rotating propeller at the time of impact (see Figure 5).

**Figure 5:** The state of the propellers after the accident.

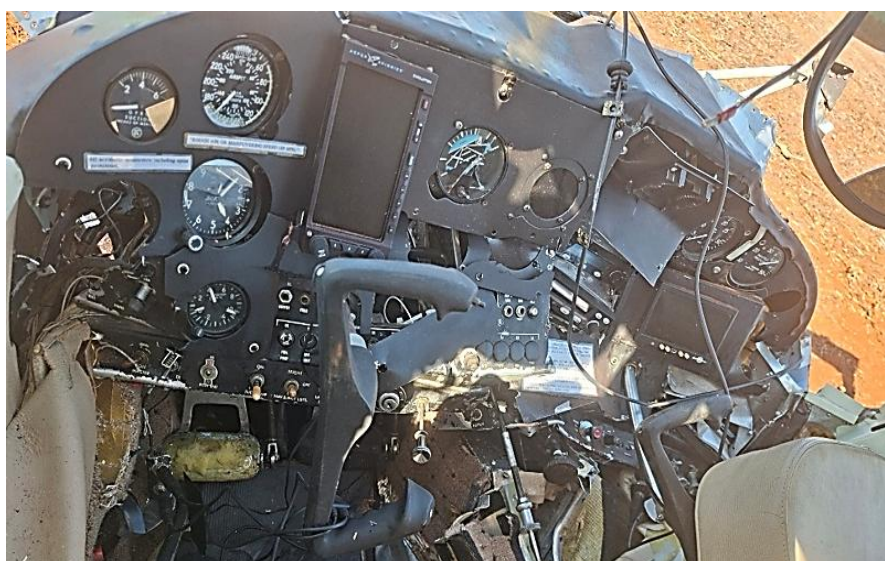
1.12.7. The instrument panel had broken into multiple pieces with various indicators found dislodged from their original positions (see Figure 6).

**Figure 6:** The aircraft's instrument panel.
