**PRELIMINARY SERIOUS INCIDENT REPORT**

**Accident and Incident Investigations Division**

Serious Incident  
- Preliminary Report -  
AIID Ref No: CA18/3/2/1447

On Sunday morning, 21 April 2024 at approximately 0948Z, a Boeing 737-800 aircraft with registration ZS-FGE was on a scheduled commercial flight from O.R. Tambo International Aerodrome (FAOR) in Gauteng province to Cape Town International Aerodrome (FACT) in the Western Cape province when the left outer (No.1) mainwheel separated from its axle during rotation. The crew opted to fly to the holding pattern to burn fuel. After being airborne for 2 hours and 17 minutes, the crew was cleared to land on Runway 21R at FAOR. The landing was uneventful; however, approximately 30 metres (m) before the aircraft was brought to a stop on the runway, the left inner (No. 2) mainwheel tyre burst. No person was injured during the serious incident.

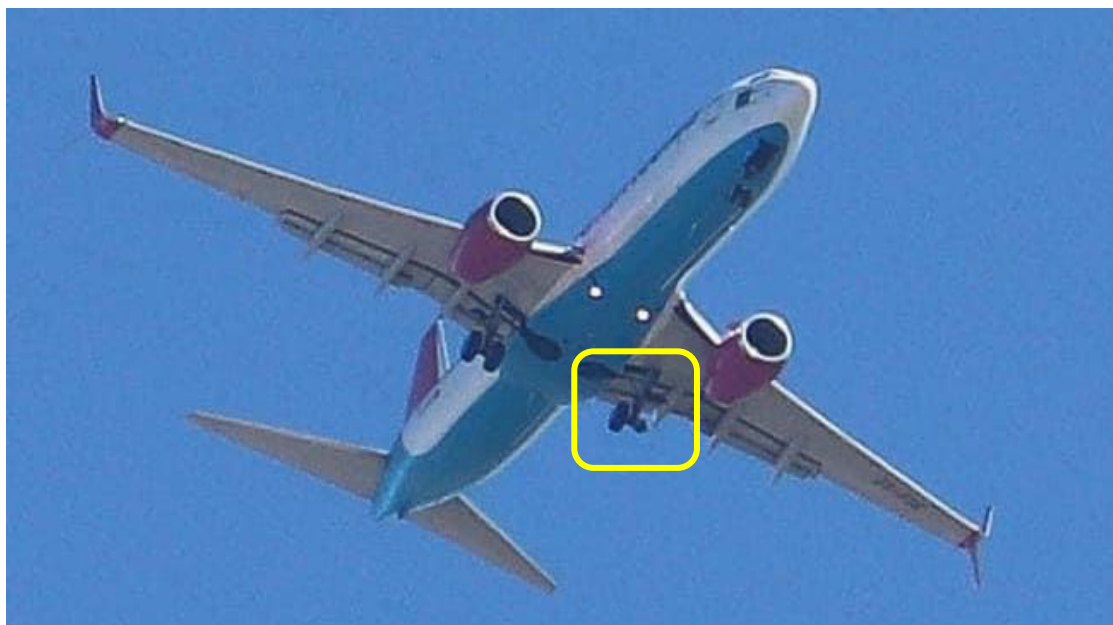
1.1.4 After being in the hold for approximately 90 minutes, the crew enquired from ATC if they could perform a low fly pass at their maintenance facility at FAOR with the landing gear extended to enable the technicians to assess the left main landing gear and advise accordingly. The request was granted, and the aircraft was cleared to 6 500ft, which was approximately 1 000ft above ground level (AGL). Figure 2 shows the missing left outer mainwheel.

**Figure 2:** The aircraft with the missing left outer mainwheel.

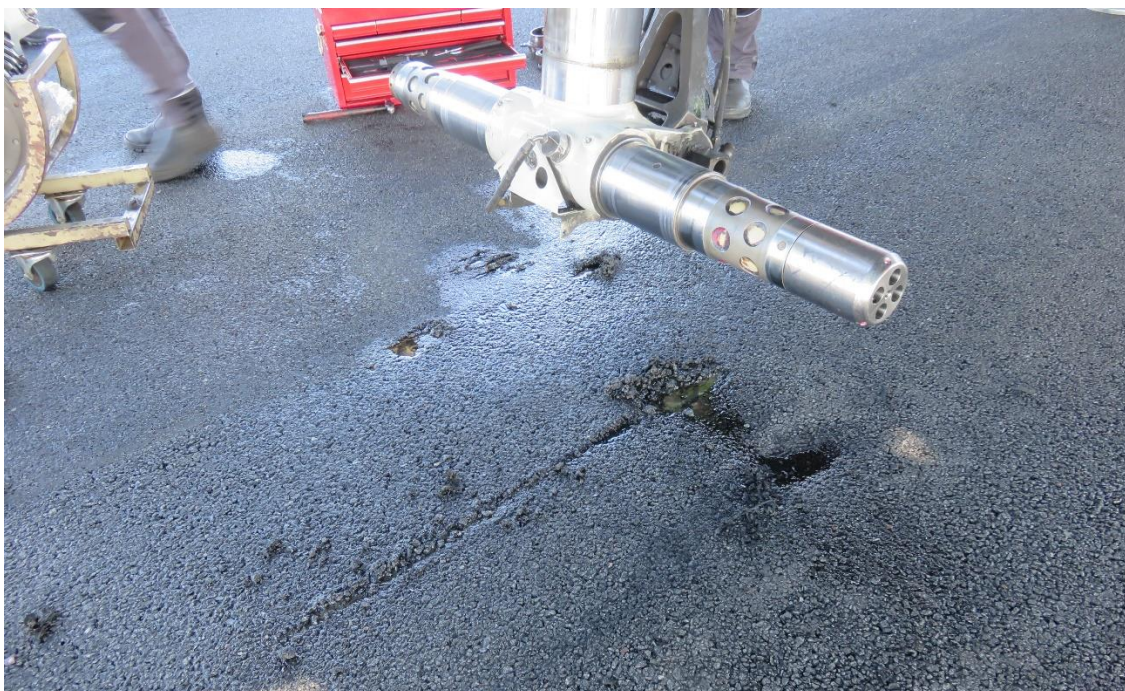
1.4.1 Minor damage was observed on the runway surface.

**Figure 4:** Damage to the runway surface where the aircraft had stopped.

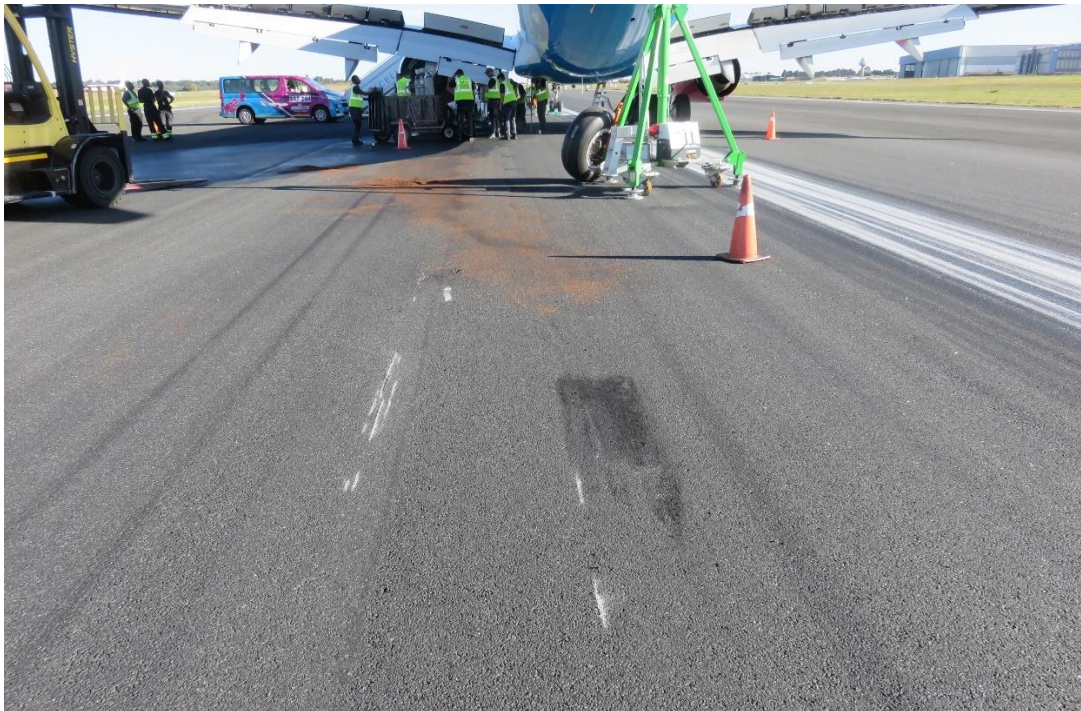
1.12.1 The crew performed a normal landing on Runway 21R after the left outer mainwheel separated from the axle. The left inner mainwheel tyre burst approximately 30m before the crew brought the aircraft to a stop on the runway centreline. The runway surface sustained minor damage (marks) because of the collapsed and missing outer mainwheel and the burst inner tyre.

**Figure 5:** First markings on the runway surface caused by the brake assembly and the inner wheel rim when they contacted the runway.

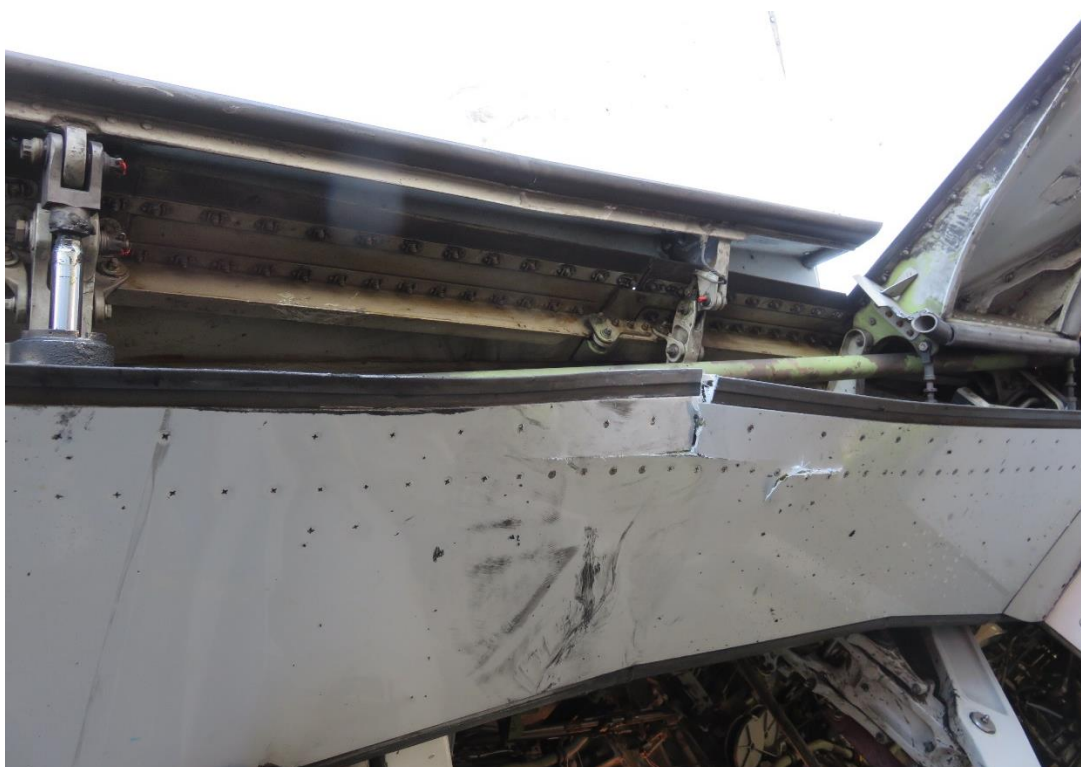
1.3.1 The left main landing gear on the left outer brake unit was damaged. Minor damage was observed on the left inboard flap and the inboard ground spoiler which was caused by debris from the burst tyre.

**Figure 6:** The ground spoiler protection fairing that was damaged by the tyre debris.

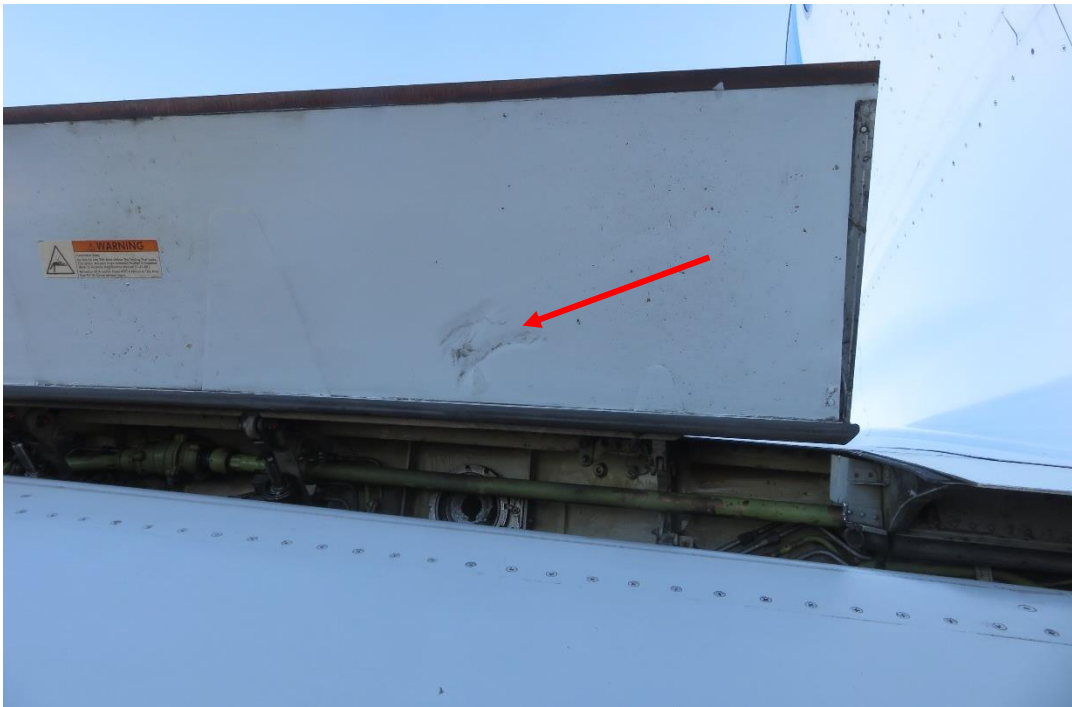
**Figure 7:** Damage on the inboard ground spoiler caused by the tyre debris.

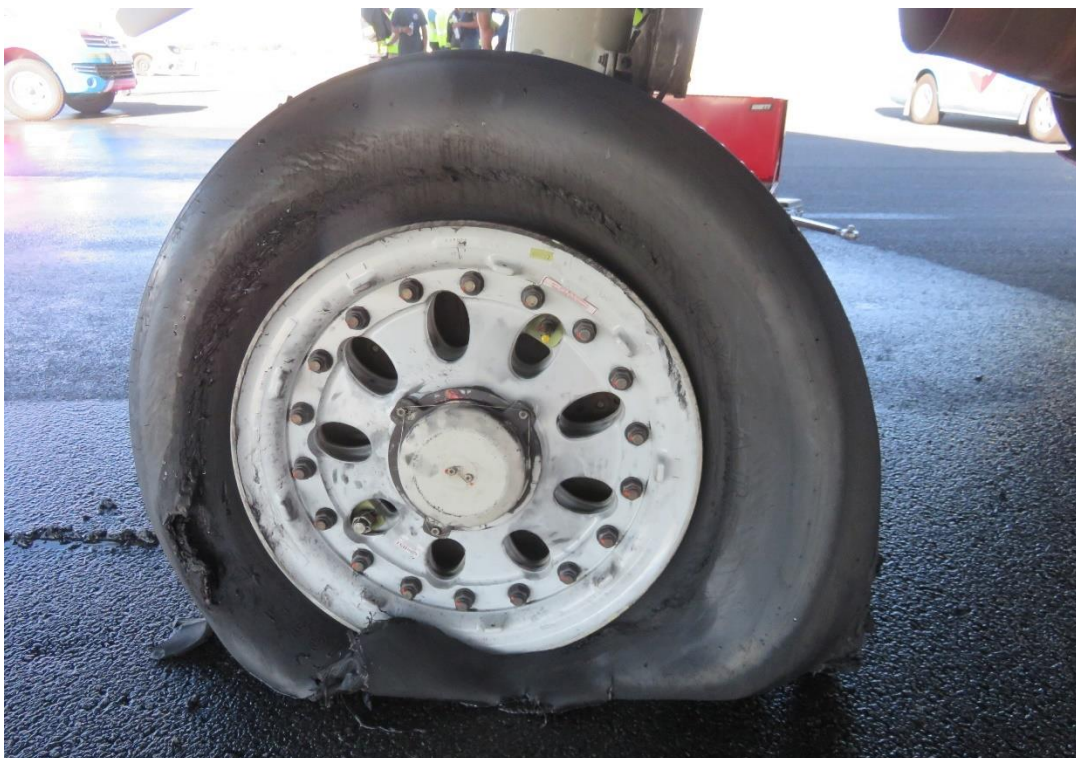
**Figure 8:** The left inner mainwheel tyre that burst during the landing roll.

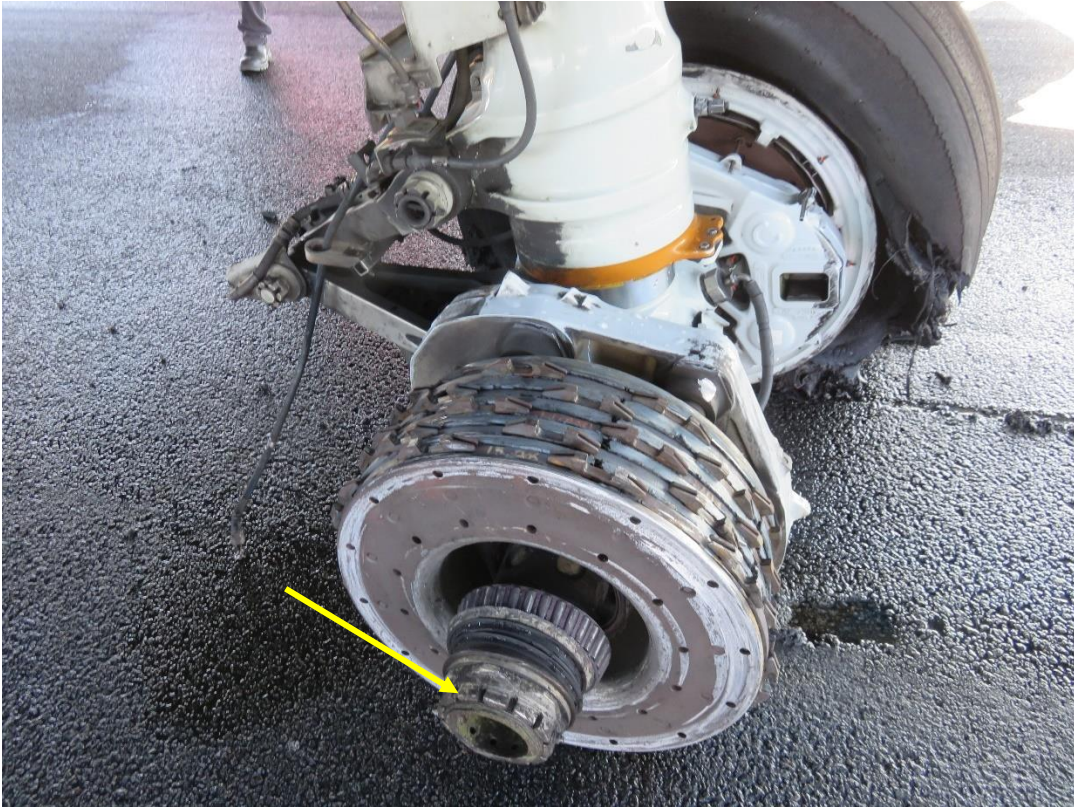
**Figure 9:** The left mainwheel brake assembly with the wheel nut still secured to the axle.

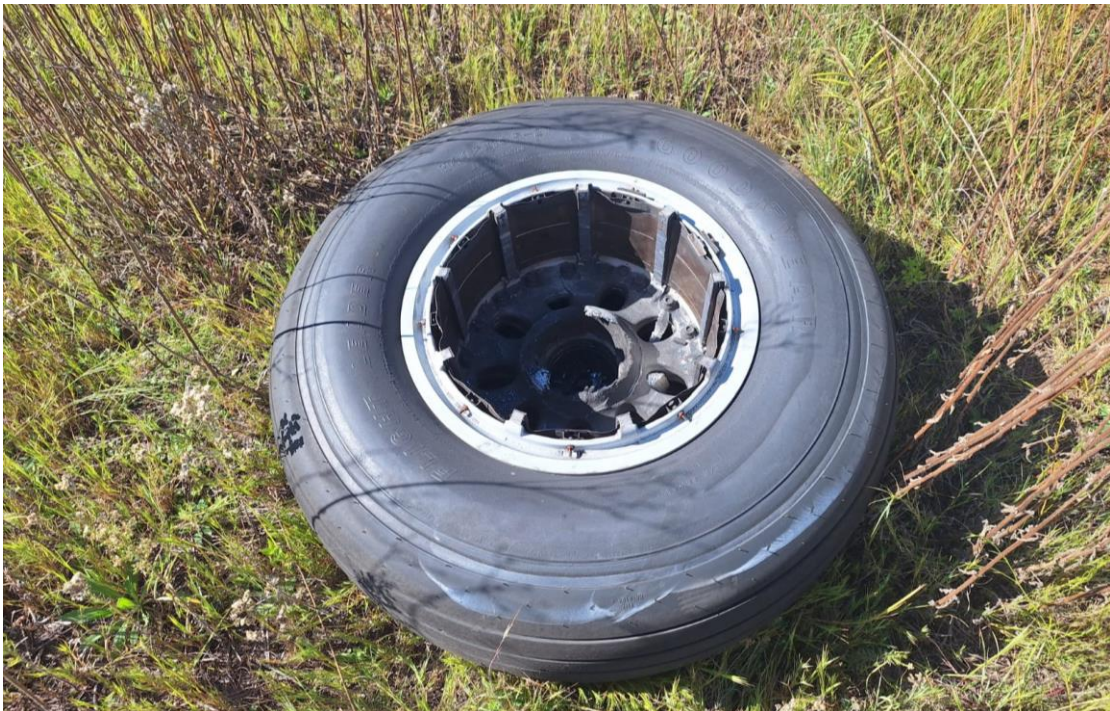
**Figure 10:** The left outer mainwheel assembly as it was found within the aerodrome parameter.

2.2.6 The mainwheel that separated from the axle was installed on the aircraft on 6 April 2024; it had since completed 67 cycles. It was last overhauled on 13 September 2023 and had since completed 963 cycles.
