PRELIMINARY ACCIDENT REPORT

Accident and Incident Investigations Division

Accident
- Preliminary Report -
AIID Ref No: CA18/2/3/10415

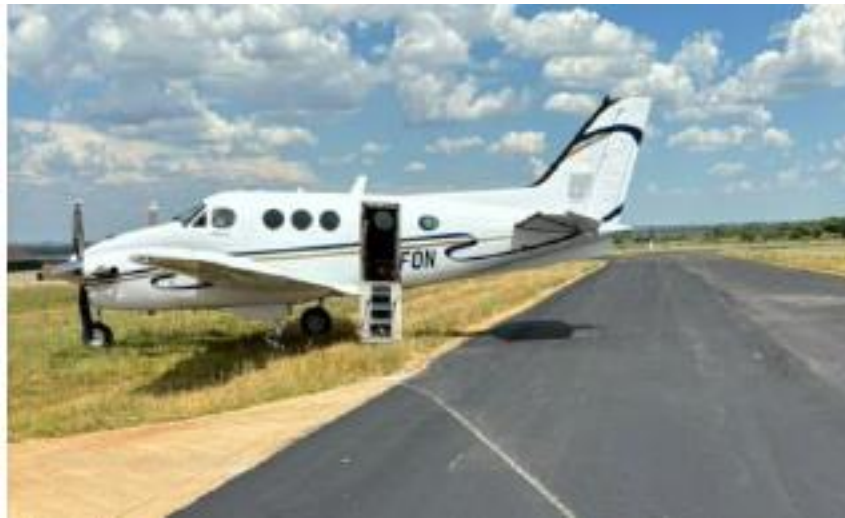
Figure 1: File picture of the aircraft post-accident. (Source: Operator)

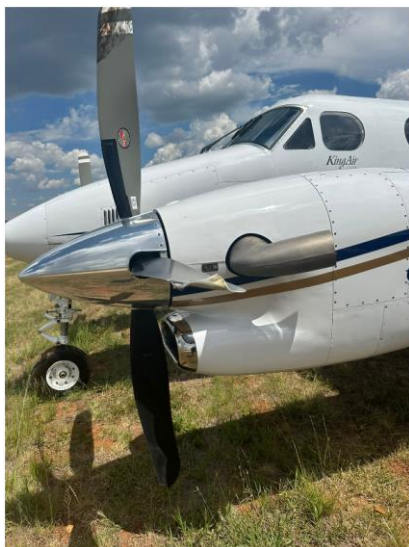
1.3.1. The No.1 engine propeller blades and the left-side gear wheel assembly (hubs and bearings) were damaged.

Figures 3 and 4: Damage to the No.1 engine propeller blades (left) and the left-side wheel assembly hubs (right).

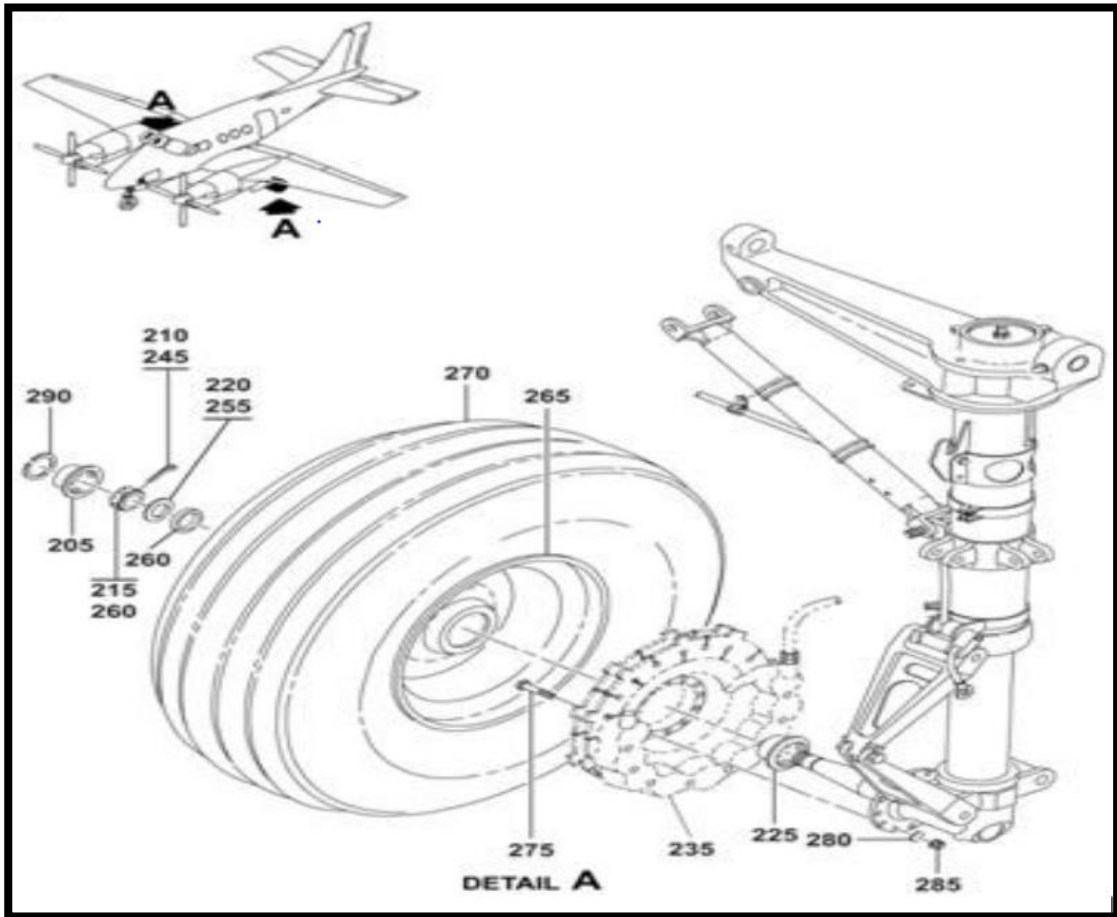
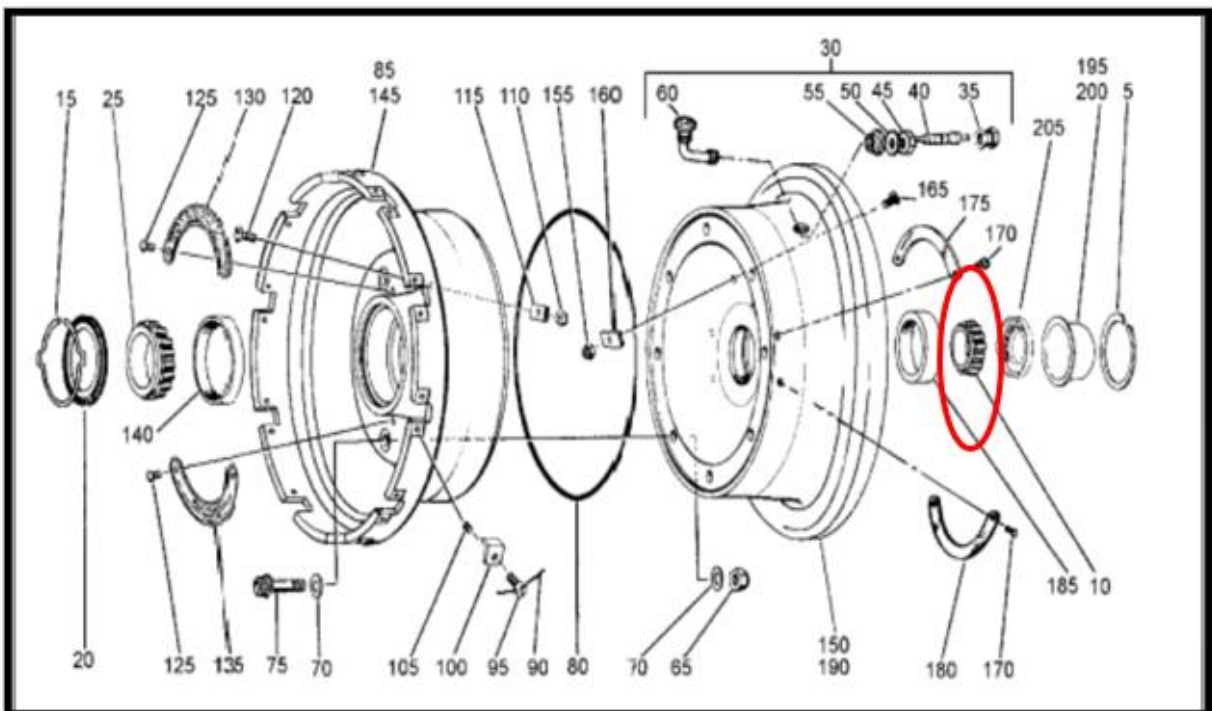
Diagram / Tables 1: The main landing gear wheel assembly sketch and explanatory tables.

1.6.4 The left-side main wheel outer bearing (item number 10 in the Diagram / Table 1) was damaged, which resulted in the main wheel assembly separating from the axle.

- 2.2.9 The left-side main wheel outer bearing item number 10 (Diagram / Table 1) was damaged which caused the main wheel assembly to separate from the axle. As a result, the No.1 engine propeller blades and the left-side gear wheel assembly were damaged.

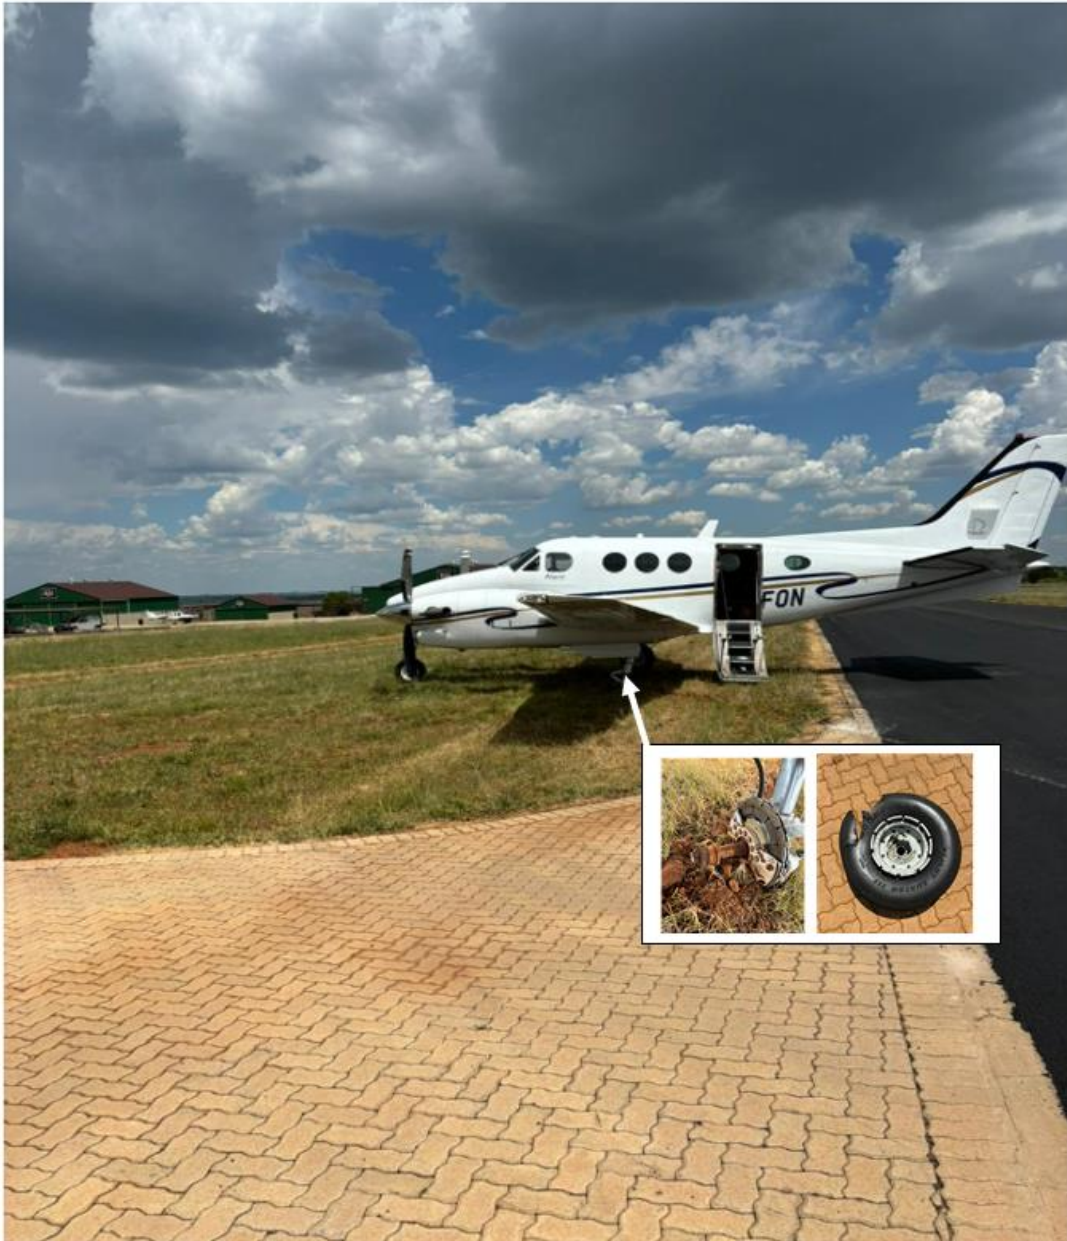
1.12.1. During the landing roll on Runway 17 at Bona-Bona Lodge Airfield, the No. 1 engine propeller blades contacted the left main gear wheel assembly which separated from the axle. The aircraft skidded on its left gear brake assembly for approximately 38m before it stopped on the grass on the left side of Runway 17.

Figure 5: Damaged tyre struck by the propeller blades. (Source: Pilot)

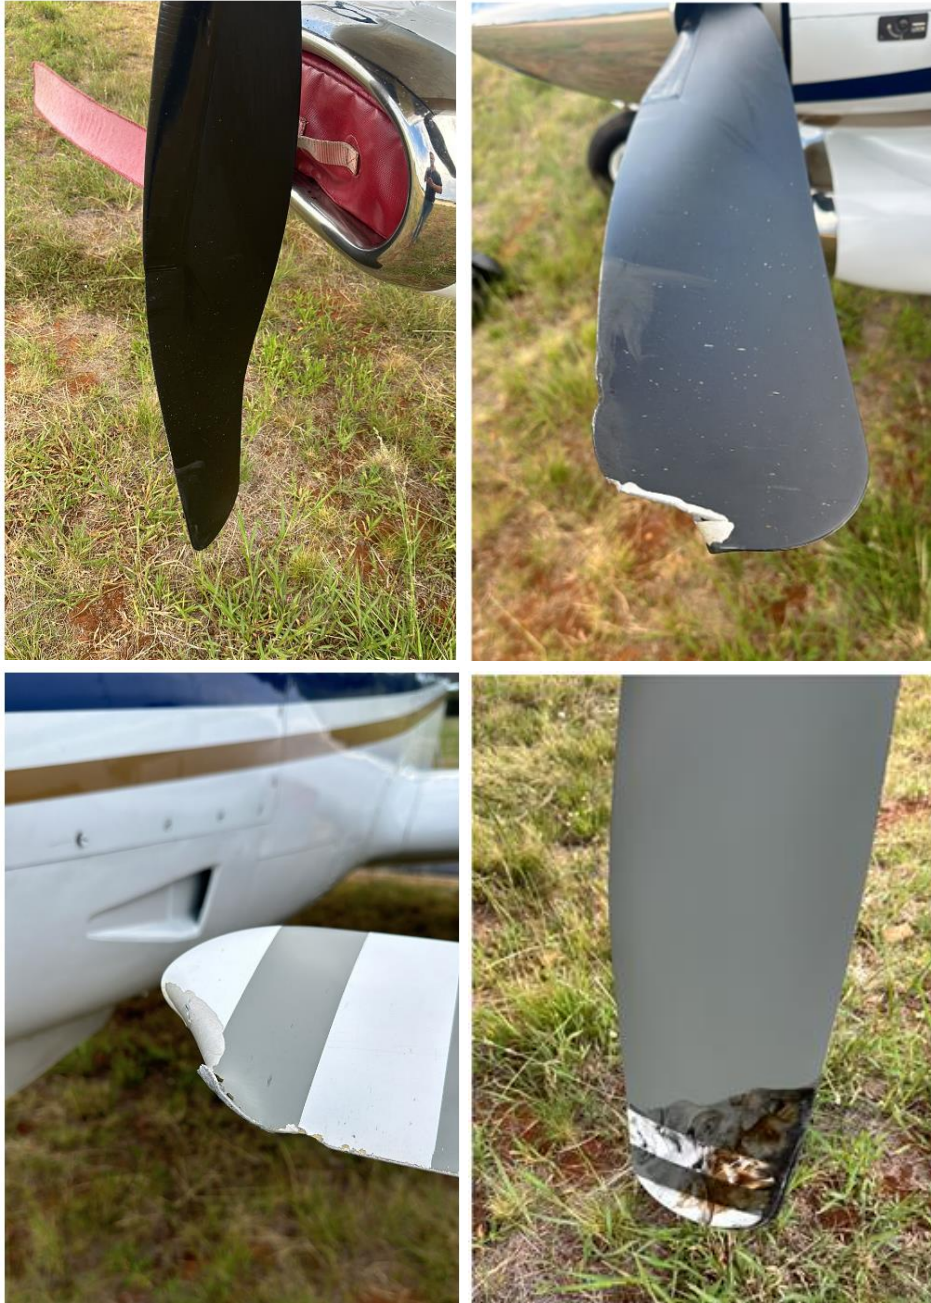
Figures 6, 7, 8 and 9: Damage sustained to the four (4) propeller blades. (Source: Pilot)
