PRELIMINARY ACCIDENT REPORT

Accident and Incident Investigations Division

Accident
- Preliminary Report -
AIID Ref No: CA18/2/3/10606

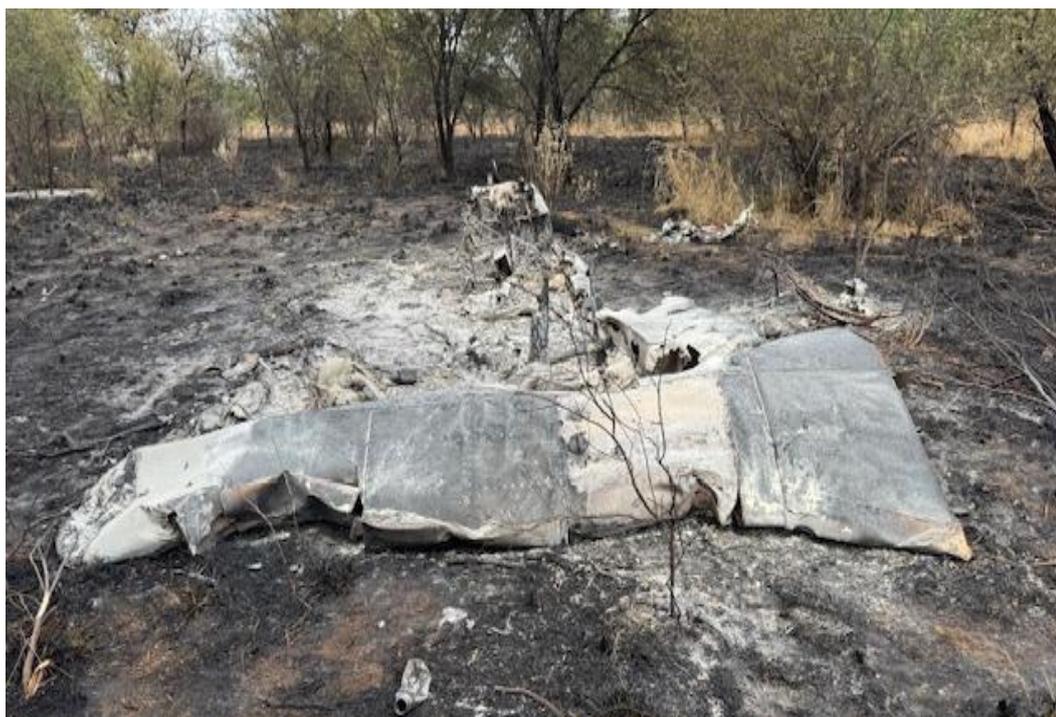
1.3.1. The aircraft was destroyed by post-impact fire.

Figure 3: The wreckage at the accident site.

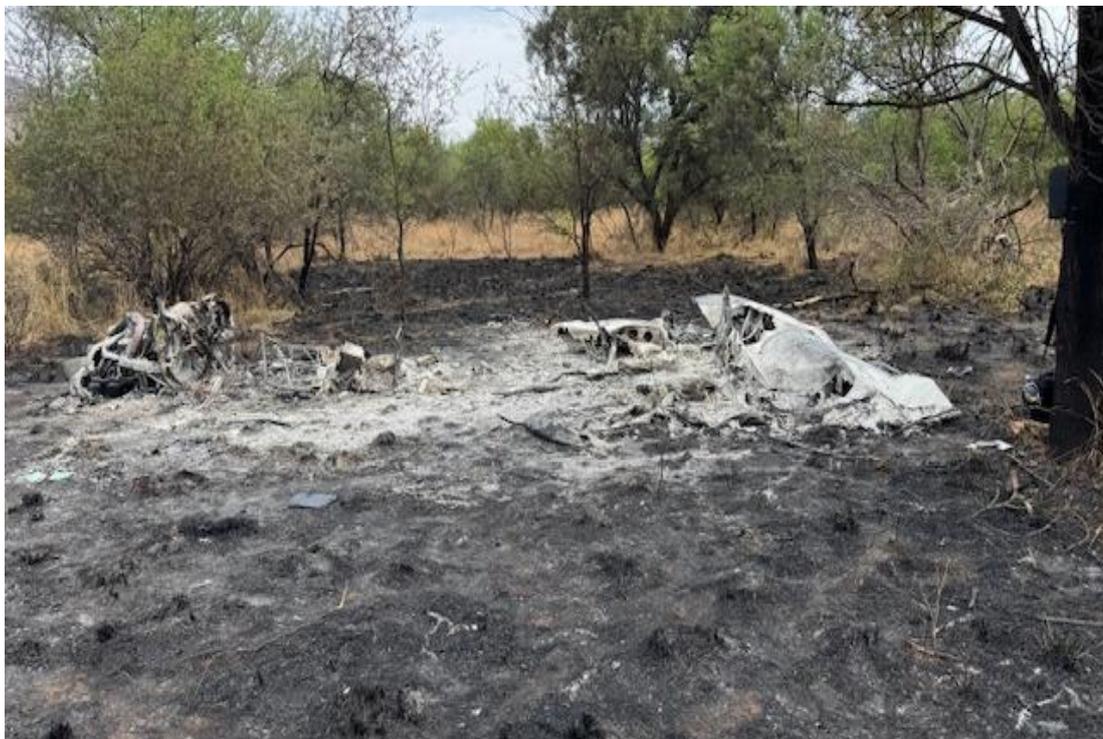
1.12.1. The first point of impact was a tree located south-westerly at GPS co-ordinates 25°21'6"S 27°9'38"E and at an elevation of 3 412 ft. After the initial impact with the tree, the aircraft continued forward and struck two smaller trees whilst in a left-wing low attitude (*the trees were approximately 4 metres from the final position of the main wreckage*). The aircraft subsequently impacted a larger tree; this caused the left wing to wrap-around the trunk and, as a result, the bark of the tree was stripped from the point of contact. The right wing remained largely intact; however, the left wing was destroyed by the post-impact fire that ensued.

Figure 10: The wreckage after the fire was extinguished.

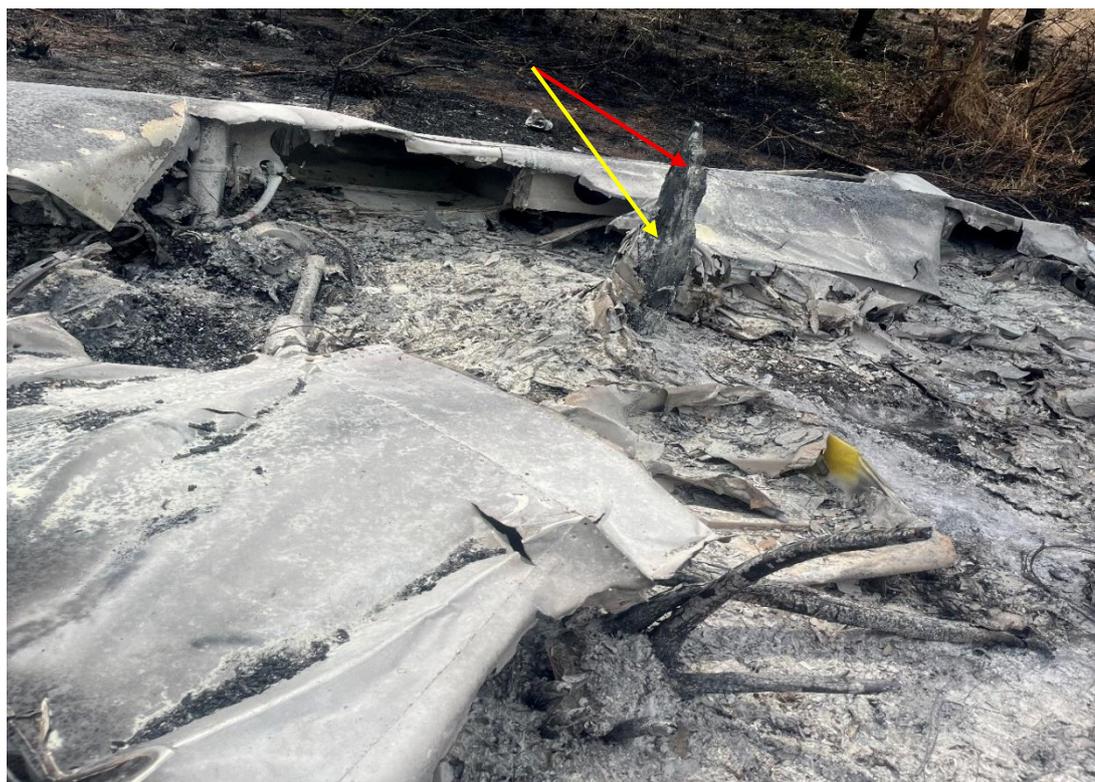
Figure 11: The right wing and the left wing wrapped around the tree trunk (red and yellow arrows).

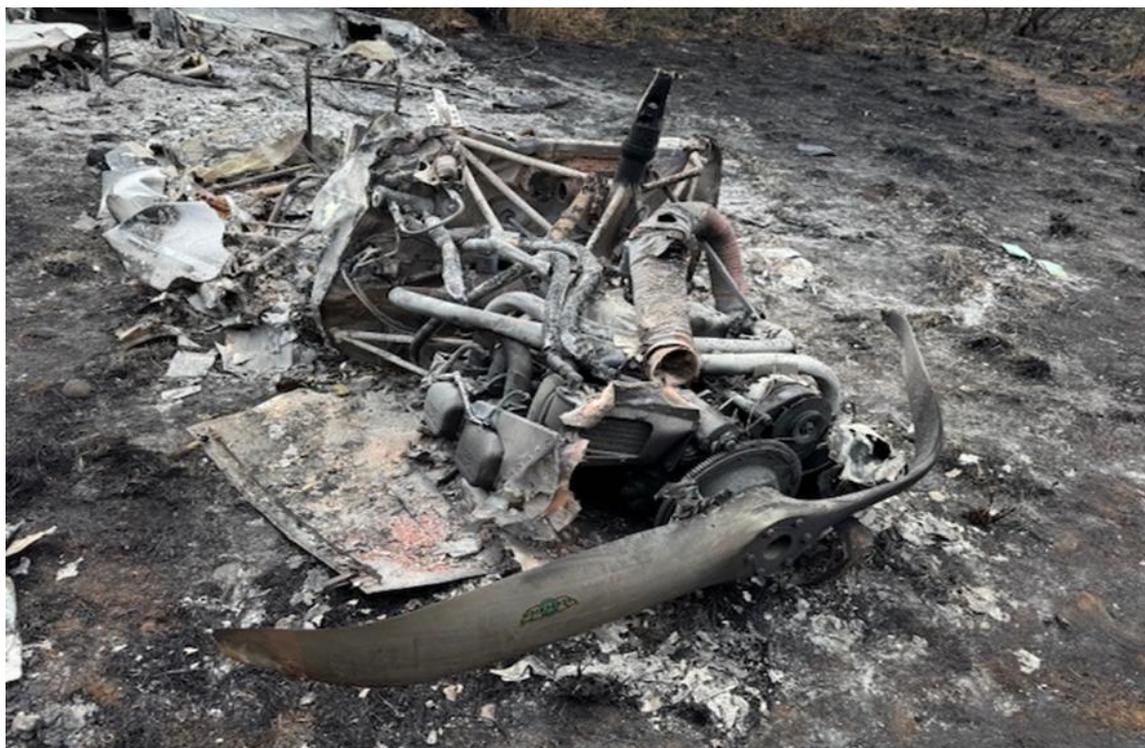
1.12.3. Examination of the engine revealed significant thermal and fire damage. The propeller blades displayed minimal deformation and no evidence of rotational scoring or chordwise scratches, indicative that the engine was not producing power at the time of impact. The extent and nature of the damage of the aircraft were consistent with a low-energy impact, followed by an intense post-impact fire. The aircraft was destroyed by fire, which consumed the majority of the fuselage, cockpit and left-wing structure.

Figure 12: The engine and propeller blades exhibited minimal deformation.
