INTERIM STATEMENT

Accident and Incident Investigations Division

Accident
- Interim Statement -
AIID Ref No: CA18/2/3/10064

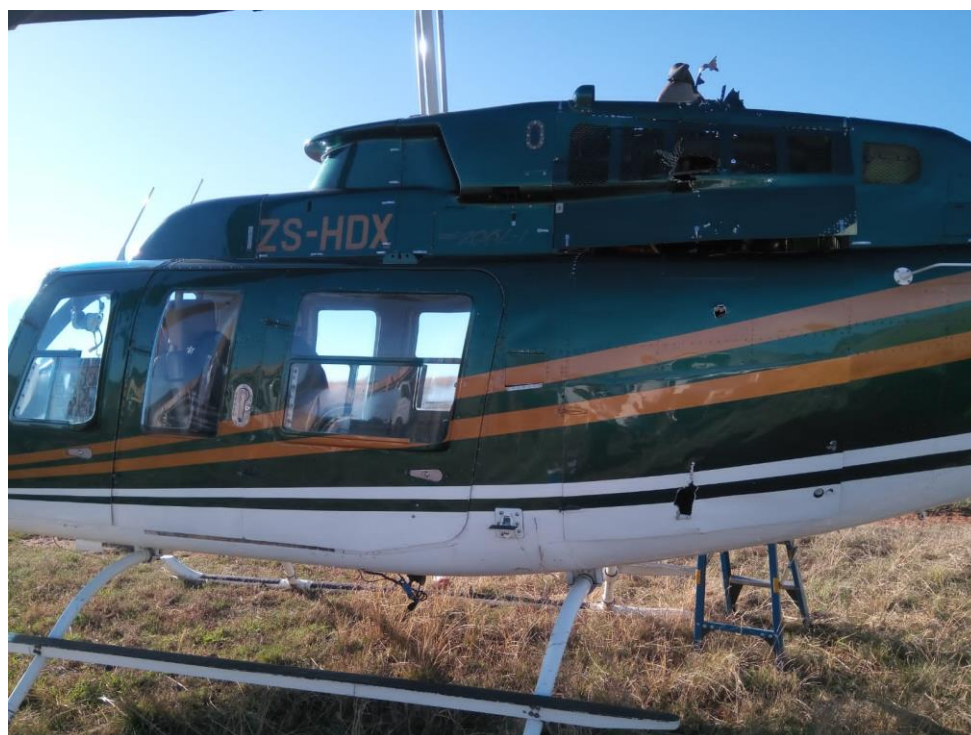
Figure 1: The Bell 206L helicopter, ZS-HDX, as it came to rest post-accident.

On 2 November 2021 at 0925Z, a pilot and a passenger on-board a Bell 206L helicopter with registration ZS-HDX were engaged in a repositioning flight operation from Rand Airport (FAGM) in Gauteng province to Buffels Mine near Klerksdorp in the North West province. Approximately 35 minutes into the flight during the cruise phase, the pilot noticed an engine out warning light. Thereafter, he noticed that the cockpit indicators were on zero for the oil pressure, torque and gas generator (Ng). The rotor revolutions per minute (RRPM) and transmission oil temperature (TOT) gauges indications were normal. Immediately thereafter, a loud bang was heard, followed by a low RRPM warning which got activated. The pilot then induced autorotation and turned the helicopter into wind in preparation for a forced landing. However, all pedal controls were lost but the pilot was able to execute a successful forced landing and, thereafter, shut down the helicopter engine. A post-landing fire erupted in the engine bay, which the pilot extinguished using the on-board portable fire extinguisher. The pilot and the passenger did not sustain any injuries. The helicopter sustained damages to the engine, cowling, fuselage, tail rotor drive shaft and one main rotor blade.

After completing the emergency shutdown procedure and vacating the helicopter with the passenger unassisted, the pilot noticed smoke emanating from the engine bay. The source of the smoke was the fire that had erupted, which the pilot put out using the on-board fire extinguisher. The two occupants were not injured. The helicopter sustained damages to the turbine section, fuselage, tail rotor drive shaft and main rotor blade.
