PRELIMINARY ACCIDENT REPORT

Accident and Incident Investigations Division

Accident  
- Preliminary Report -  
AIID Ref No: CA18/2/3/10590

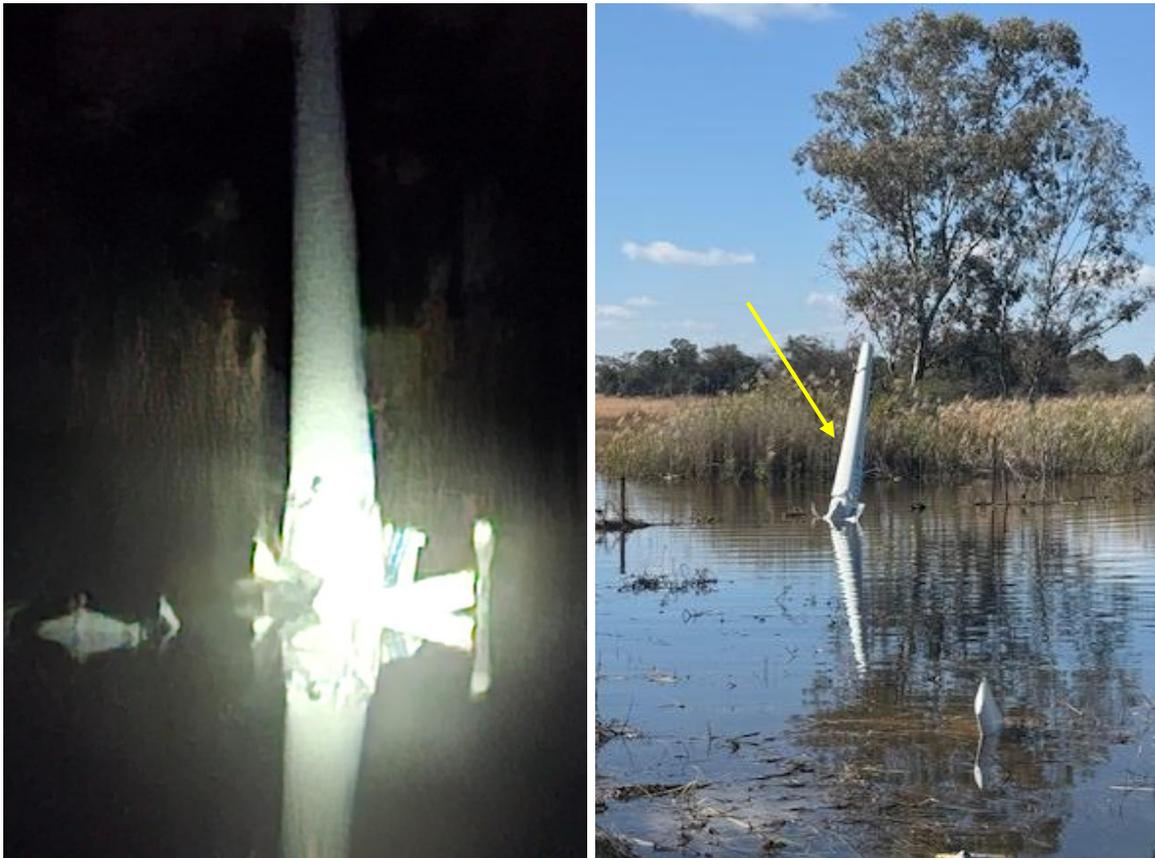
**Figures 4 and 5:** A picture of the helicopter taken whilst still dark (left picture). A picture (right) taken in the morning which shows the helicopter almost fully submerged in a flooded ditch with the tail boom tilted up (right picture). (Source: Farm production manager)

1.12.1 The accident occurred in a flooded ditch on the border of Metsi Berries Farm, approximately 600m from the lift-off point at an elevation of 4 067ft. All the major components were present at the site which indicated that nothing detached from the helicopter prior to impact. Evidence at the accident site showed that the helicopter was in a nose-down attitude before the accident. The helicopter first clipped the top of a tree with the main rotor before it crashed into the water on the side of the flooded ditch and at a heading of approximately 147°. The skid landing gears broke during the accident sequence. It was evident that a significant amount of energy at impact was absorbed by the skid landing gears. The stabiliser was severed after impact and was found close to a tree that the main rotor blade had struck. The helicopter came to rest in a flooded ditch next to a fence with the cockpit cabin area submerged in the water and the tail boom

tilted up. The tail boom structure showed compression damage. The main rotor mast and rotor head were still attached to the main gearbox. The V-belts remained attached to the upper sheave and were split between the vees. The upper sheave forward and aft faces had rotational scoring around the entire circumference. The clutch centering strut had rotational scoring running in the direction of rotation of the upper sheave.

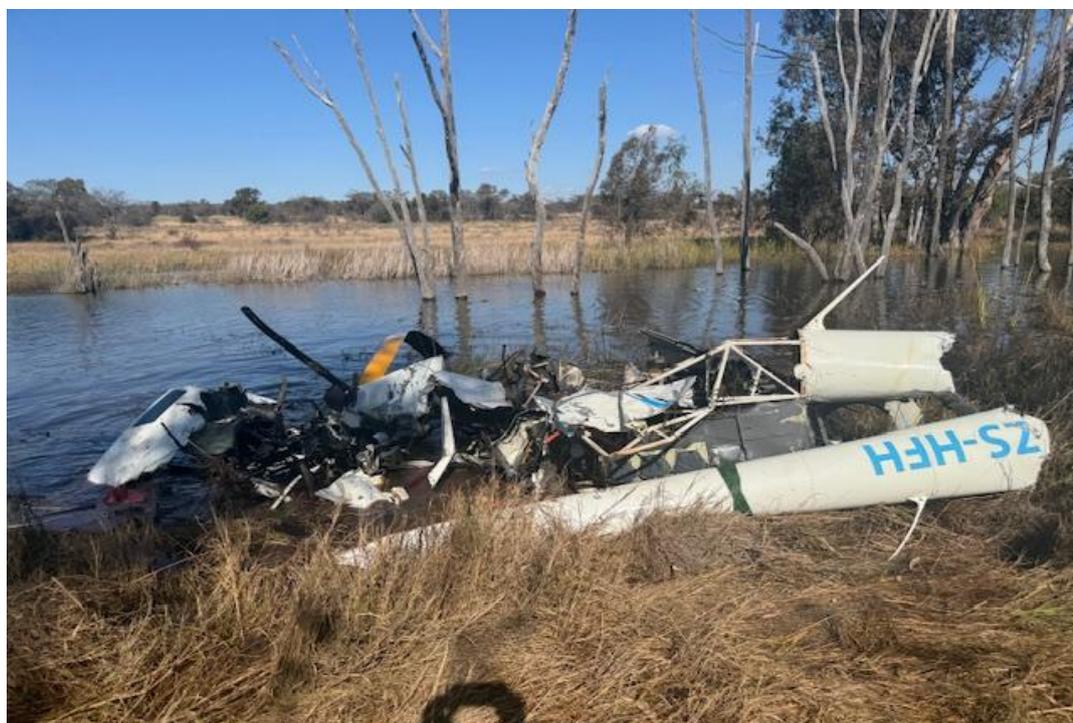
1.3.1. The helicopter was destroyed during the accident sequence.

**Figure 6:** The wreckage after it was recovered from the flooded ditch.

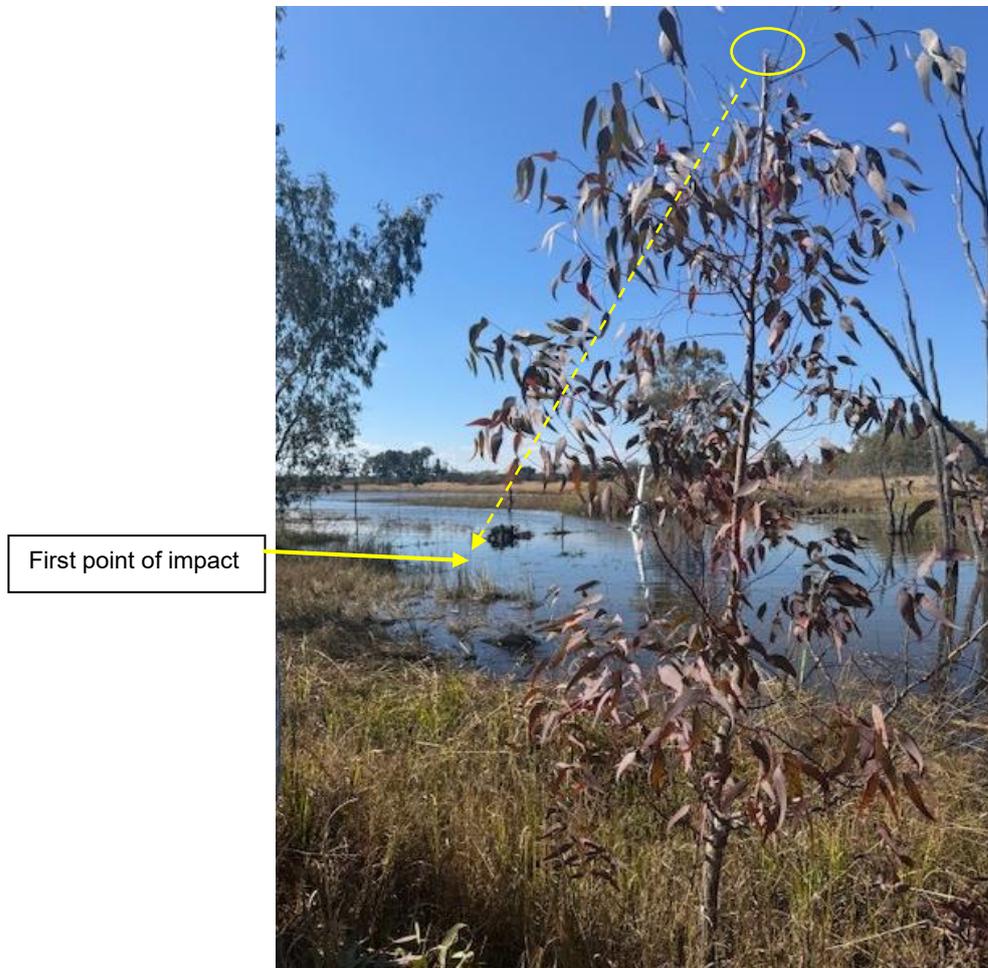
**Figure 7:** View of the first impact area and a tree that the helicopter clipped with the main rotor (yellow circle).

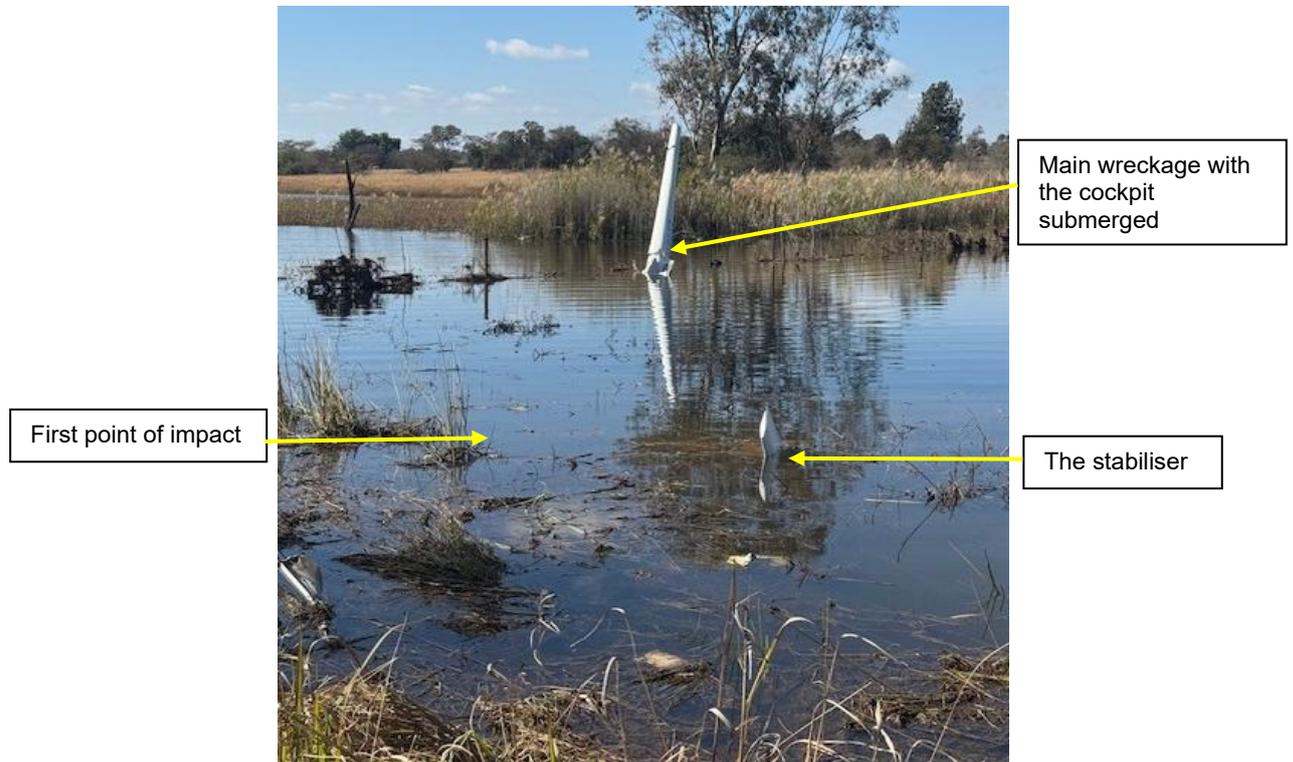
**Figure 8:** The first point of impact, the main wreckage and the stabiliser that separated during the accident sequence.

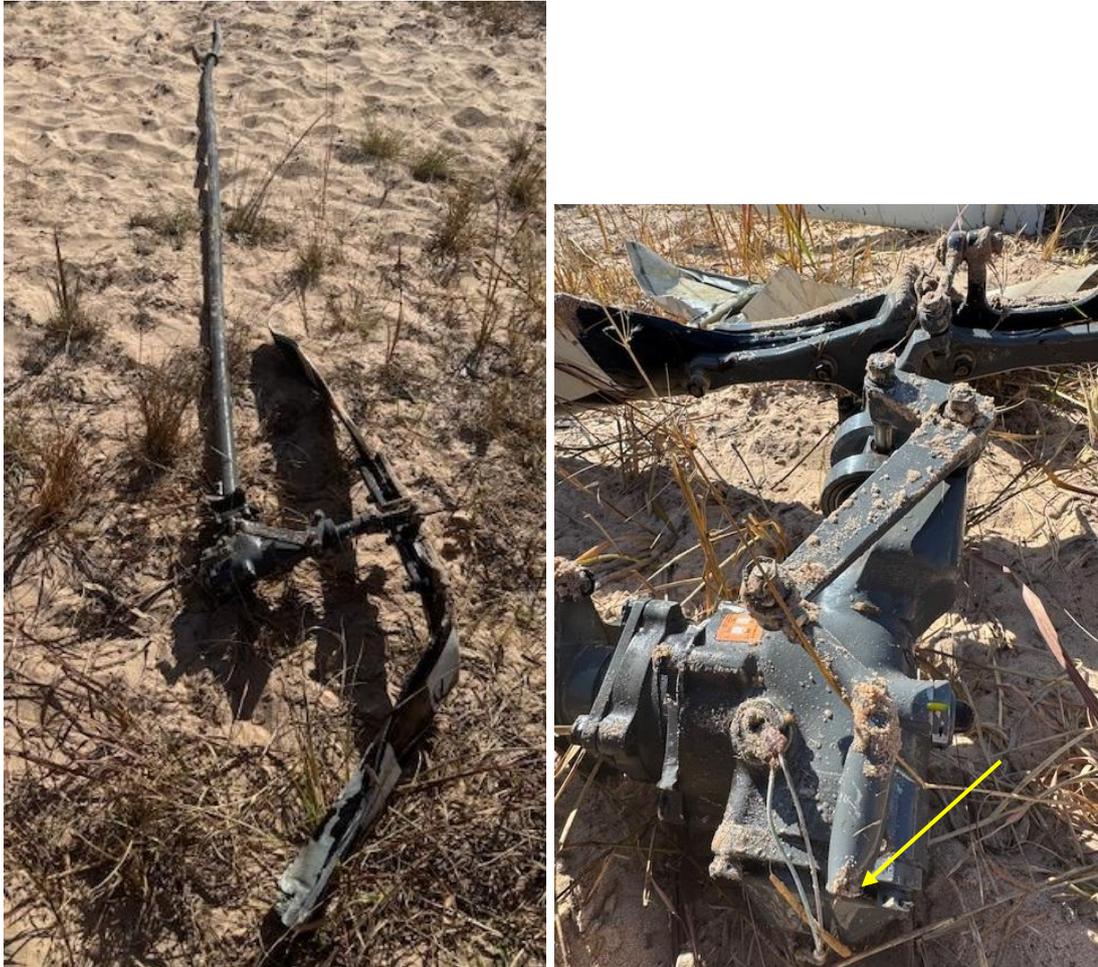
1.12.2 The tail rotor drive shaft separated from the tail rotor and the gearbox was found still attached to it. None of the flex plates on the tail rotor drive shaft failed. The tail rotor blades showed signs of rotation. The pitch control bell crank was found broken off. The flight controls had several disconnects between the cyclic, collective pitch control levers and swashplate. All fractures exhibited signatures consistent with overload. The tail rotor flight controls had several disconnects from the pedals and tail rotor, and all separations exhibited overload signatures.

**Figures 9 and 10:** The separated tail rotor drive shaft (left picture); and the broken pitch control bell crank (right picture).

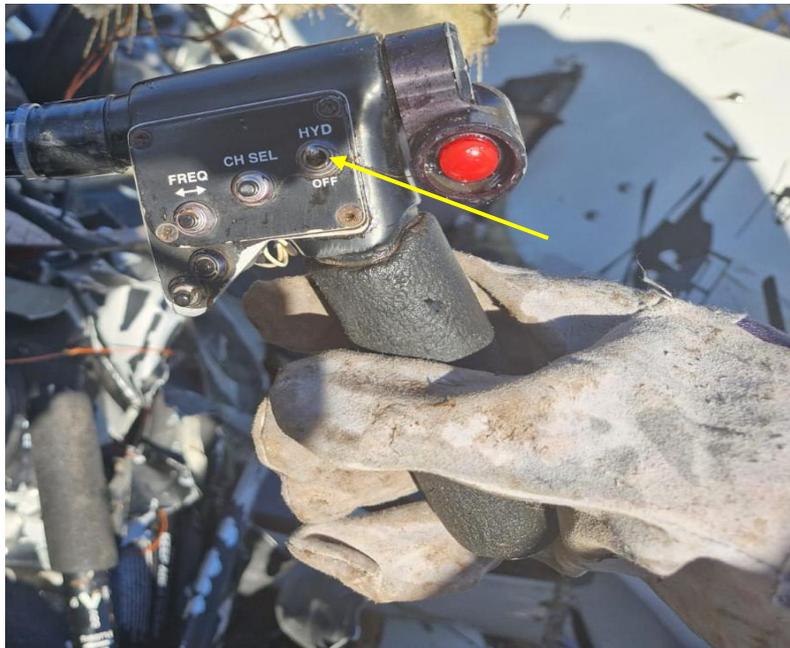
1.12.3 The cockpit cabin area was crushed. Examination of the cockpit instrumentation could not establish their pre-impact indications. The instrument panel illumination, warning and indication light bulbs showed that at impact, the illumination lighting was on, which was consistent with a flight conducted at nighttime; this also indicated that the electrical system was functioning. The Perspex windshield was found shattered; the rear doors and the left-side front door had ejected, leaving only the pilot's door still attached to its frame. Fragmented sections of Plexiglass were spotted around the accident area. Both bladder fuel tanks contained sufficient Avgas 100LL. The doors that ejected during the accident sequence were found at the accident site; each door handle was in a closed and locked position, and with the latch pin protruding. The position of the doors was consistent with them being in a closed position. The pilot was still harnessed to his seat (right side). The cyclic pitch control lever was examined, and no anomalies were noted. The hydraulic switch was in the ON position (see Figure 11). The pilot (right side) throttle twist grip was in the ON position and fully open. The collective pitch control lever was near the full UP position and the engine governor was in the ON (UP) position (see Figure 12). The friction locks for the cyclic and collective pitch control levers were ON. The circuit breakers (CB) on the cabin floor below the left front seat were depressed.

**Figure 11:** The cyclic pitch control lever with the hydraulic switch in the ON position.

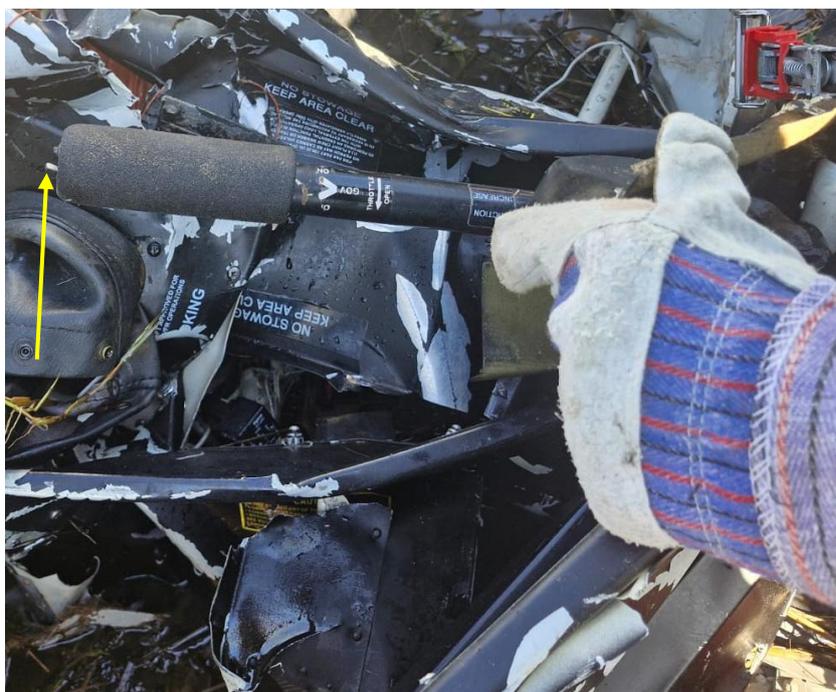
**Figure 12:** The collective pitch control lever was near the full UP position, and the engine governor was in the ON (UP) position (yellow arrow).
