PRELIMINARY ACCIDENT REPORT

Accident
- Preliminary Report -
AIID Ref No: CA18/2/3/10536

Reference Number : CA18/2/3/10536
Occurrence Category : Category 2
Type of Operation : Private Part 91
Name of Operator : Mach 1
Aircraft Registration : ZS-ISI
Aircraft Make and Model : Piper PA-28-180
Nationality : South African
Place : Outside FASI on an open field with an uneven surface.
Date and Time : 11 December 2024
Injuries : None
Damage : Substantial

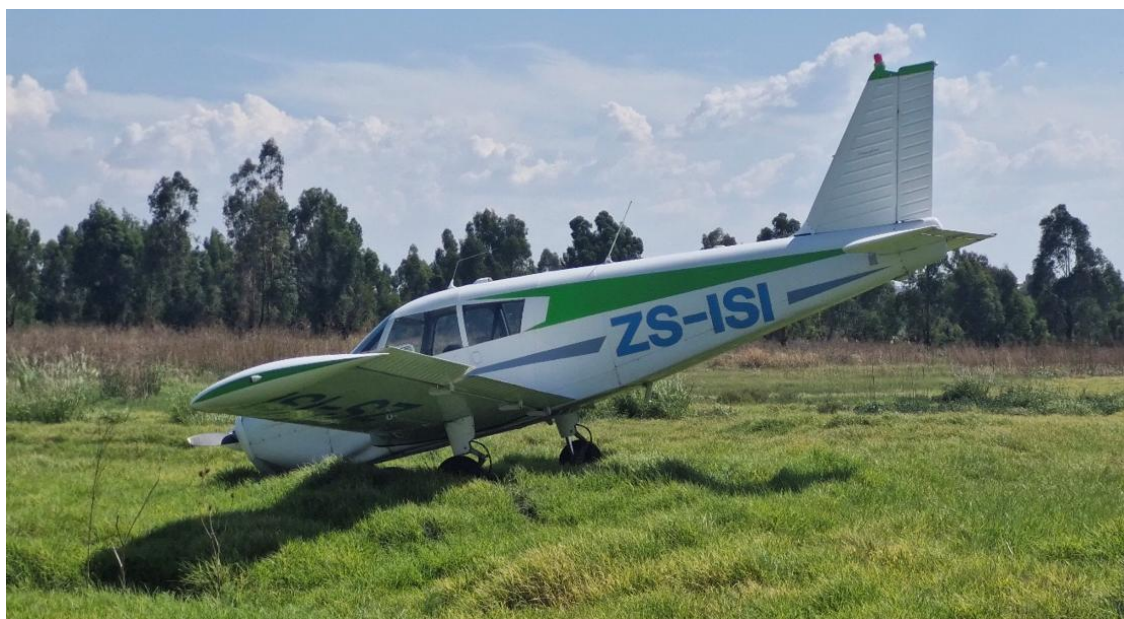
1.3.1. The aircraft sustained damage to the nose landing gear and nose section.

Figure 3: The aircraft as it came to a full stop with the damaged nose landing gear.

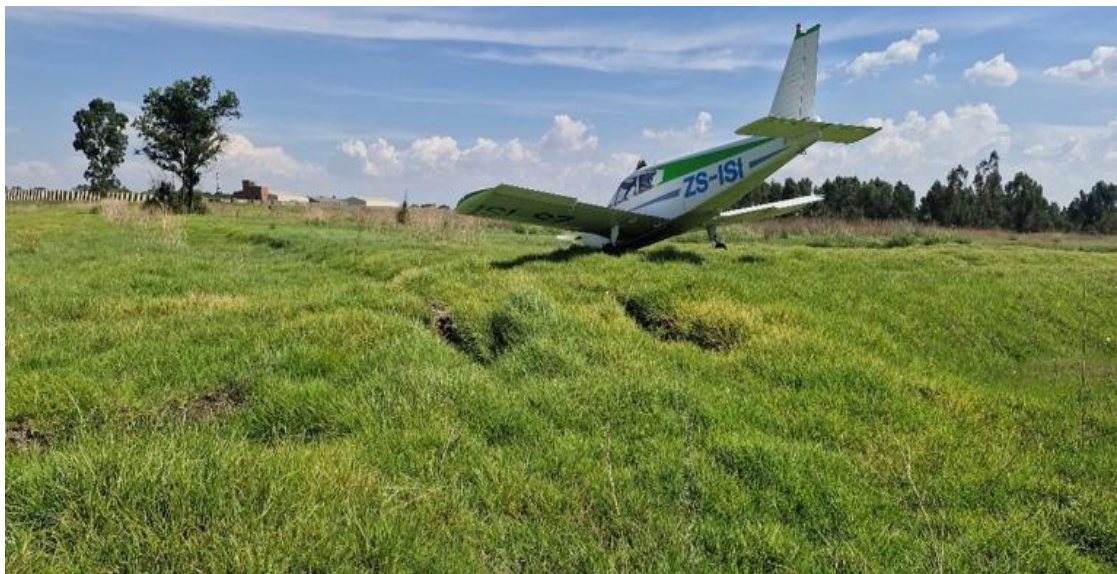
Figure 4: Aircraft at the accident site

1.12.1. The aircraft accident occurred following take off on an open field near the FASI. The area at which the aircraft has an uneven surface. The area during heavy rainfall is susceptible to accumulating storm water. This area is also close to an informal settlement situated northwest of the aerodrome at approximately 450 m from the accident site.

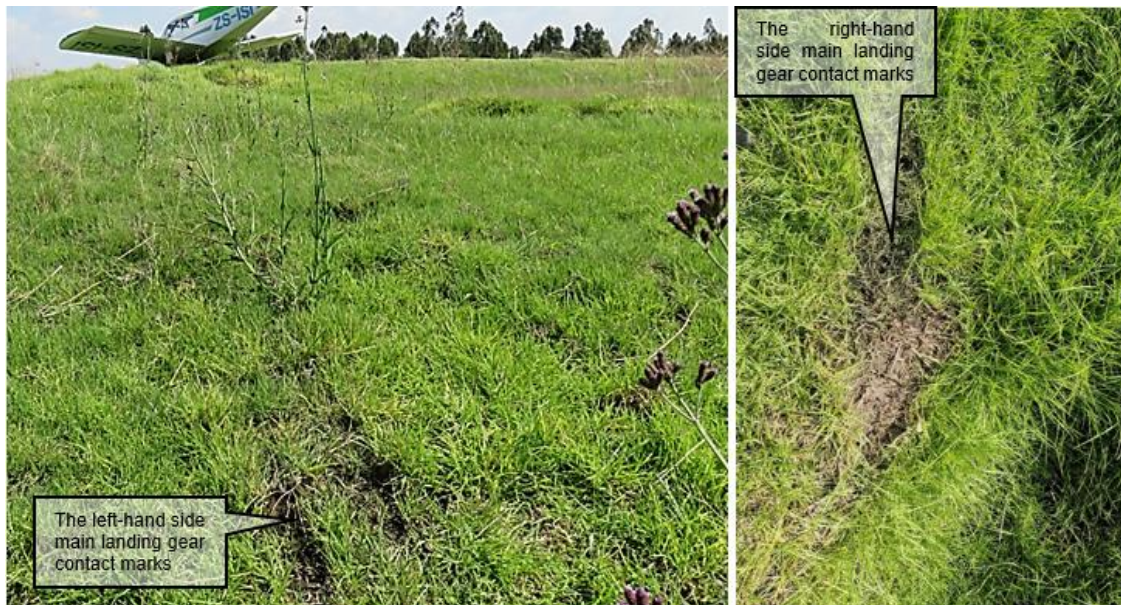
Figure 5: The initial impact marks of the left and right main landing gear.

1.12.2. The aircraft's initial touchdown was approximately 12 meters at the bottom of an embankment of the uneven terrain. There were ground marks associated with a hard impact with the main landing gear first which resulted in a bounce onto an embankment. (See Figure 5 above).

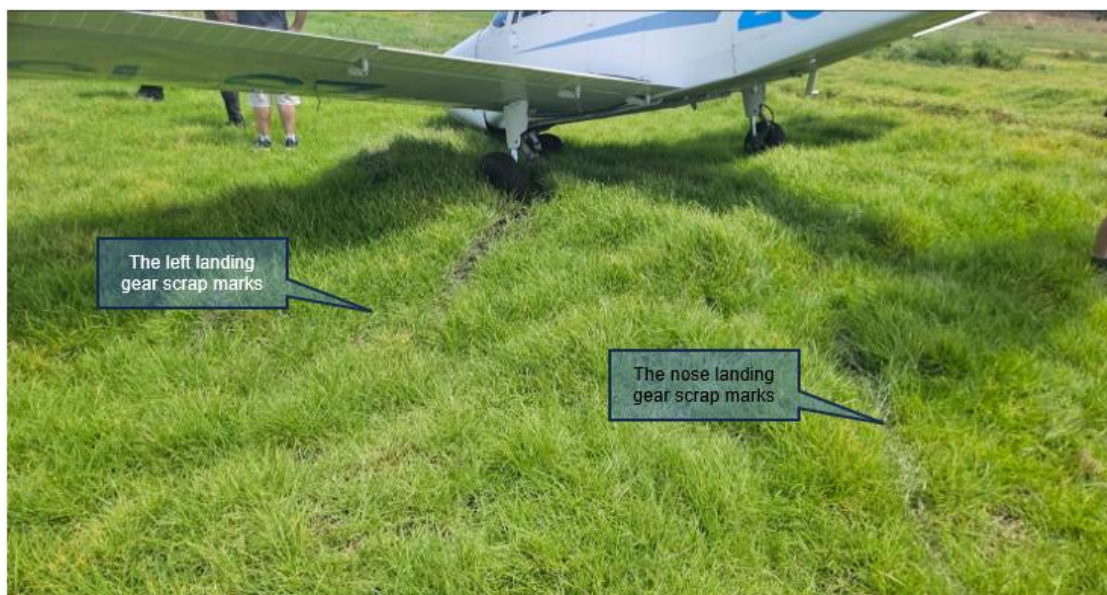
Figure 6: Shows the landing gear scrape marks over the embankment

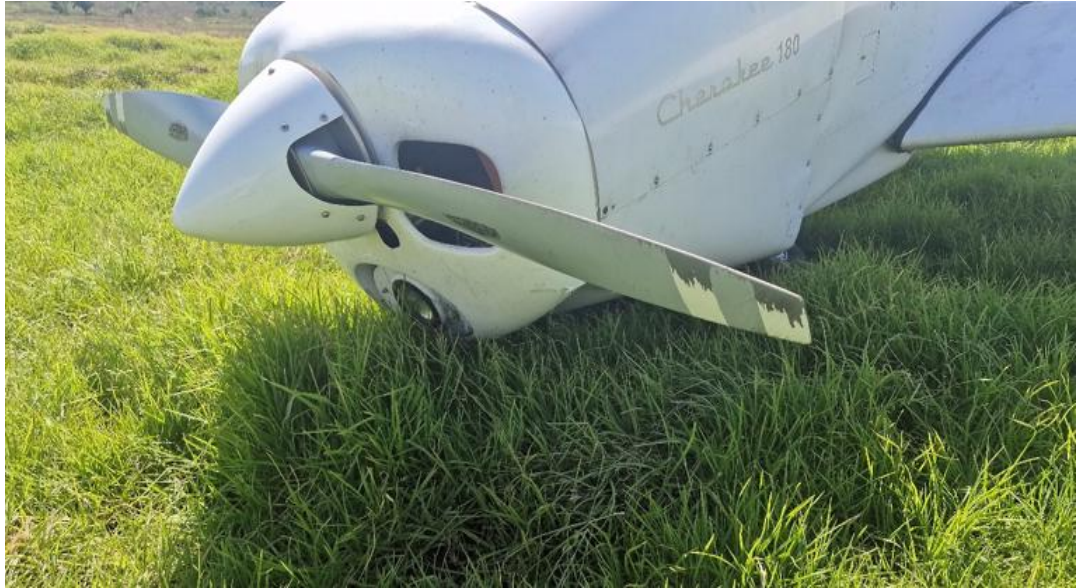
1.12.4. There was no visible sign of damage or contact with the ground on the propeller blades. According to the observation, the propeller had stopped rotating and remained in the same position before landing. (See Figure 7 below).

Figure 7: Aircraft nose section on the ground.

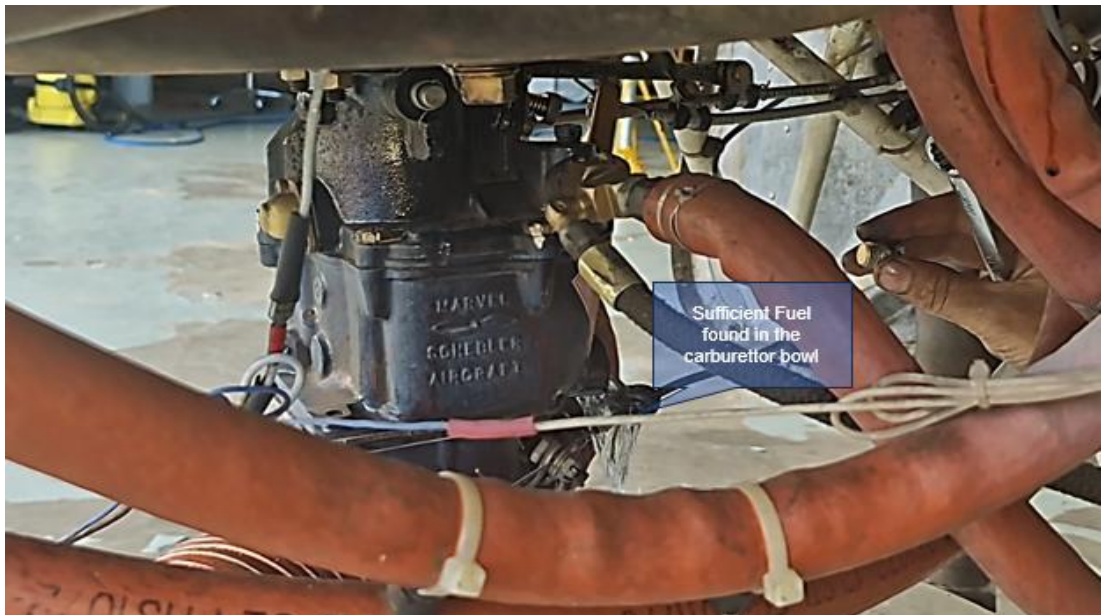
1.12.5. There was sufficient fuel in both tanks and the fuel system, including the fuel filter and carburettor bowl. See Figures 7 and 8).

Figure 7: Snapshot of fuel found in the carburettor bowl.

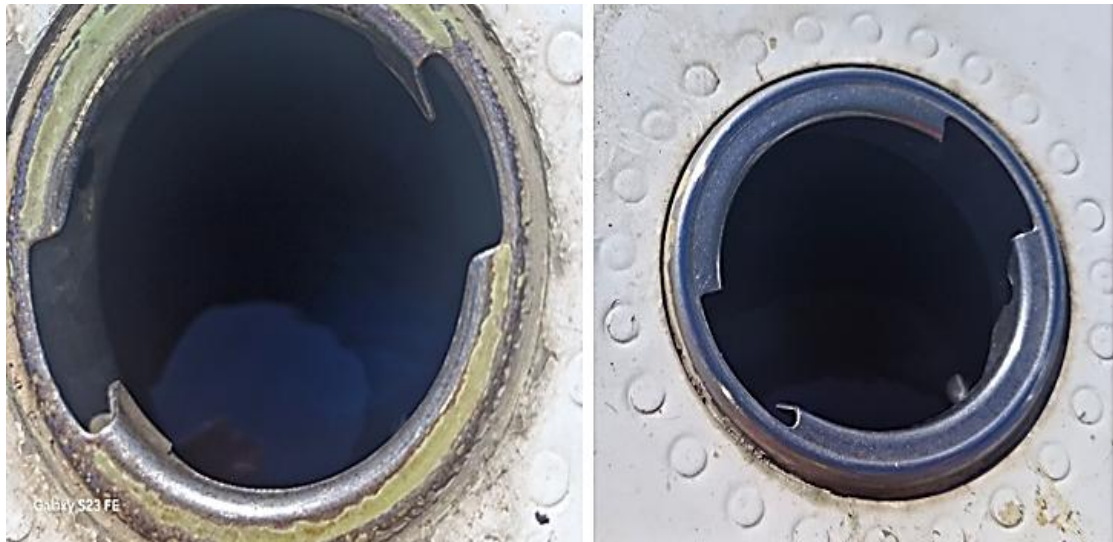
Figure 8: left fuel tank (left) and right fuel tank (right)
