**PRELIMINARY ACCIDENT REPORT**

**Accident and Incident Investigations Division**

Accident  
- Preliminary Report -  
AIID Ref No: CA18/2/3/10657

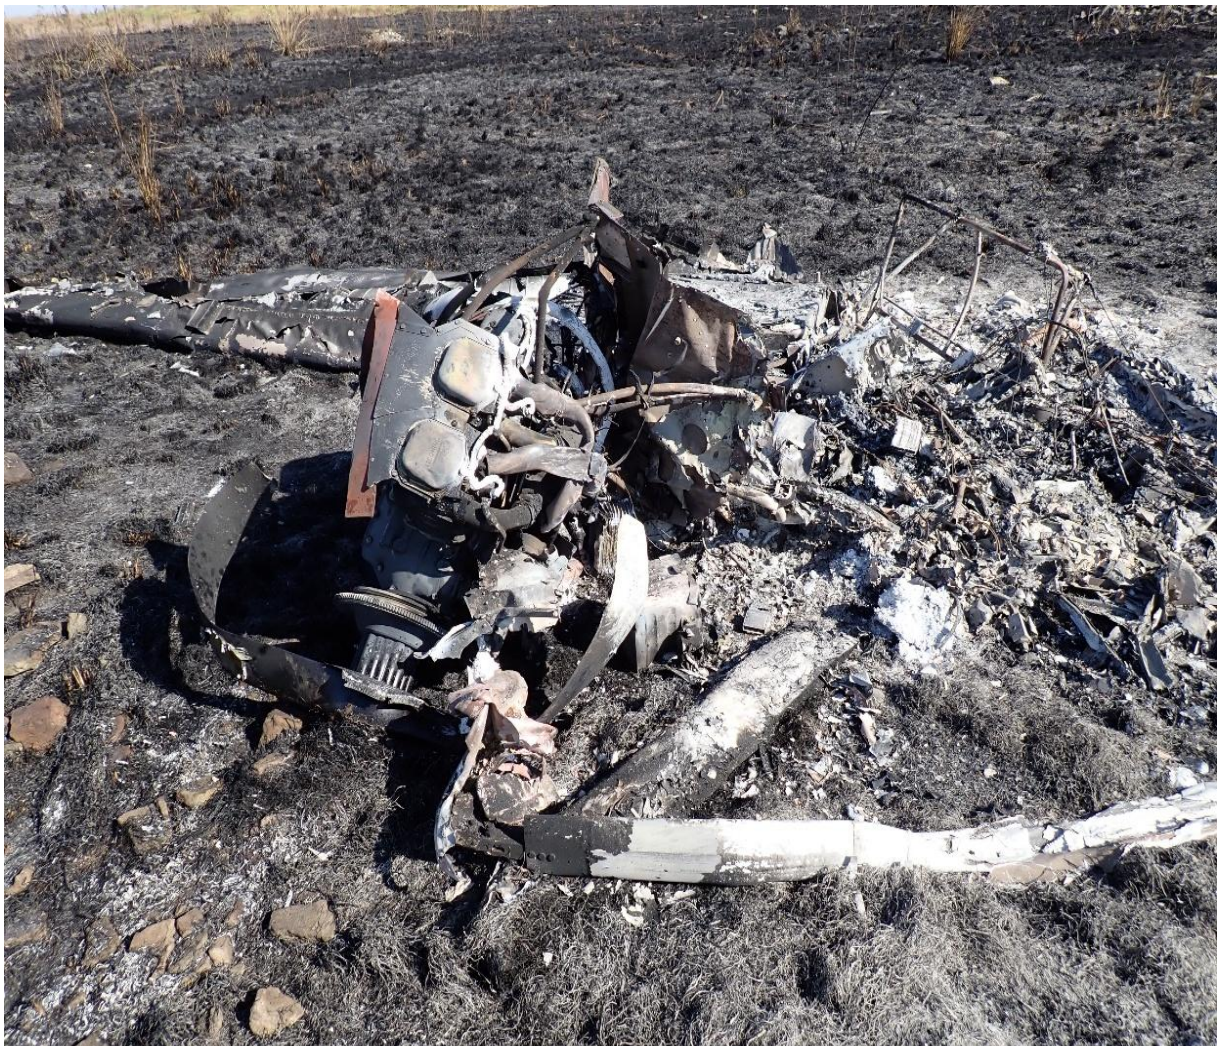
1.3.1. The aircraft was destroyed by the fire which initiated from the cockpit.

**Figure 3:** The burnt wreckage of ZS-JBO.

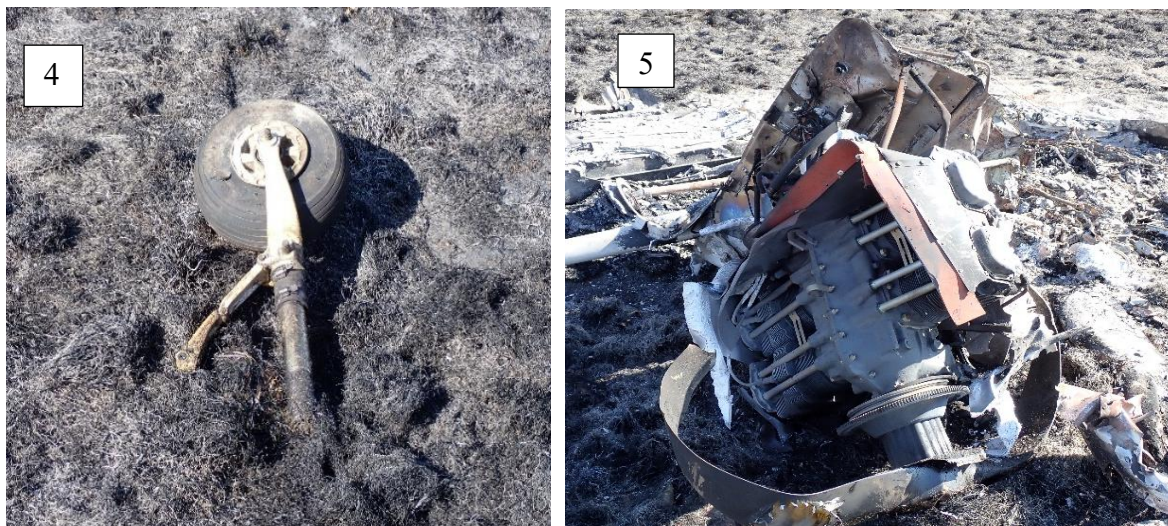
**Figures 4 and 5:** The nose landing gear and the engine casing were not scorched by the fire.

1.12.3. It could not be determined at this stage how the aircraft impacted the ground; however, the nose landing gear and left main landing gear (MLG) were found detached from the fuselage; they were not burnt by the fire. The main wreckage was destroyed by the fire which made it difficult to identify some of the aircraft's components. The main cabin was reduced to ashes, and the right-side MLG and wing were found in their correct places in relation to the design of the aircraft; however, the left wing sustained structural damage and was found near the empennage, (see Figure 6). The engine casing did not sustain any scoring. Both propeller blades were found bent backwards.

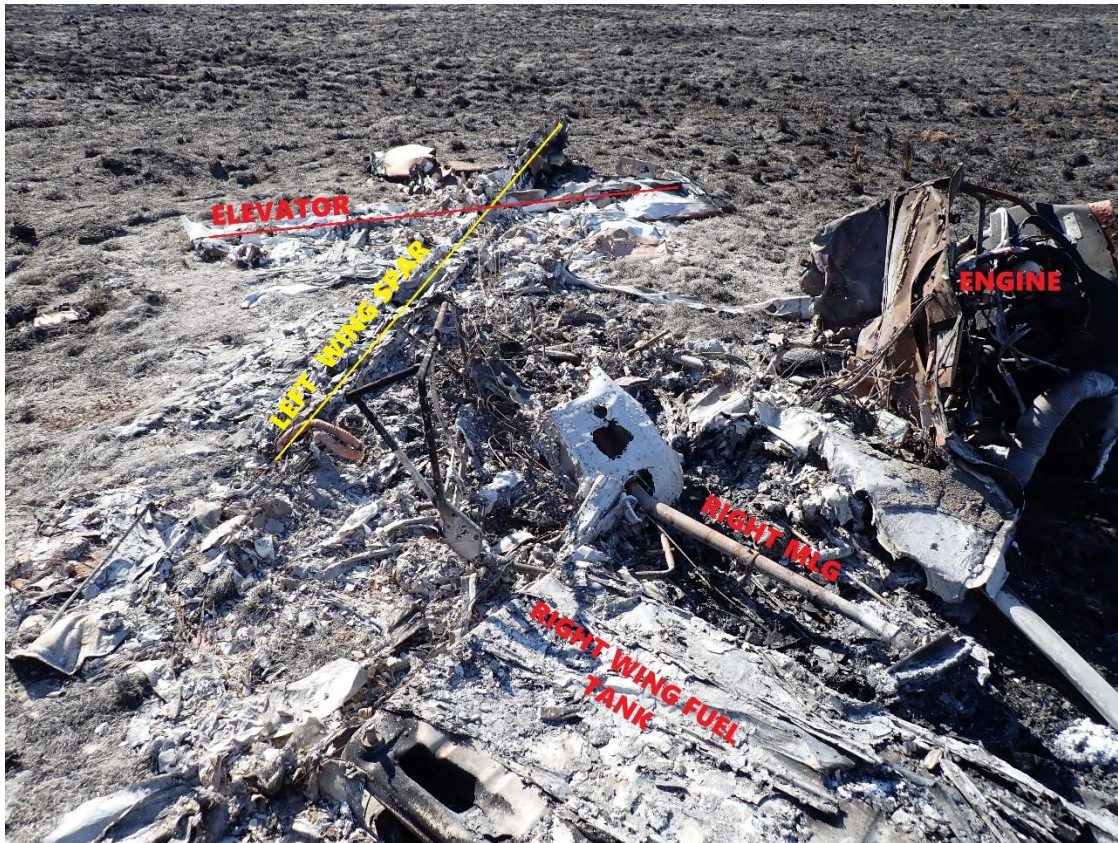
**Figure 6:** Identification of major aircraft components.
