PRELIMINARY ACCIDENT REPORT

Accident and Incident Investigations Division

Accident
- Preliminary Report -
AIID Ref No: CA18/2/3/10378

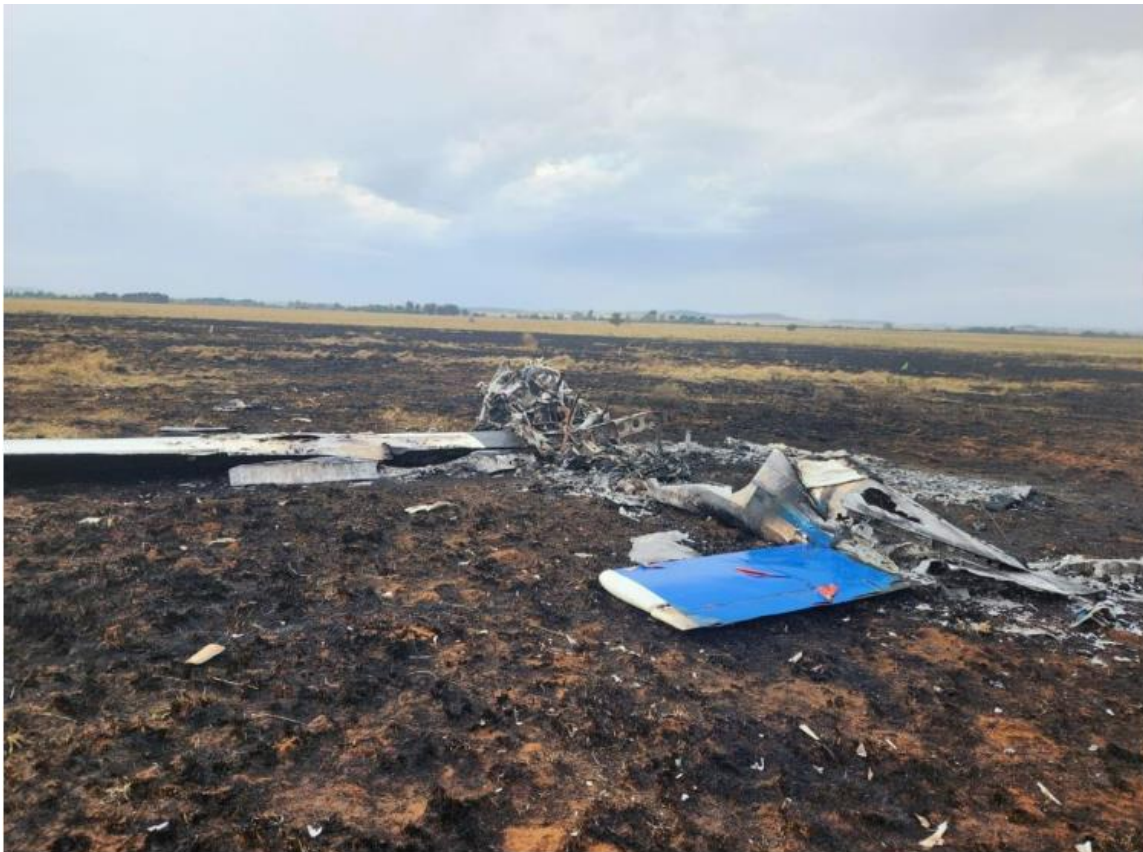
1.3.1. The aircraft was destroyed by post-impact fire.

Figure 3: The wreckage post-accident.

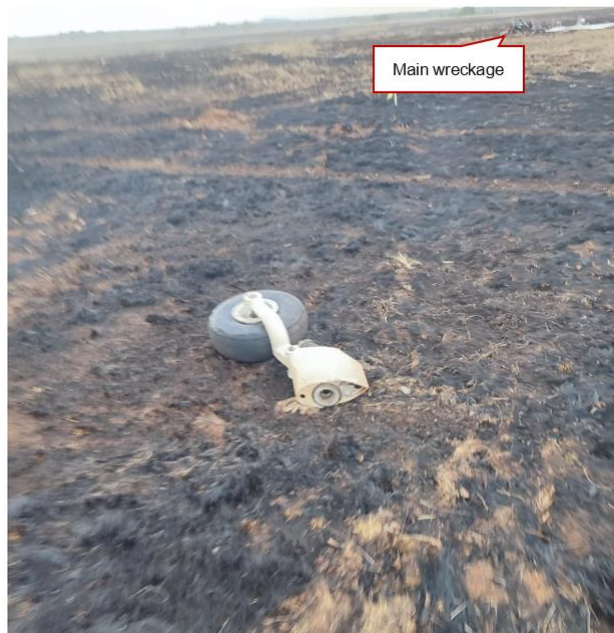
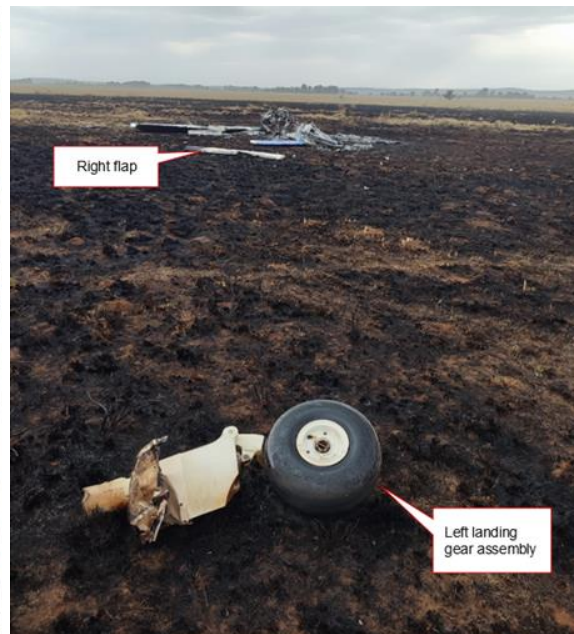
- 1.12.1 The aircraft impacted the ground hard, which caused the right main landing gear to break off. The aircraft then spun 180° clockwise to face the direction from which it had approached. The left main landing gear and the right flap also broke off whilst the aircraft was spinning. The aircraft burst into flames, which consumed the right side of the aircraft, wing section and horizontal and vertical stabilisers. The control surfaces and the wiring were all accounted for at the accident site.

Figures 4 and 5: The right main landing gear assembly (left); and the left main landing gear assembly with rear view of the main wreckage in the background (right).

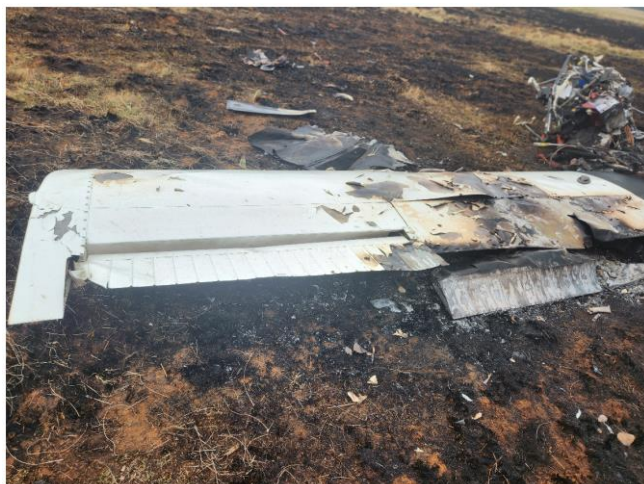
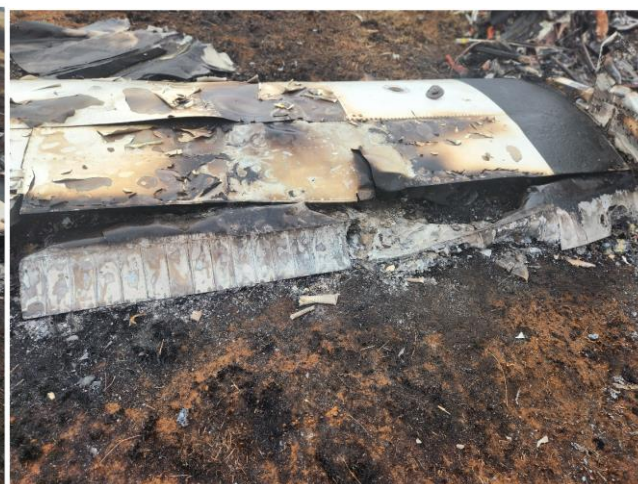
1.12.2 The left aileron, flap and part of the left wing were damaged by post-impact fire; they were still attached to the aircraft.

Figures 6 and 7: The damaged outboard (left) and inboard (right) of the left wing.

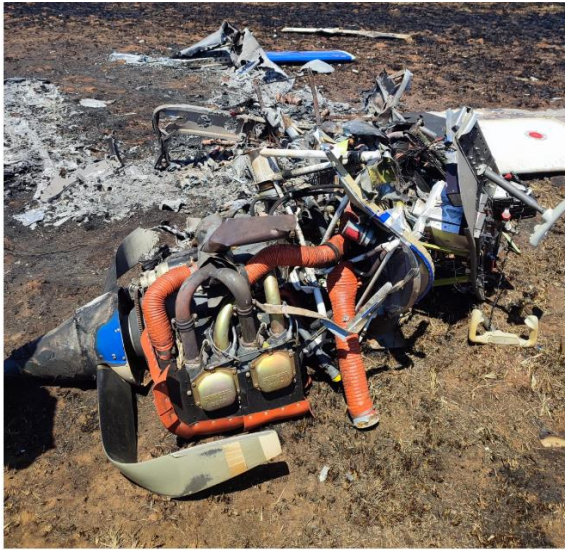
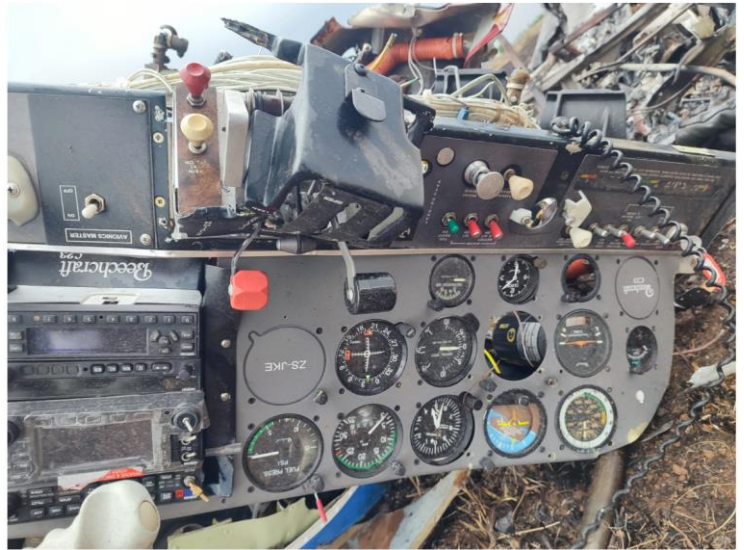
1.12.3 The engine and the propeller sustained impact damage; the spinner was burnt. The instrument panel, both control columns and the electrical wires behind the instrument panel also sustained damage during the accident sequence.

Figures 8 and 9: The damaged engine (left) and instrument panel (right).

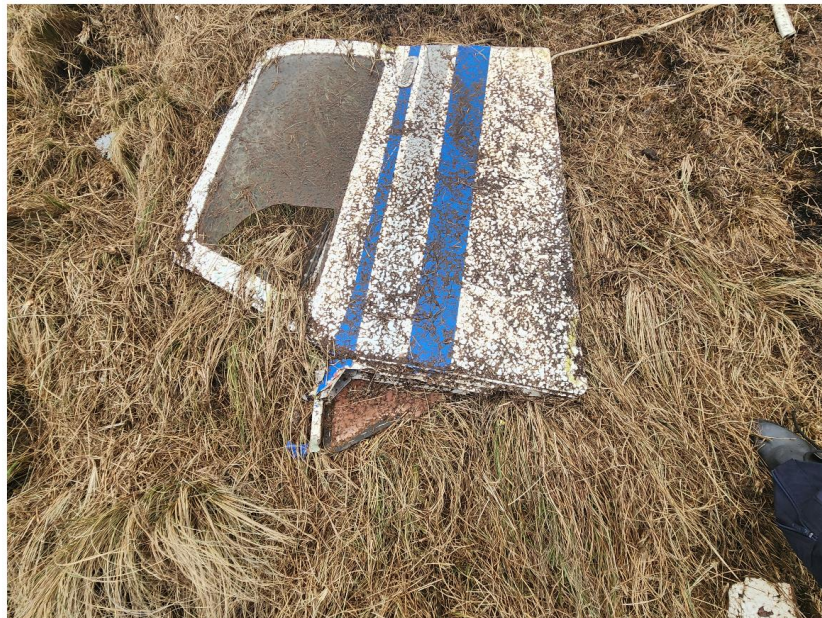
1.12.4 The left door had detached during impact and was not burnt.

Figure 10: Left door.
