**PRELIMINARY ACCIDENT REPORT**

**Accident and Incident Investigations Division**

Accident  
- Preliminary Report -  
AIID Ref No: CA18/2/3/10375

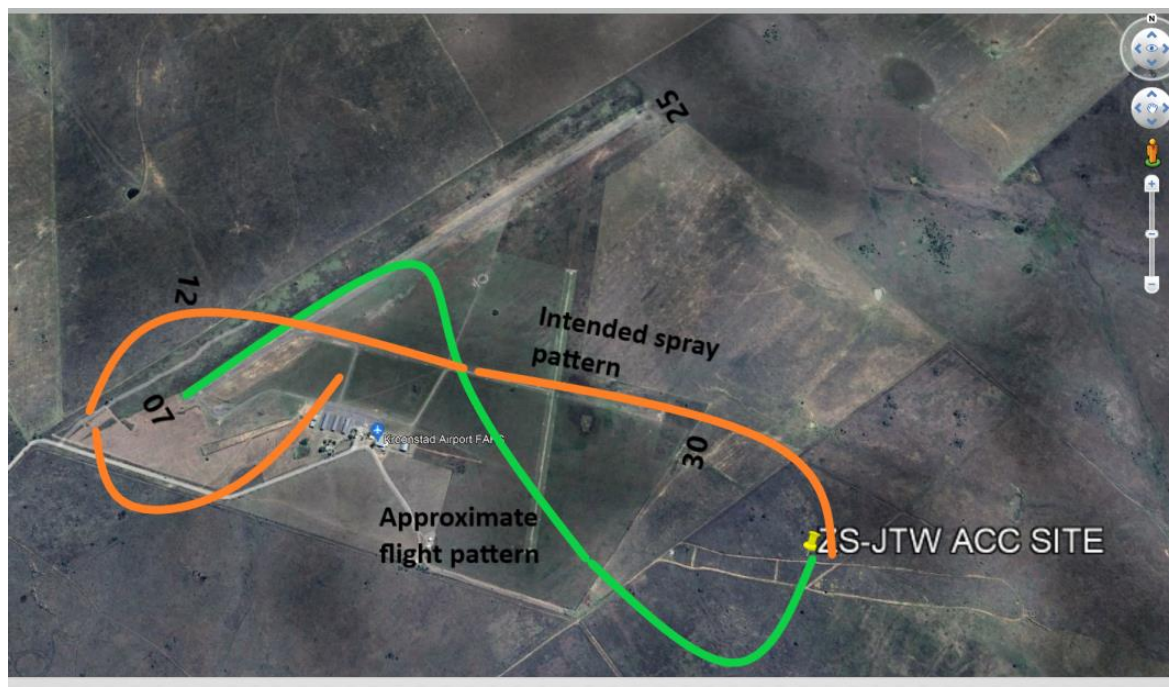
- 1.1.3 The accident occurred during daytime near FAKS at Global Positioning System (GPS) co-ordinates determined to be 27°40'15.66" South 027°19'30" East, at a field elevation of 4 582 feet (ft).

**Figure 2:** The view of the accident site. The green line shows the approximate flight plan, and the orange line shows the intended spray pattern. (Source: Google Earth)

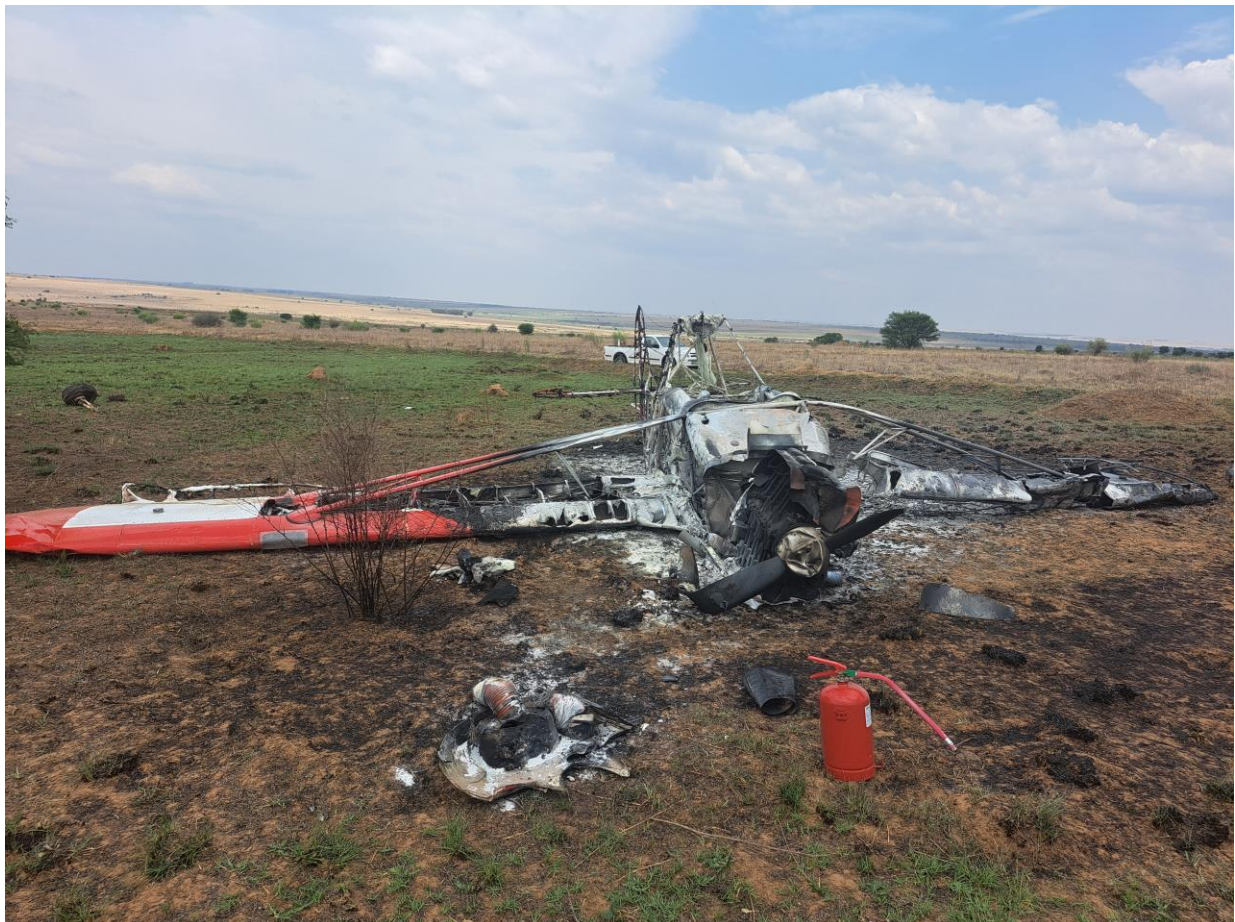
1.3.1 The aircraft was destroyed on impact with the ground and by post-impact fire.

**Figure 3:** The wreckage post-accident. (Source: Operator)

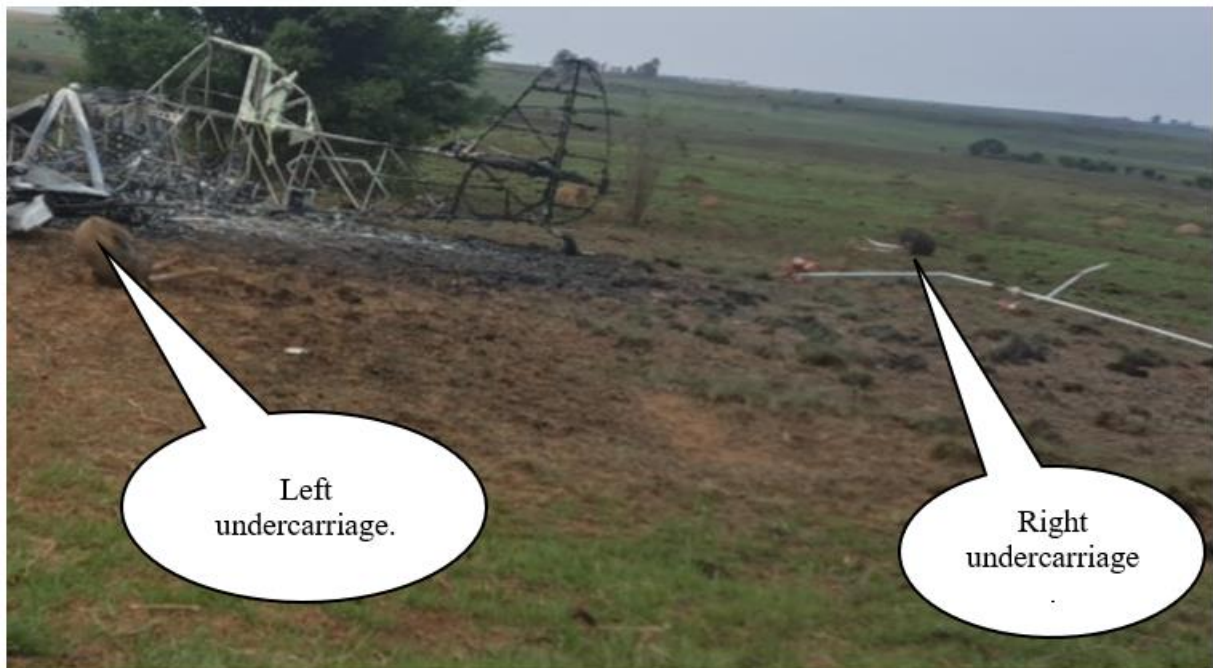
1.12.1 The investigation determined that during the base turn, the aircraft was flown low in a northerly direction. The main landing gear impacted an embankment (hump) on the edge of a gravel road that ran from the east to the west and bounced over the road. It then impacted the ground again about 10 metres after the first bounce and skidded approximately 5m before it came to a stop next to a tree; the aircraft faced west when it stopped. A post-impact fire erupted and consumed the aircraft. The pilot succumbed to her injuries.

**Figure 4:** The left and the right landing gears at the accident site.

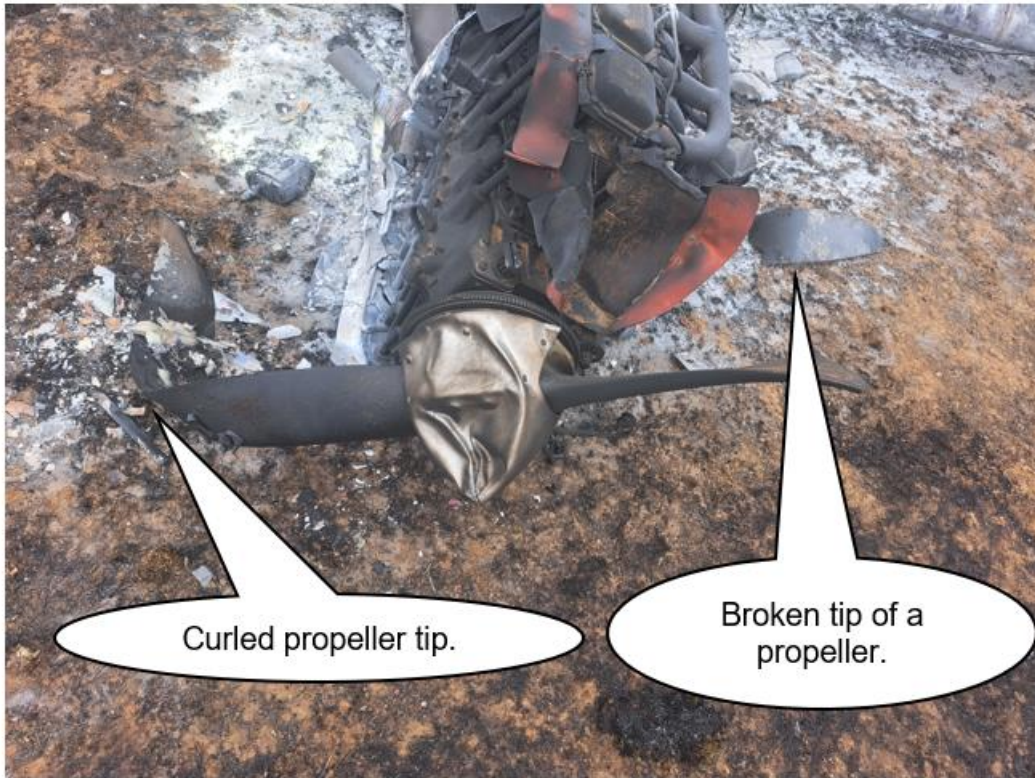
1.12.2 When the aircraft impacted the ground, both the left and the right undercarriages broke off, as well as the spraying system. One of the propeller blades was found curled and still attached to the fuselage. The second propeller blade's tip was severed. The engine sustained minor damage towards the rear section as a result of the fire, including the two magnetos. The main fuel tank behind the engine had ruptured and the instrument panel was completely burnt. The auxiliary tanks on both wing tips were not damaged and were empty. The wiring of the control columns was relatively intact. Continuity test was conducted on-site, and all the wires moved freely.

**Figure 5:** The damaged engine and propellers.

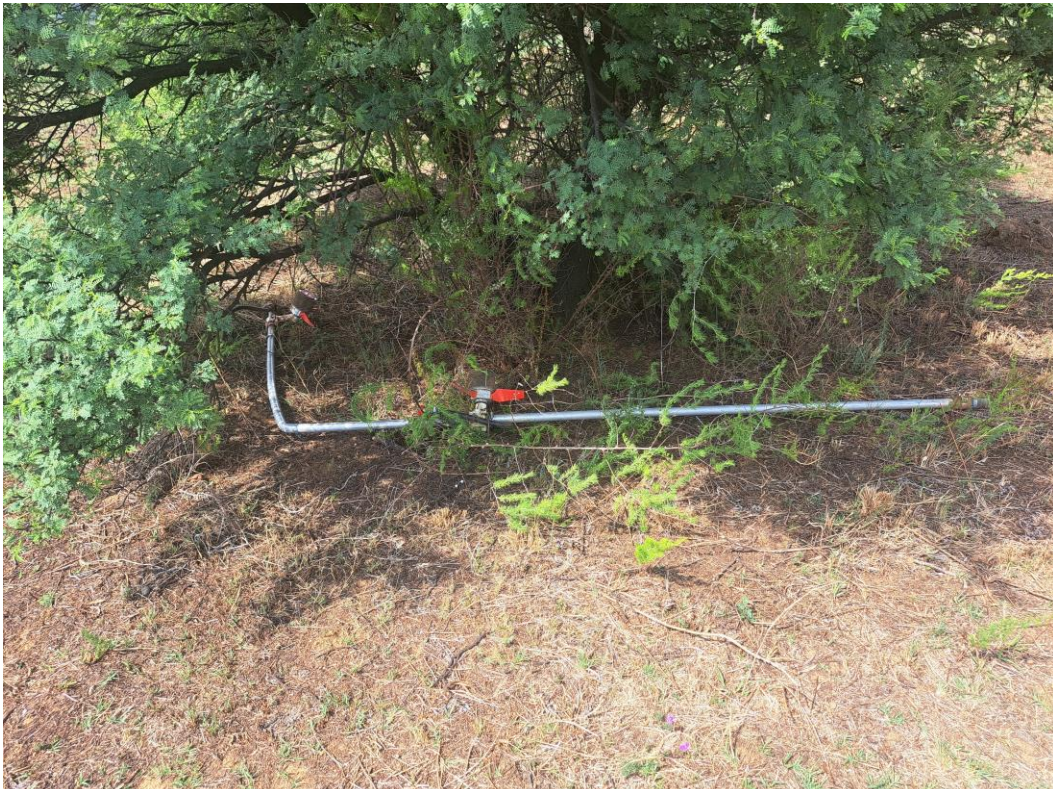
**Figure 6:** The broken spray system.
