**PRELIMINARY ACCIDENT REPORT**

Accident  
- Preliminary Report -  
AIID Ref No: CA18/2/3/10537

On Saturday morning, 14 December 2024, a solo student pilot onboard a Piper PA-38-112 aircraft with registration ZS-KHZ took off from Cape Town International Aerodrome (FACT) in the Western Cape province on a navigational training flight to conduct a touch-and-go at Saldanha Aerodrome (FASD) before returning to FACT for a full stop landing. The flight was conducted under visual meteorological conditions (VMC) by day. The student pilot joined overhead FASD and followed the unmanned aerodrome joining procedure and he assessed the wind by looking at the windsock at the aerodrome. He opted to perform a touch-and-go on Runway 02. The student pilot was unable to maintain directional after applying power for lift-off, the aircraft veered to the left and departed the runway surface. The nose landing gear bent backward, and the aircraft nosed over coming to rest in an inverted attitude. The student pilot suffered minor injuries, and the aircraft sustained substantial damage.

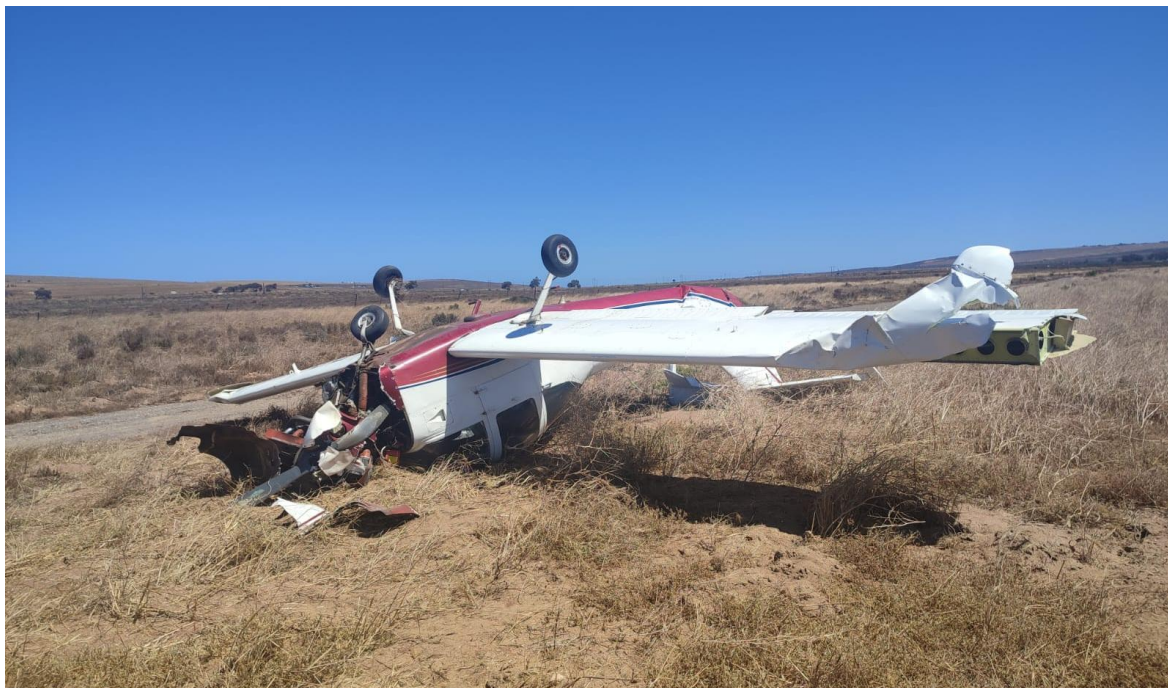
1.3.1 The aircraft was substantially damaged during the accident sequence.

**Figure 3:** The wreckage came to rest next to the runway.

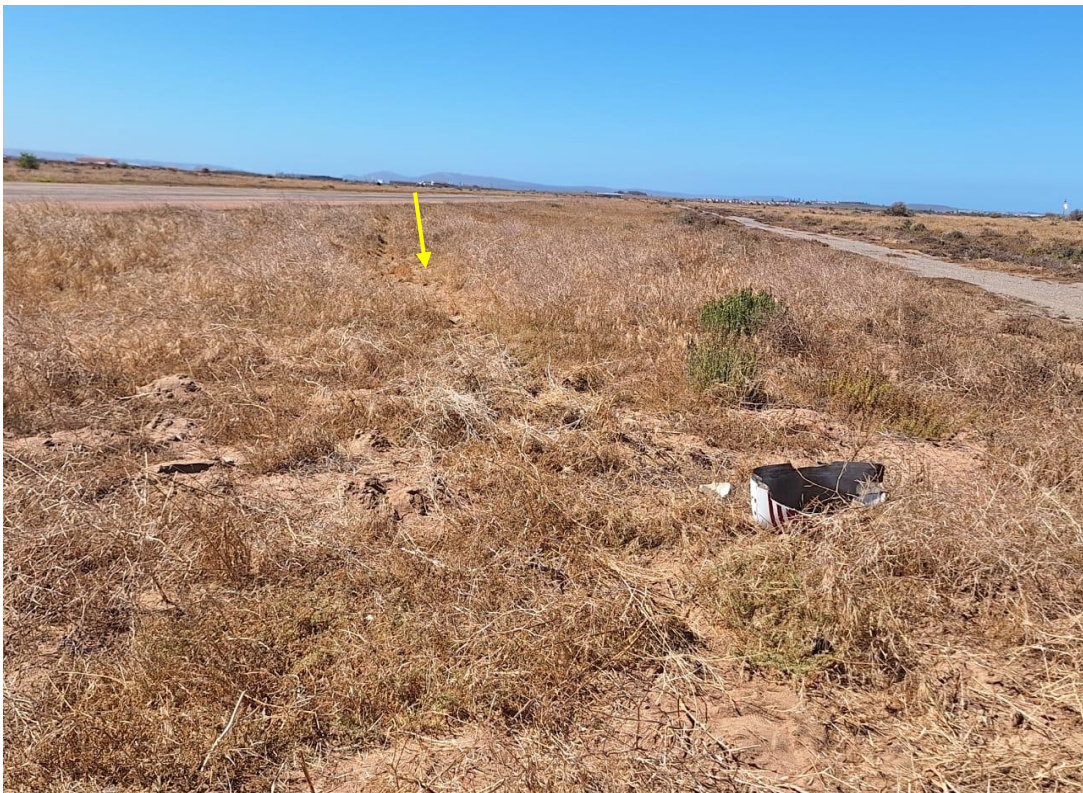
1.12.1 The aircraft veered off the runway to the left approximately 600m past the threshold of runway 02. It then careers through the dry grass, bouncing on the uneven terrain for a distance of approximately 25m. The nose wheel strut assembly bent backward during this sequence and the aircraft nosed over, coming to rest in an inverted attitude.

**Figure 4:** The path through the grass after the aircraft veered off the runway.

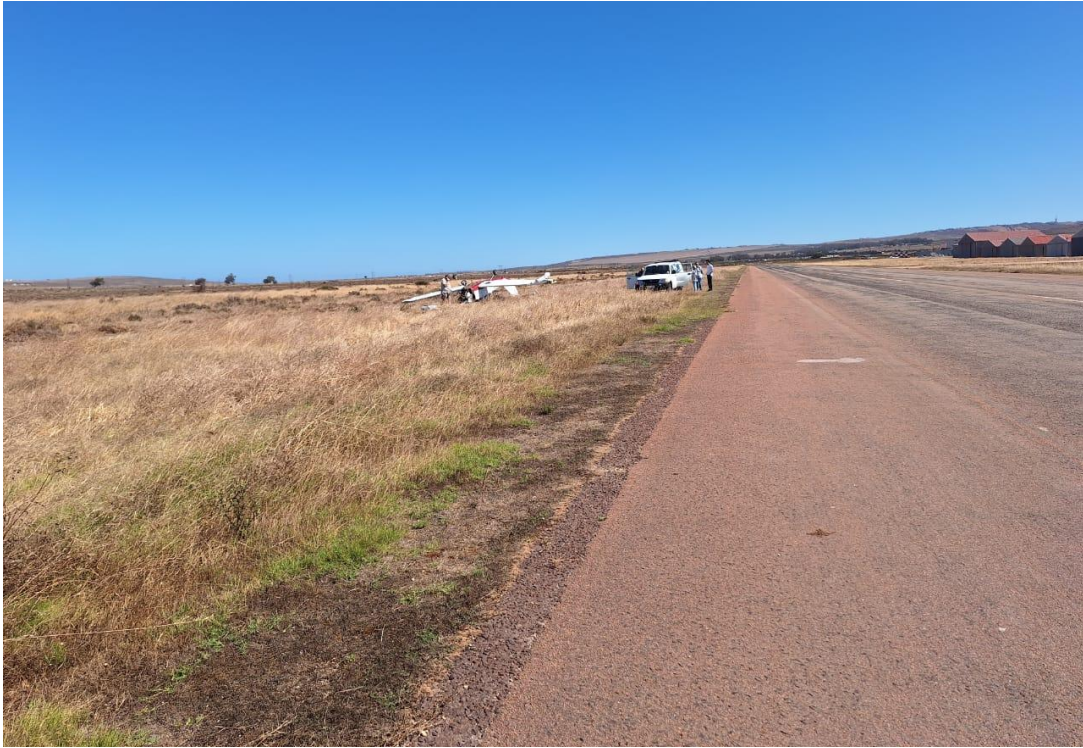
**Figure 5:** A section of the runway with the aircraft next to it.

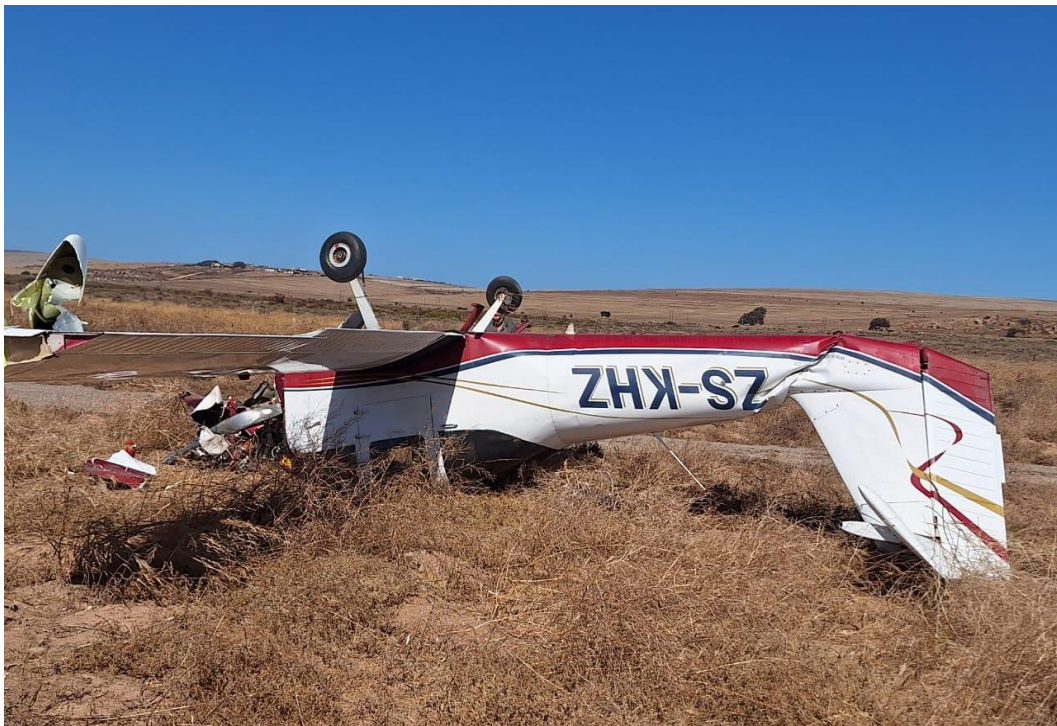
**Figure 6:** The aircraft as it came to rest.

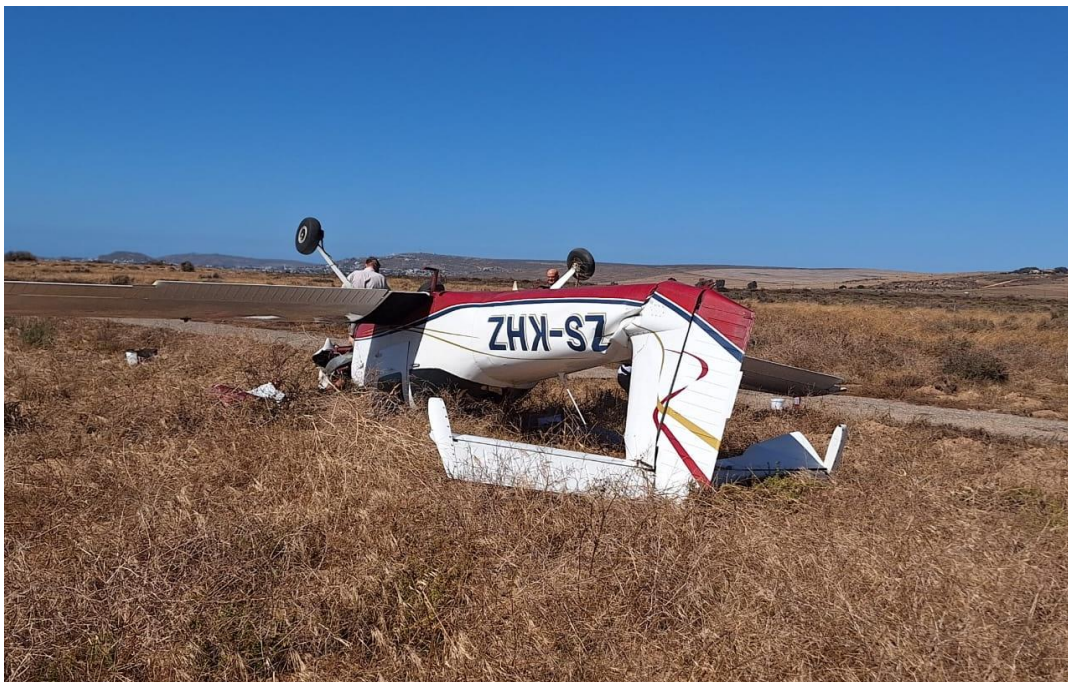
**Figure 7:** Aft view of the wreckage.
