PRELIMINARY ACCIDENT REPORT

Accident
- Preliminary Report -
AIID Ref No: CA18/2/3/10443

Reference Number	: CA18/2/3/10443
Occurrence Category	: Category 1
Type of Operation	: Private (Part 91)
Name of Operator	: Kishugu Aviation
Aircraft Registration	: ZS-KNE
Aircraft Make and Model	: Cessna 172 RG
Nationality	: South African
Registration Marks	: ZS-KNE
Place	: Blesbok Coal Mine, approximately 582m from the threshold of Runway 22
Date and Time	: 21 April 2024 at 1340Z
Injuries	: Four fatalities
Damage	: Destroyed

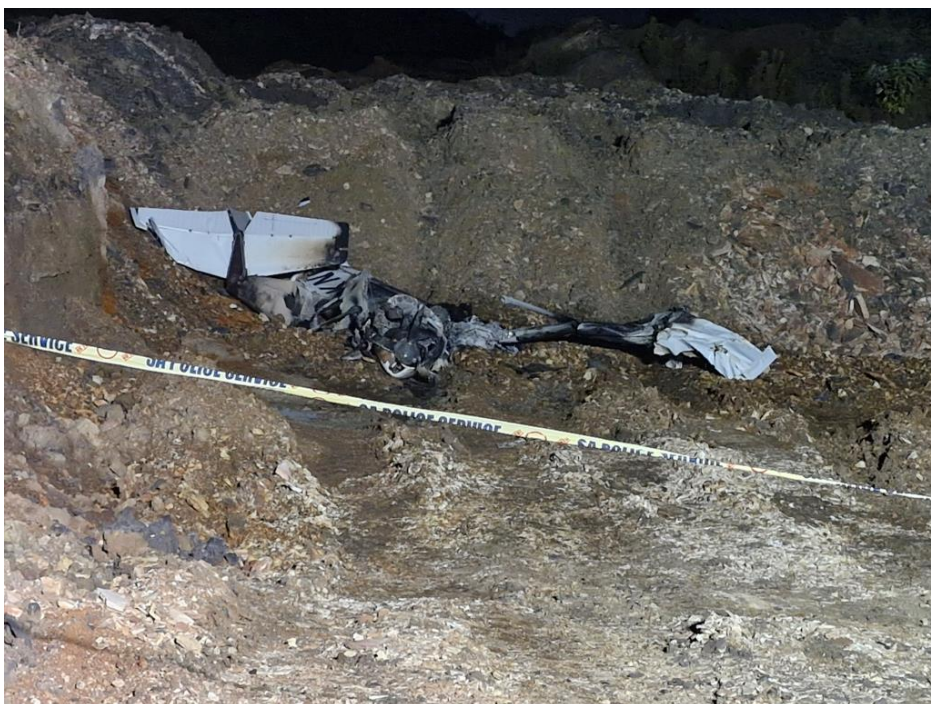
1.3.1. The aircraft was destroyed by impact and post-impact fire.

Figure 3: The wreckage post-accident.

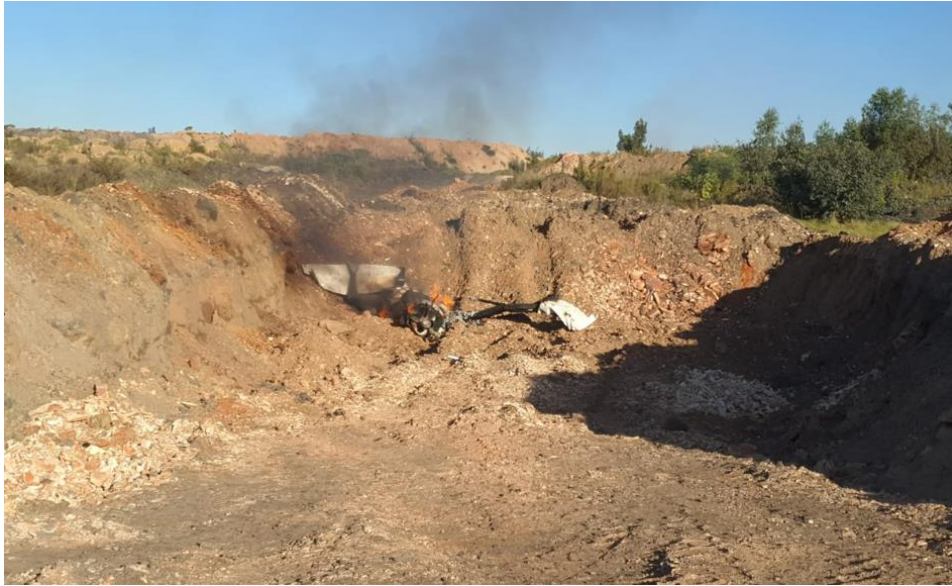
1.12.1. The wreckage was found in an inverted position with the nose facing north-west. The wreckage was contained in one area. The fuselage was consumed by the post-impact fire. The tail section was still intact with impact damage observed on the left elevator tip. The pitch control surfaces were still secured. The flight control cables were still intact and secured to their respective control surfaces. The left and right wings had impact damage, buckling and deformation was also noticed in the mid-section, outboard sides and on the leading edge which is indicative of impact with the ground whilst in a yaw. The landing gears were found retracted.

Figure 4: The aircraft after impact.

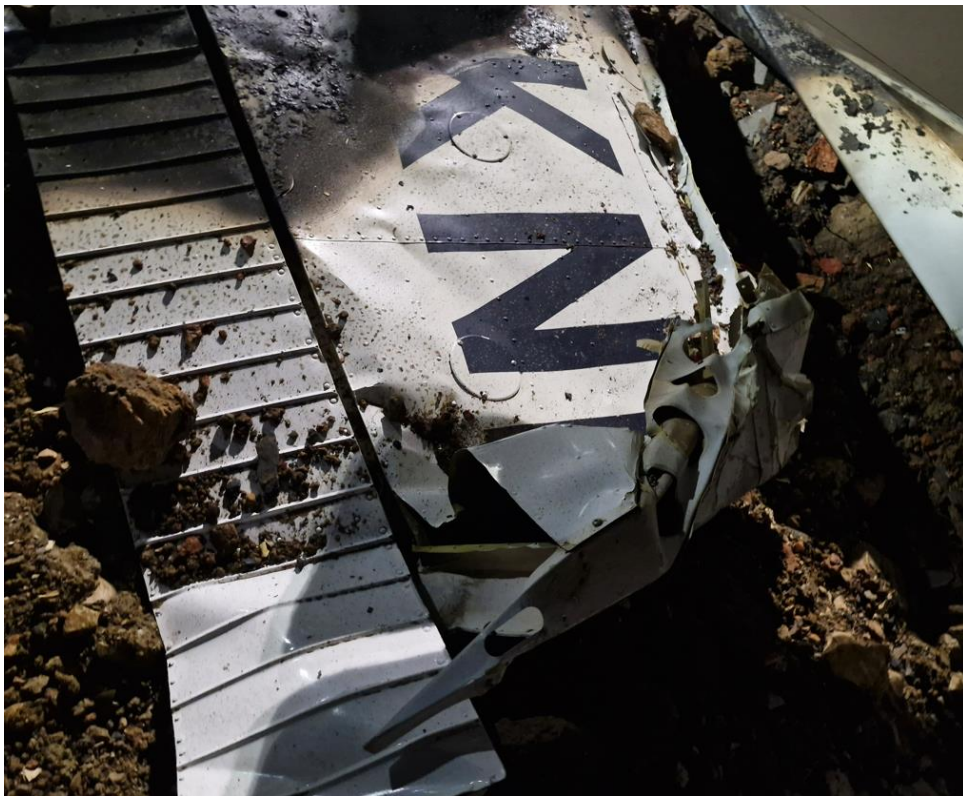
Figure 5: The deformed left-wing tip and aileron.

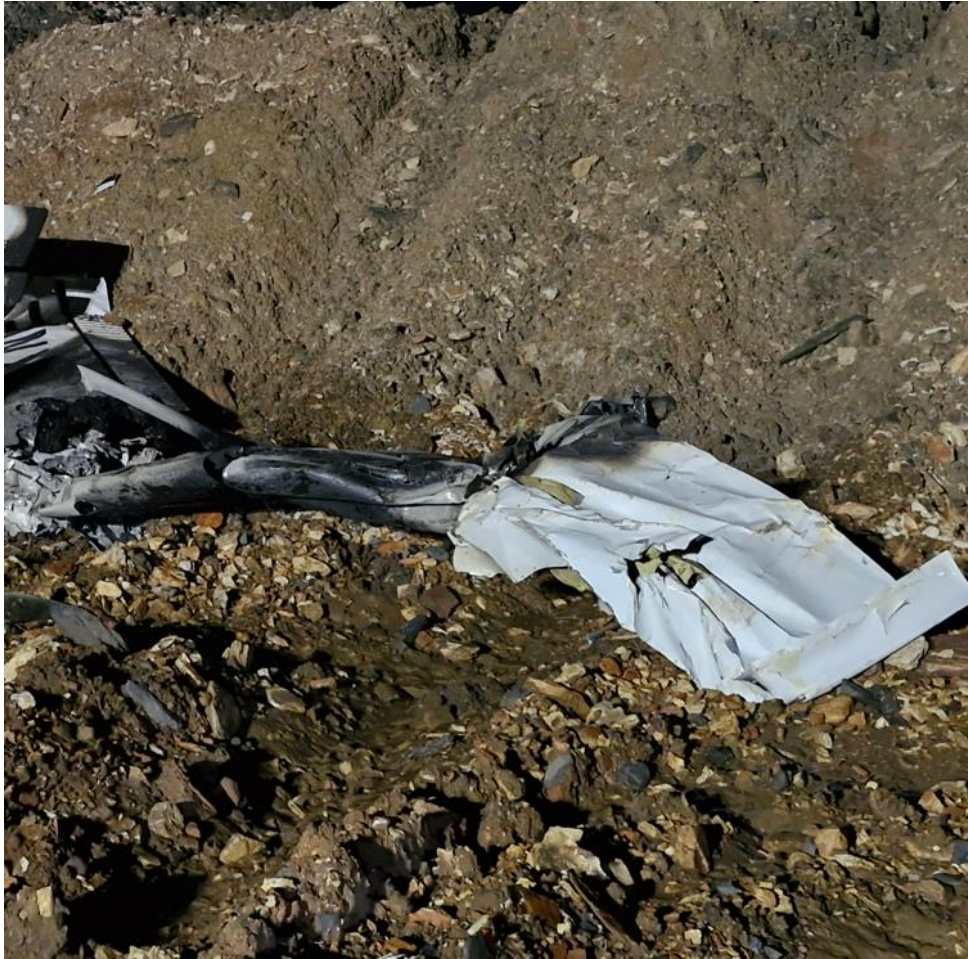
Figure 6: The deformed right wing.

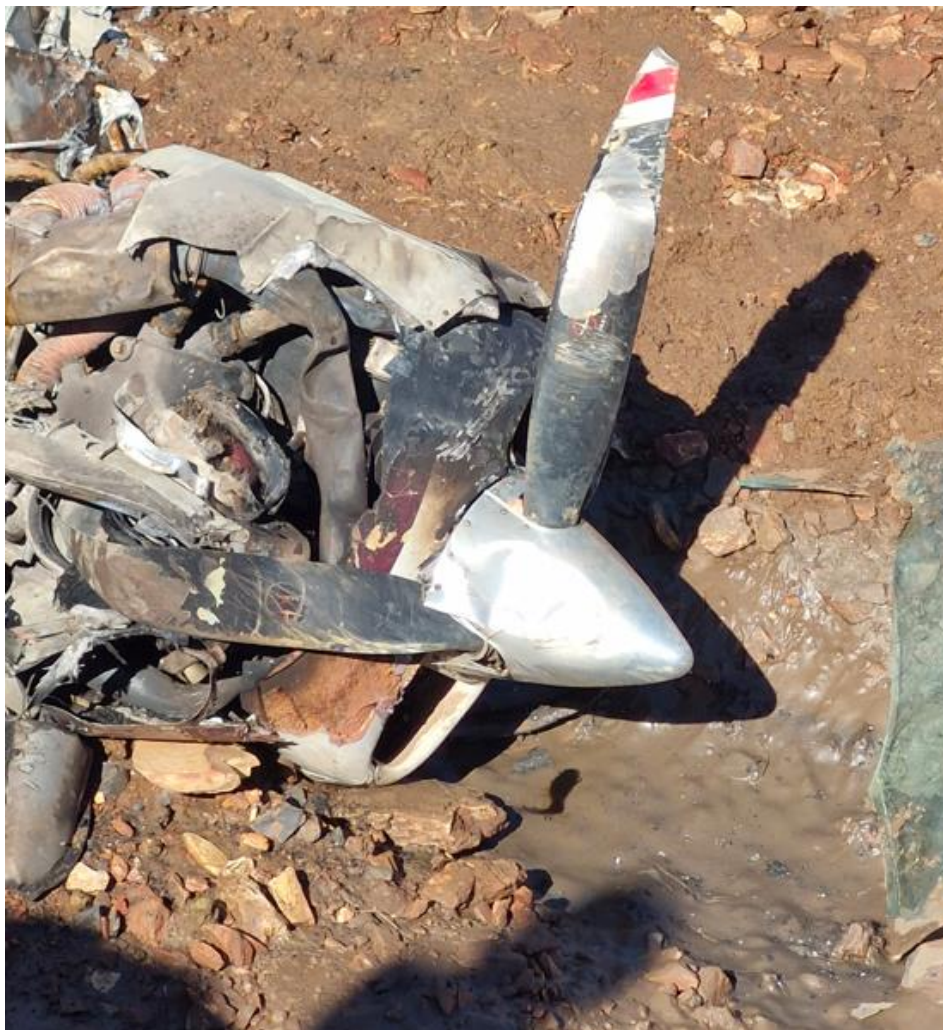
1.12.2. The engine was still secured in the cradle. The exterior condition of the engine appeared intact. The propeller flange was still connected to the engine. One of the three propeller blades had dislodged from the hub. The propeller blades were found twisted in the middle section and the tips were slightly bent backward. Deep impact markings on the leading edge indicated power signatures.

Figure 7: Damaged propeller blades.

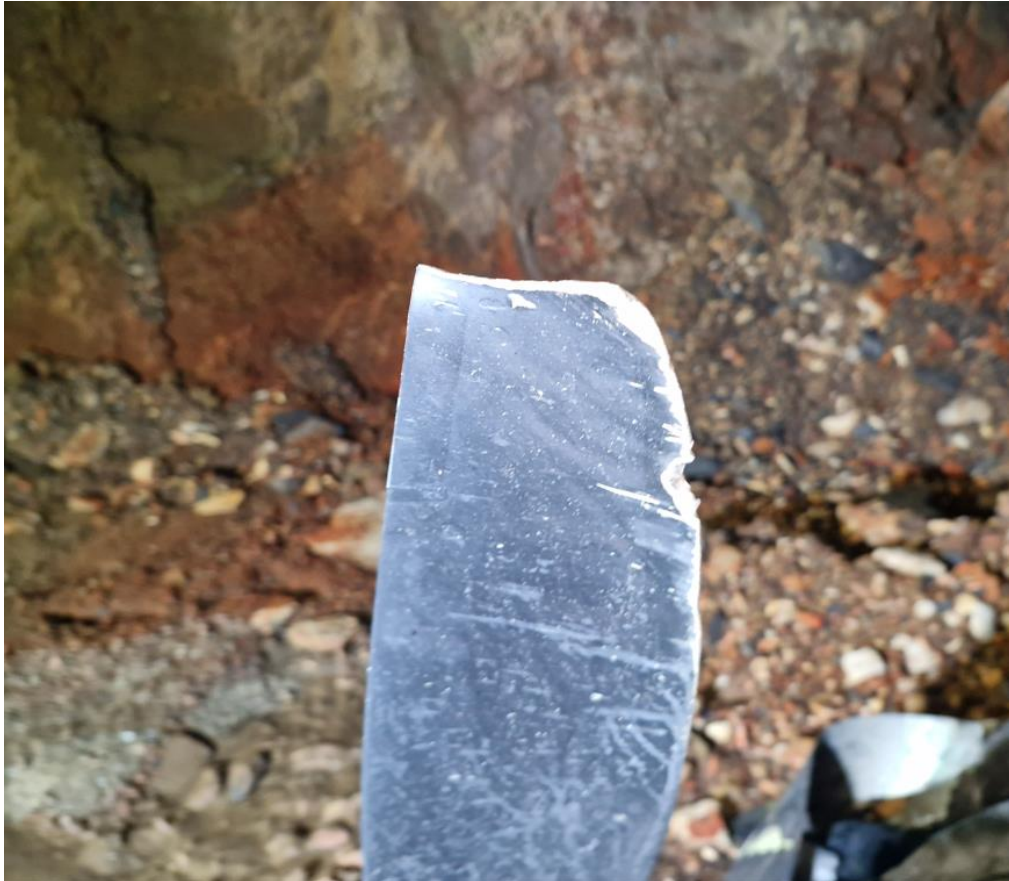
Figure 8: The damaged leading-edge tip.
