PRELIMINARY ACCIDENT REPORT

Accident and Incident Investigations Division

Accident
- Preliminary Report -
AIID Ref No: CA18/2/3/10572

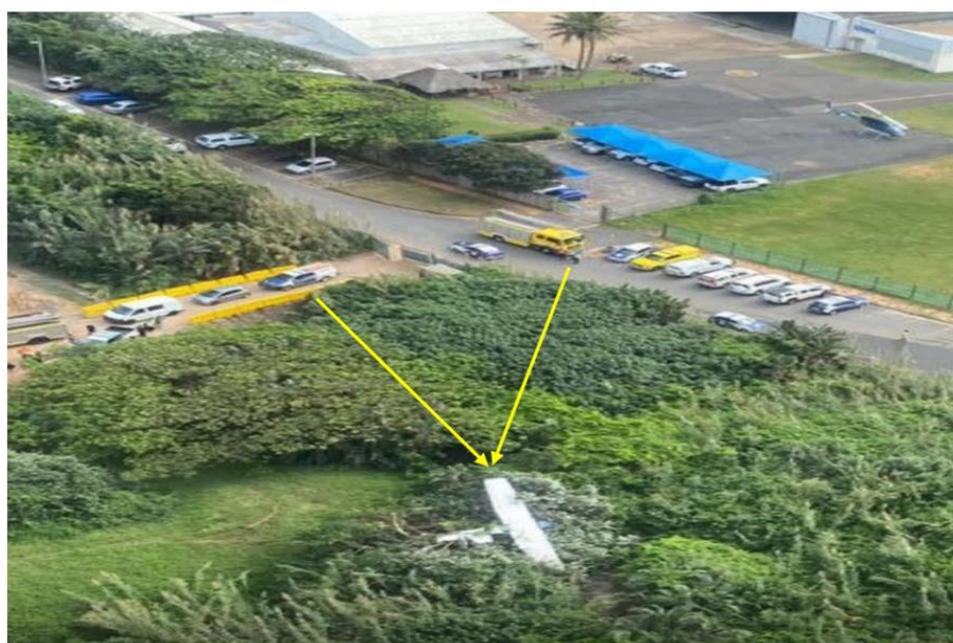
Figure 3: The aircraft and the emergency vehicles at the accident site. (Source: Operator)

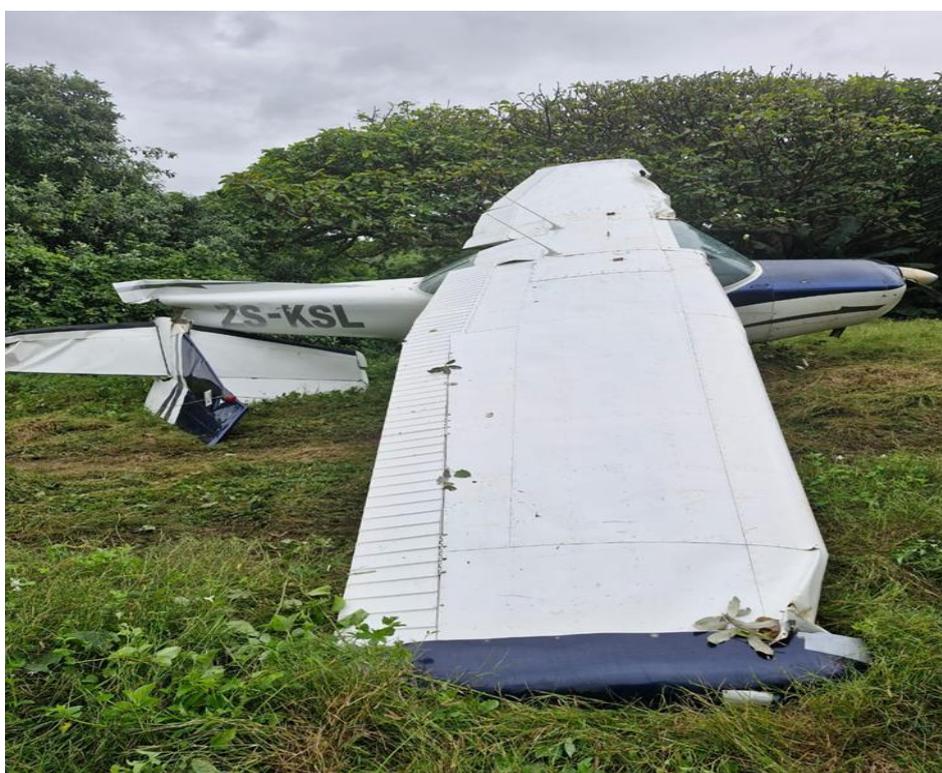
1.3.1. The aircraft was substantially damaged.

Figure 4: The aircraft post removal from the treetops.

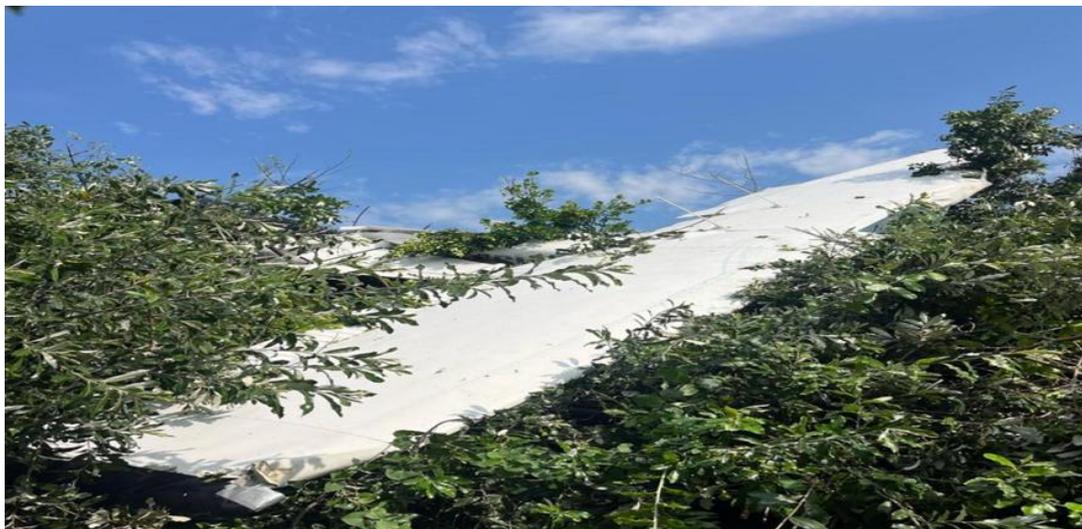
1.12.1. The aircraft impacted the Beachwood Golf Course treetops, approximately 300m short of the threshold of FAVG Runway 05. Upon inspection of the aircraft after the accident, the engine oil level was found at the maximum mark after a dipstick check was conducted. There was no trace of oil leakage found at the accident site. A significant amount of fuel was observed leaking from the fuel tanks; the ARFF team administered foam to avoid the possibility of a post-impact fire. The instrument panel had remained intact. The engine was found intact and in good condition. It was noted that the throttle friction nut was set to maximum friction, and the mixture control was found leaned (lean position). The battery terminal had remained connected during the accident sequence.

Figure 5: The aircraft at its resting position on top of the trees.

1.12.2. The aircraft rested upright after the accident; it was substantially damaged.

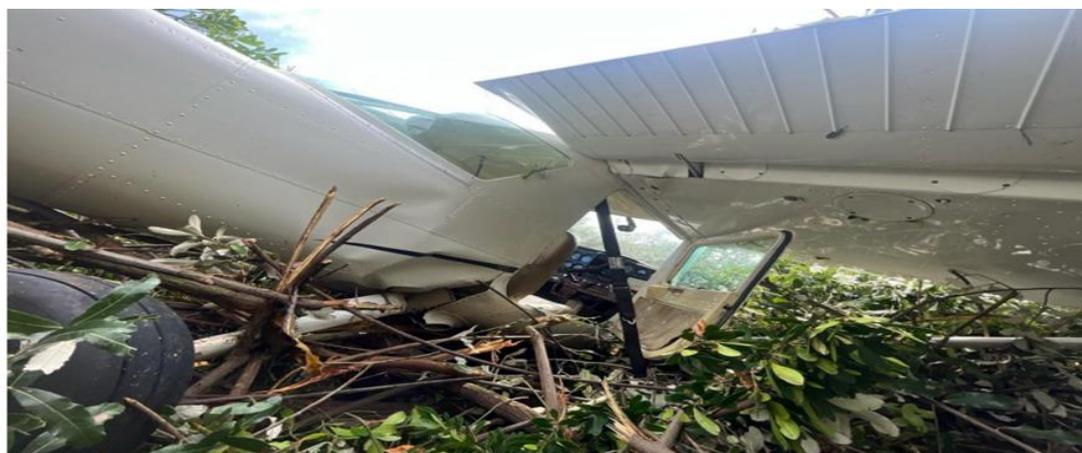
Figure 6: Right side wing of the aircraft as found at the accident site.

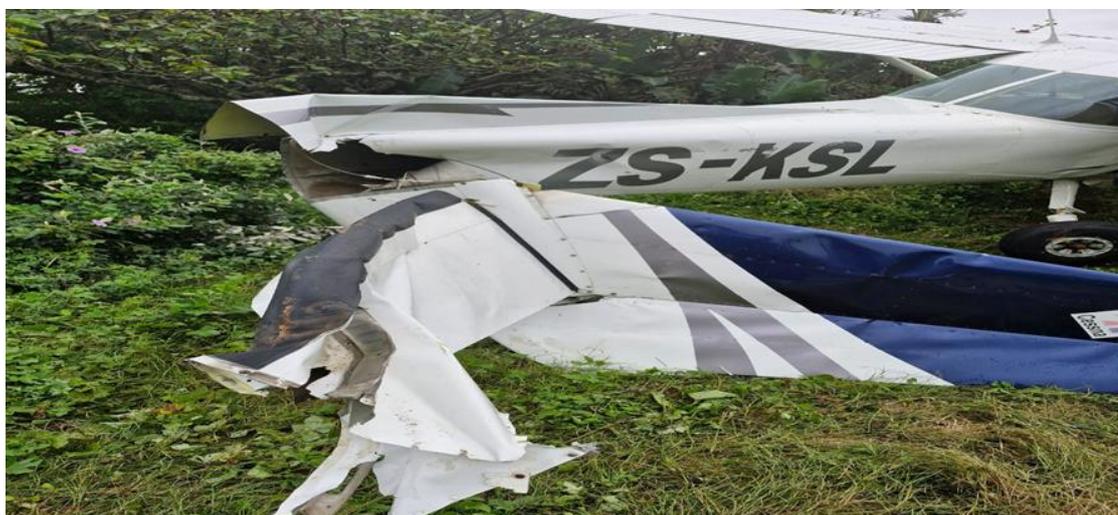
1.12.3. The empennage separated after impact. The elevator and rudder sustained severe damage, however, the control rods remained intact.

Figure 7: The severed empennage.

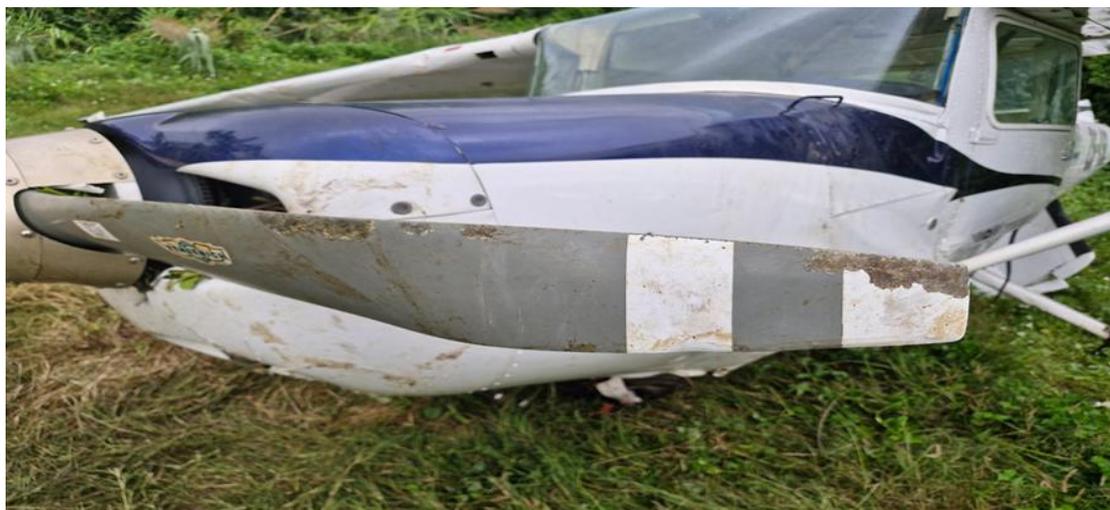
1.12.4. The nose landing gear showed signs of deformation, but it was still attached to the fuselage. Both propeller blades exhibited signs of impact damage; the propeller had slightly bent inwards.

Figure 8: The damaged propeller.

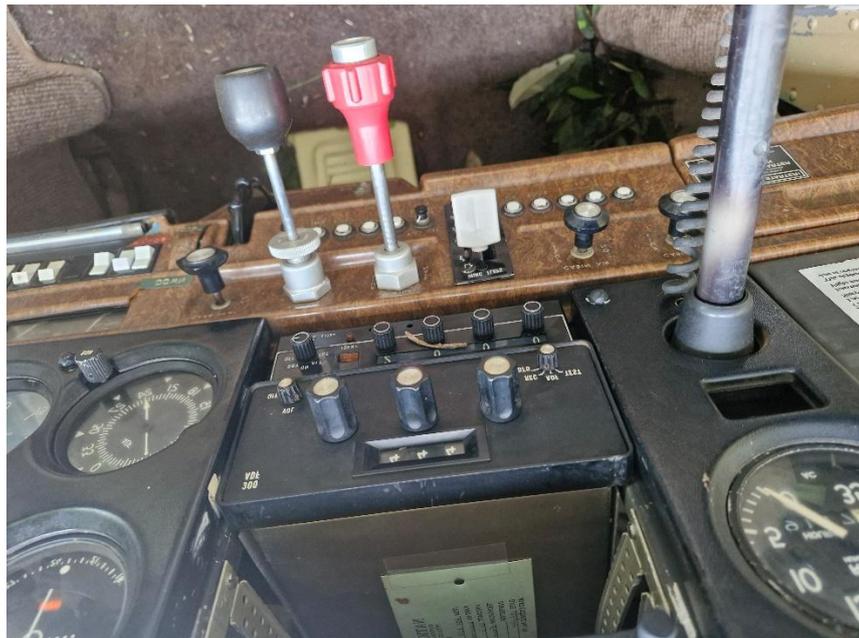
- I. Before the removal of the throttle cable, it was noted that the friction nut inside the cockpit was overly tightened, which restricted the movement of the throttle control cable.

Figure 9: Throttle and mixture as found at the accident site.

2.2.8. The throttle friction nut was overly tightened and this significantly limited throttle travel, thus, restricting the pilot's ability to command increased power.

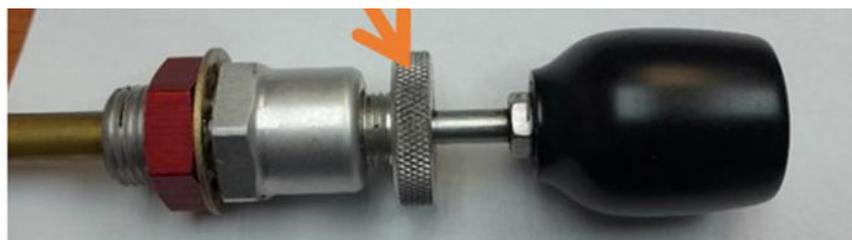
Figure 10: The throttle control cable nut.

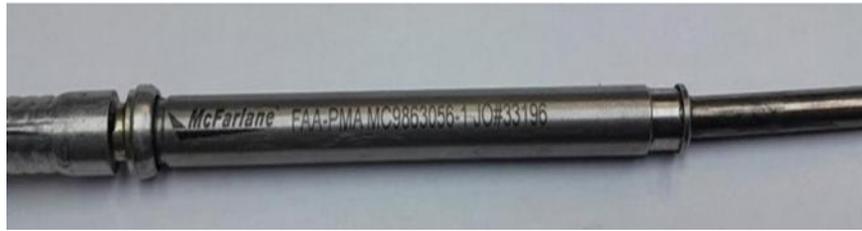
- II. After the removal of the throttle cable, the throttle control cable was inspected and found to be in good condition, with no visible signs of wear or damage.

Figure 11: The throttle control cable.

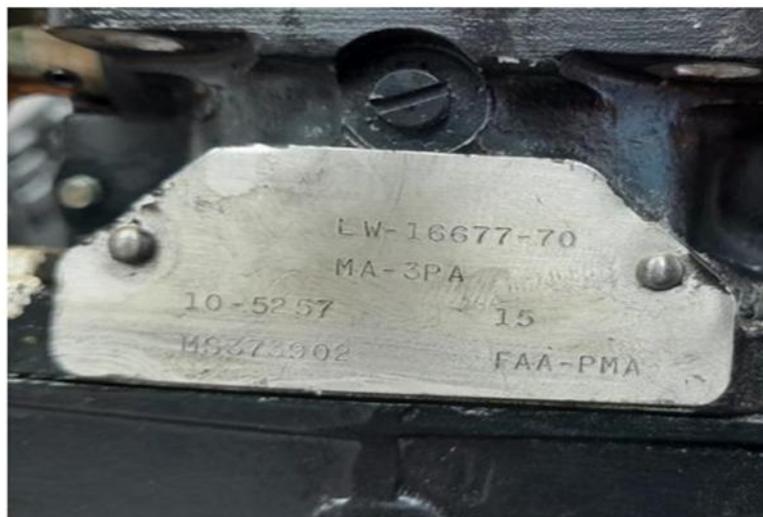
- I. The carburettor was removed and thoroughly inspected; adequate fuel was found which ruled out fuel starvation as a contributing factor to the accident.
- II. The carburettor levers, shaft and butterfly valve were examined for signs of damage, wear or defects that could have contributed to the throttle control failure.
- III. The carburettor was determined to be in good condition with no defects identified.

Figure 12: The carburettor.

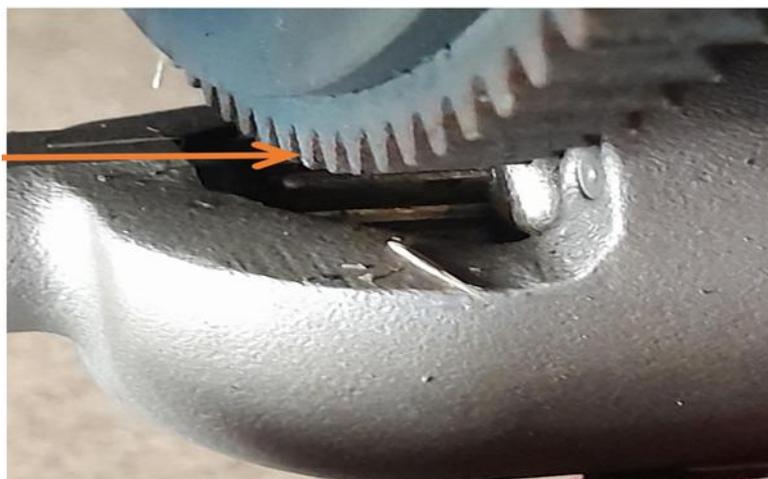
- I. It was observed that the starter's Bendix gear remained engaged, indicating an attempted engine restart. The Bendix gear can only disengage when the engine is rotating; and, on similar Lycoming engines, it typically disengages at approximately 400 RPM.

Figure 13: Engaged starter Bendix gear.

2.2.9. The engaged starter Bendix gear normally designed to disengage at approximately 400 RPM suggested an attempted engine restart. This is consistent with a scenario in which the engine was operating at a low RPM.
