PRELIMINARY SERIOUS INCIDENT REPORT

Serious Incident
- Preliminary Report -
AIID Ref No: CA18/3/2/1470

Reference Number : CA18/3/2/1470
Occurrence Category : Serious Incident
Type of Operation : Private (Part 91)
Name of Operator : Air Ambulance Health Service (PTY) LTD
Aircraft Registration : ZS-LFW
Aircraft Make and Model : Beechcraft Super King Air B200
Nationality : South African
Place : Bloemfontein
Date and Time : 8 February 2025 at 1420Z
Injuries : None
Damage : None

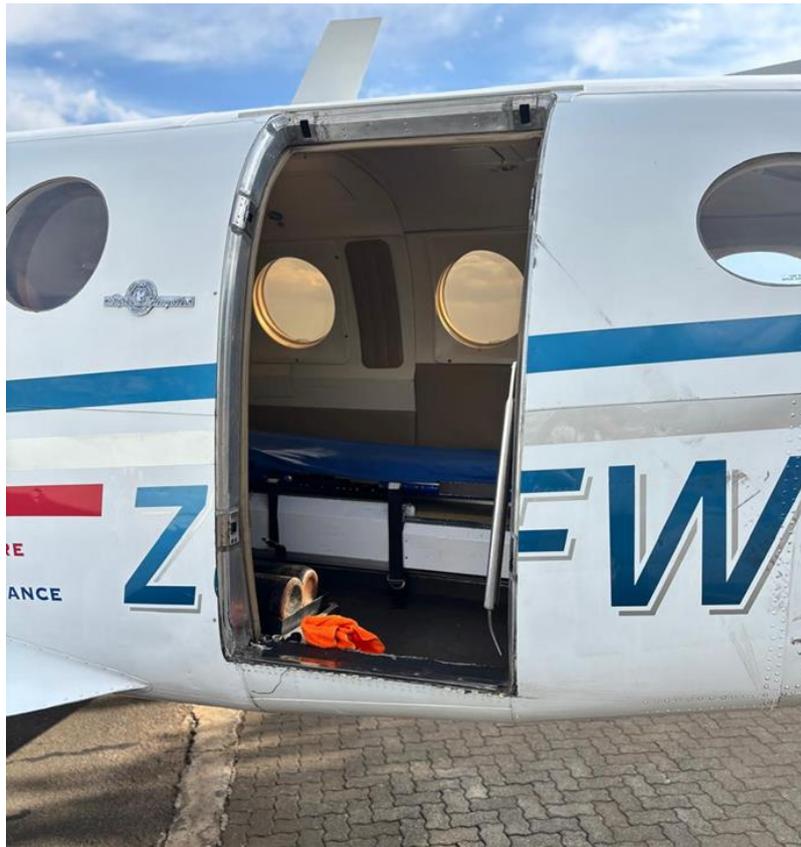
1.3.1. The door detached from the fuselage during downwind for landing on RWY 30.

1.3.2. Other damage to the aircraft included the cable attachments that kept the door in place when open.

Figure 3: The aircraft post-incident at FABL. (Source: Operator)

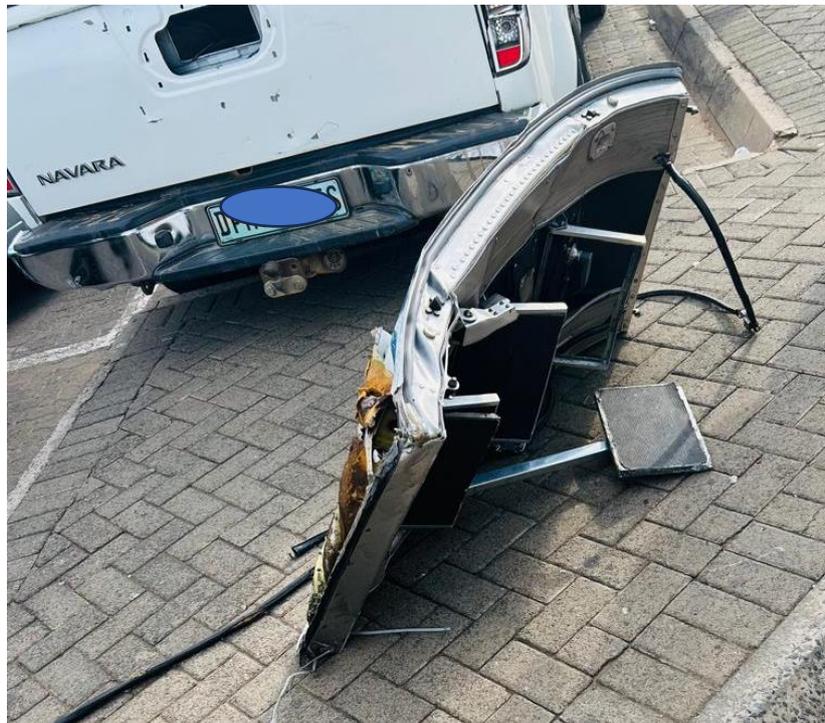
- 1.1.3. The crew started their descent from FL130 to 6 000ft and, whilst descending, they depressurised the cabin as per the Standard Operating Procedure (SOP) and, thereafter, joined a circuit for Runway (RWY) 30 at FABL. *The airport was unmanned at the time*. During the downwind leg, the captain who was the pilot flying (PF) reduced the speed before he commenced with the before landing checks. The crew selected first stage flaps and lowered the landing gear at a speed of approximately 150 knots (kts). Just before a call to select full flaps could be made, the door opened and detached from the aircraft fuselage. The crew did not change the aircraft configuration and speed; they landed safely on RWY 30. After landing, the crew found out that the door landed on a car parking lot of a shopping mall, approximately 4 nautical miles (nm) south-west of FABL. The door did not injure any person or damage property when it detached and landed on the parking lot. A security video footage at the shopping mall showed the door whilst it descended and impacted the paved parking area.

Figure 4: The aircraft door at the shopping mall parking lot. (Source: Operator)

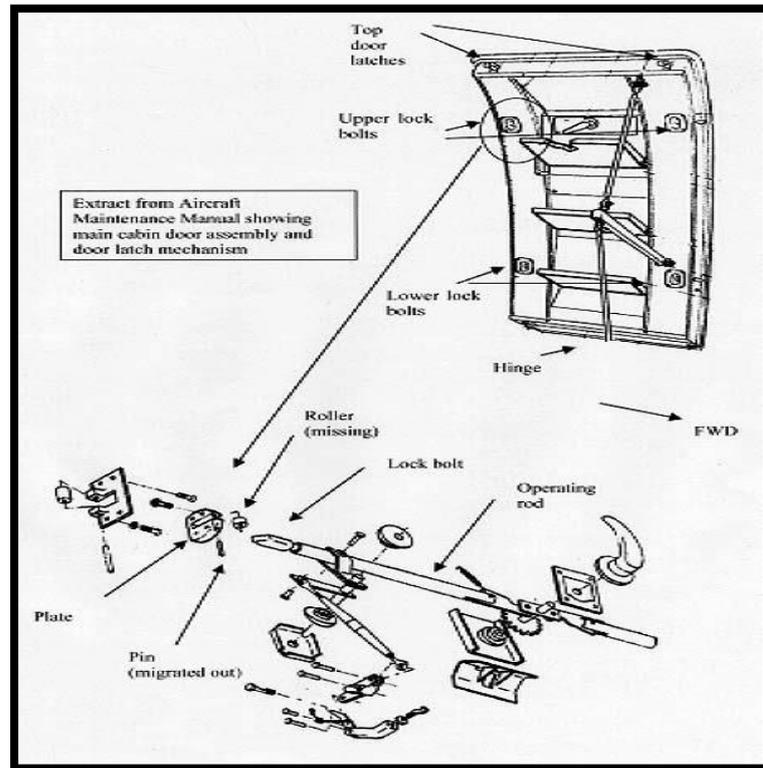
Rotation of the handle to the closed position causes two top door latches to hook into the top of the door frame and two upper (one each side) and two lower (one each side) lock bolts on the sides of the door to extend outwards into the door frame. The lock bolts move outwards over a roller located within a slot inside a plate on the side of the door. The roller is secured by a pin, which is held in position by 'staking' at both ends. 'Staking' is performed after the pin is placed through the roller and involves striking the plate around the pin with a centre punch, causing deformation of the plate material, thus preventing movement of the pin.

Diagram 1: The airstair boarding door mechanism. (Source: Aircraft Maintenance Manual [AMM])

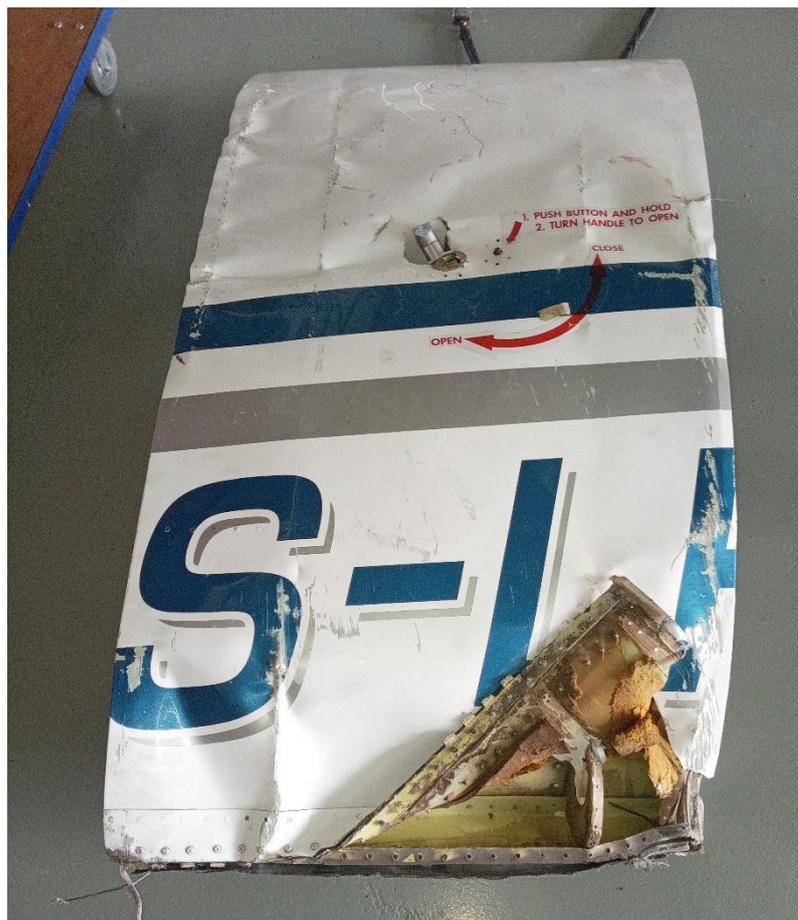
1.12.1. During approach for landing at FABL, a cabin door warning indication illuminated on the annunciator panel and the captain requested the paramedic to check the four visual indicators if they were aligned. The paramedic indicated that the top-right corner indicator was not aligned. Thereafter, the captain advised the medical personnel to put on their seatbelts and to not temper with the door. During the downwind checks, the door opened and detached from the fuselage. It landed on a shopping mall parking lot. The door sustained substantial damage. No person was injured and no property was damaged during the serious incident.

Figure 5: The damaged cabin door.

1.12.2. Other damage to the aircraft included the cable attachments that kept the door in place when open.

- 2.2.9. The status report printed on 20 January 2025 indicated that the cabin door forward and aft side latches were installed on 17 October 2019 at 14958 cycles. They have a life of 5000 cycles and, on the day of the serious incident, they had 936 cycles remaining before replacement.
