PRELIMINARY ACCIDENT REPORT

Accident and Incident Investigations Division

Accident
- Preliminary Report -
AIID Ref No: CA18/2/3/10541

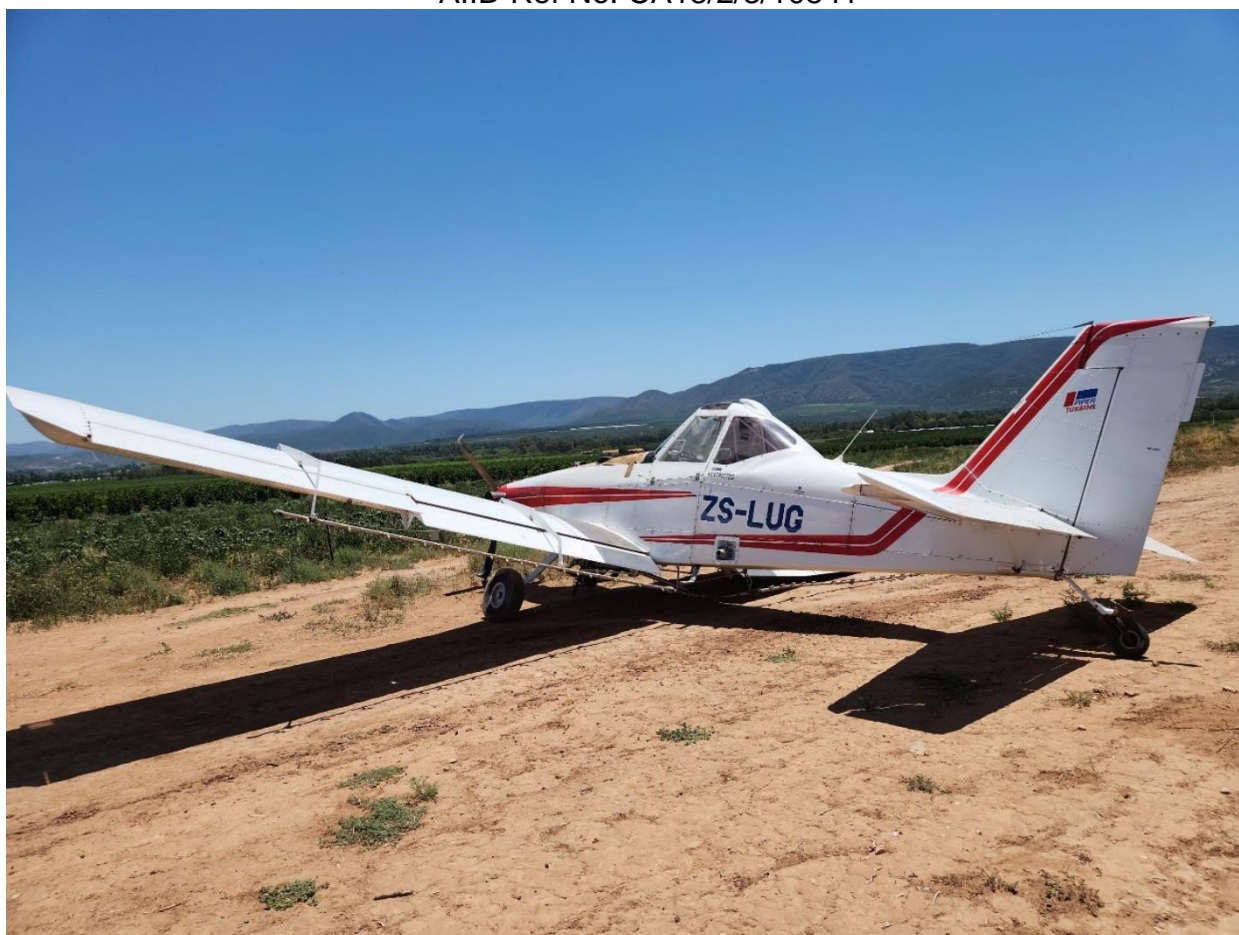
Figure 1: ZS-LUG as it came to rest. (Source: Pilot)

- 1.1.4. The aircraft swung to the right and came to a stop on the runway facing east. The pilot shut down the aircraft and exited without assistance; he was uninjured. The aircraft sustained damage to the right main landing gear, right wing, propeller and the spray gear.

1.12.1. The aircraft landed on RWY 22 at Kirkwood Airstrip and the right main gear failed and separated from the aircraft during the landing roll.

- 2.2.6 The pilot completed seven uneventful crop-spray runs and, during the landing roll on RWY 22, the right undercarriage failed and separated from the fuselage. The aircraft veered off to the right and came to a stop on the runway facing east.
