PRELIMINARY ACCIDENT REPORT

Accident and Incident Investigations Division

Accident
- Preliminary Report -
AIID Ref No: CA18/2/3/10491

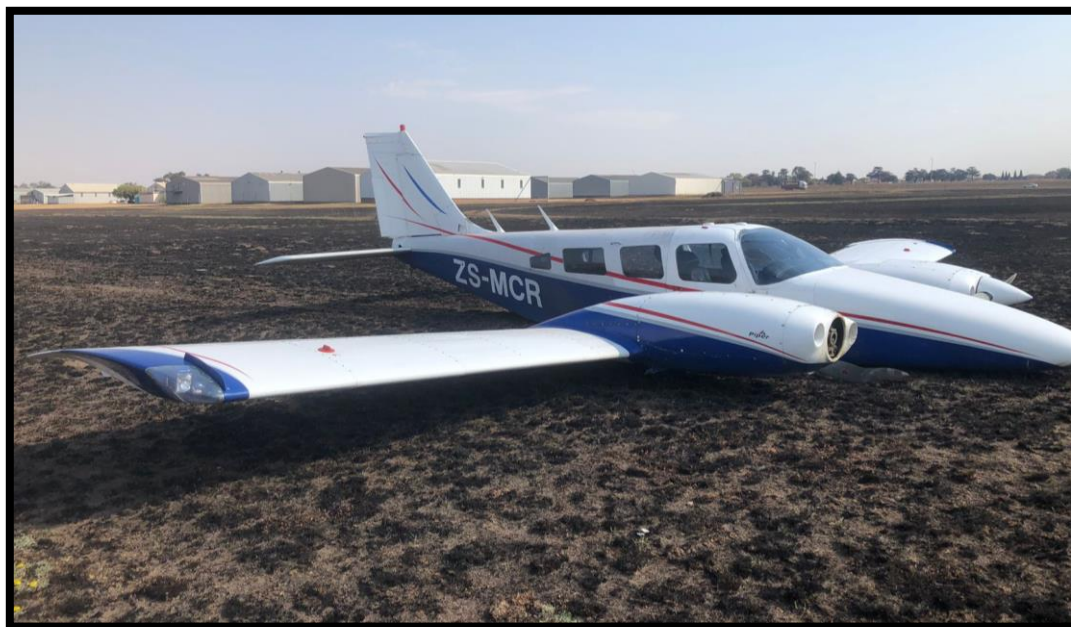
Figure 1: Piper PA 34-200T Seneca II (ZS-MCR) at the accident site.

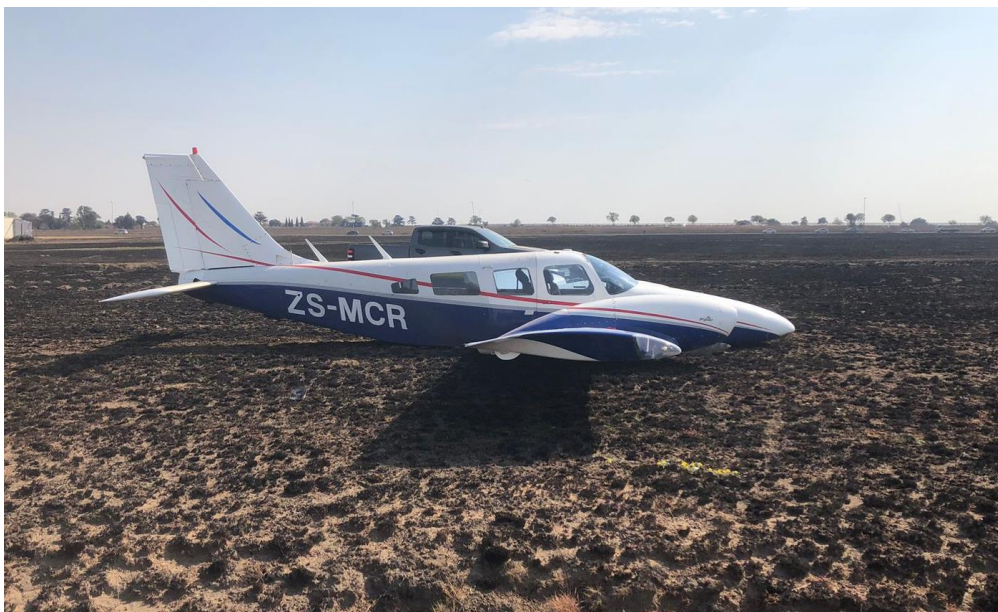
Figure 2: The aircraft after it had stopped. (Source: Operator)

1.3.1. The aircraft sustained substantial damage to both propellers and underbelly.

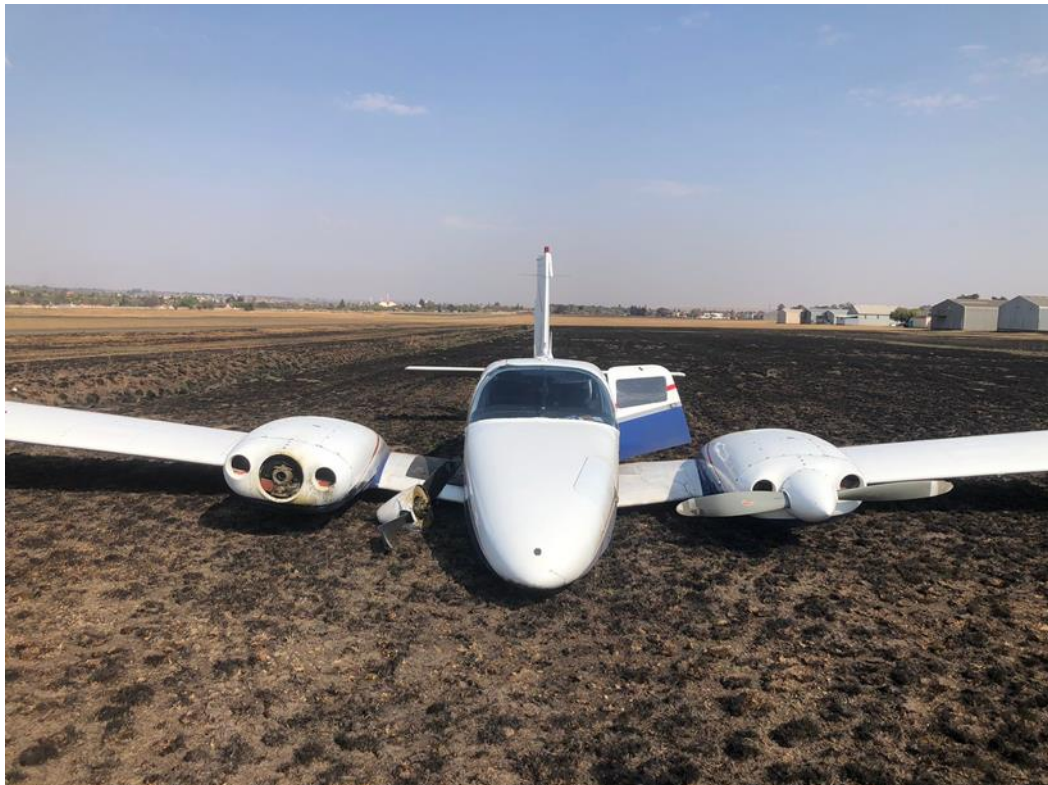
Figure 3: The right engine propeller separated from the flange during the accident sequence.
(Source: Operator)

1.12.2. The aircraft skidded for approximately 150 metres before it stopped. The right-side engine propeller separated from the flange and the left-side propeller sustained damage to one of the blades. After lifting and supporting the aircraft on jacks, the undercarriage was lowered; it was no damaged. The aircraft had minor scratches to the underbelly.

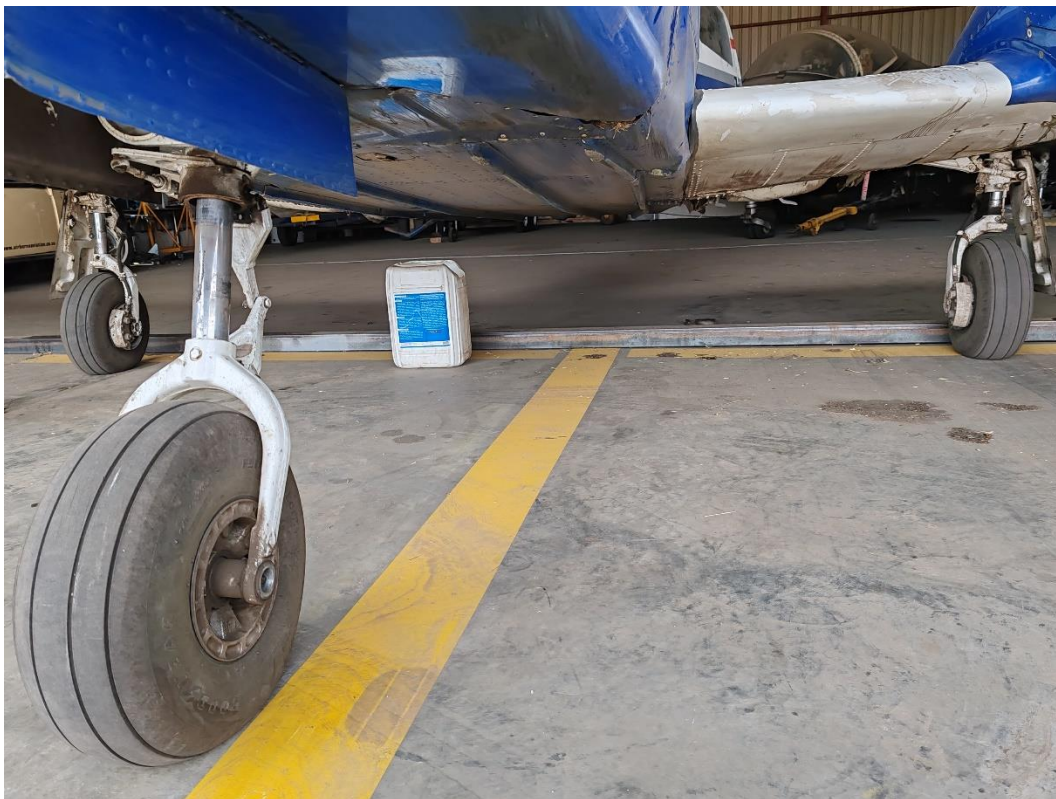
Figure 4: Scrape marks on the underbelly.
