PRELIMINARY ACCIDENT REPORT

Accident
- Preliminary Report -
AIID Ref No: CA18/2/3/10550

Figure 1: File picture of the Piper PA28-180 Cherokee ZS-MKY. (Source: www.jetphotos.com)

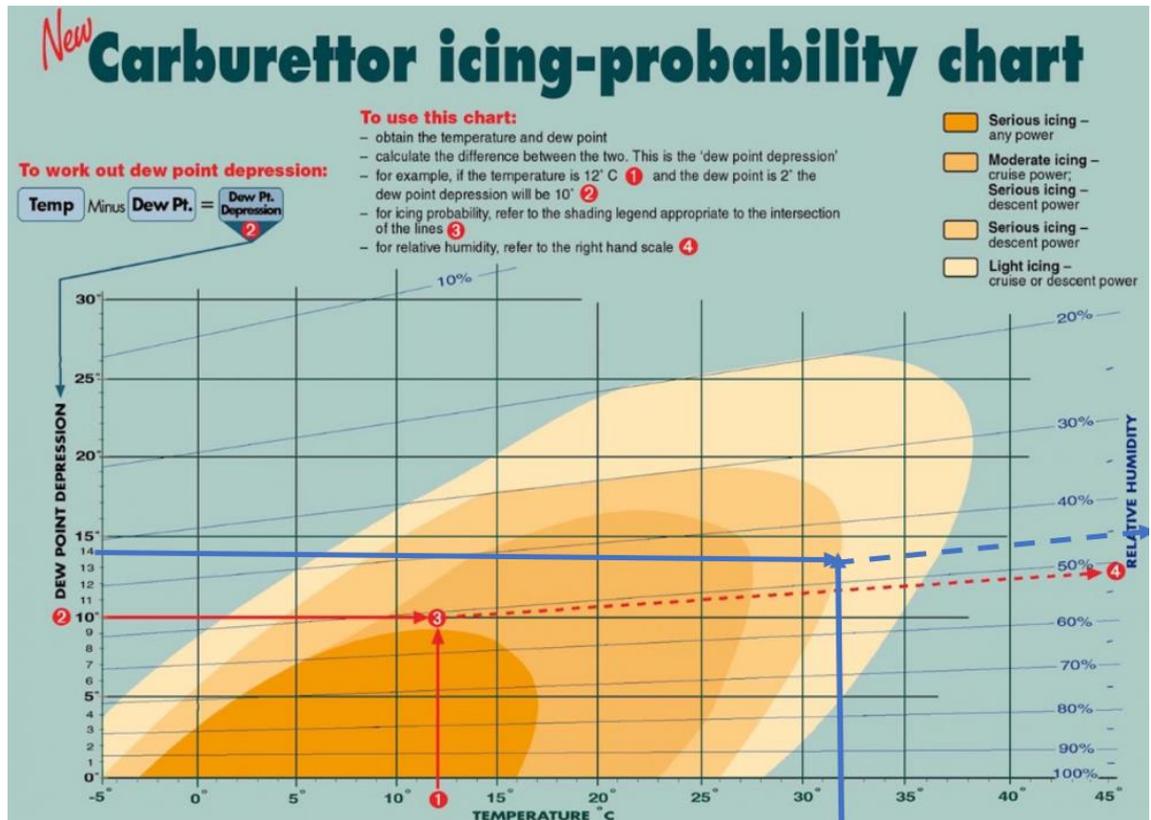
Figure 4 - Icing-probability Chart.

1.7.2. The carburettor icing probability chart on the day of the flight indicated a dew point depression of 14°C with an air temperature of 32°C and a dew point of 18°C at a relative humidity of 45%. The aircraft was in the climb phase at these icing-probability chart calculations.

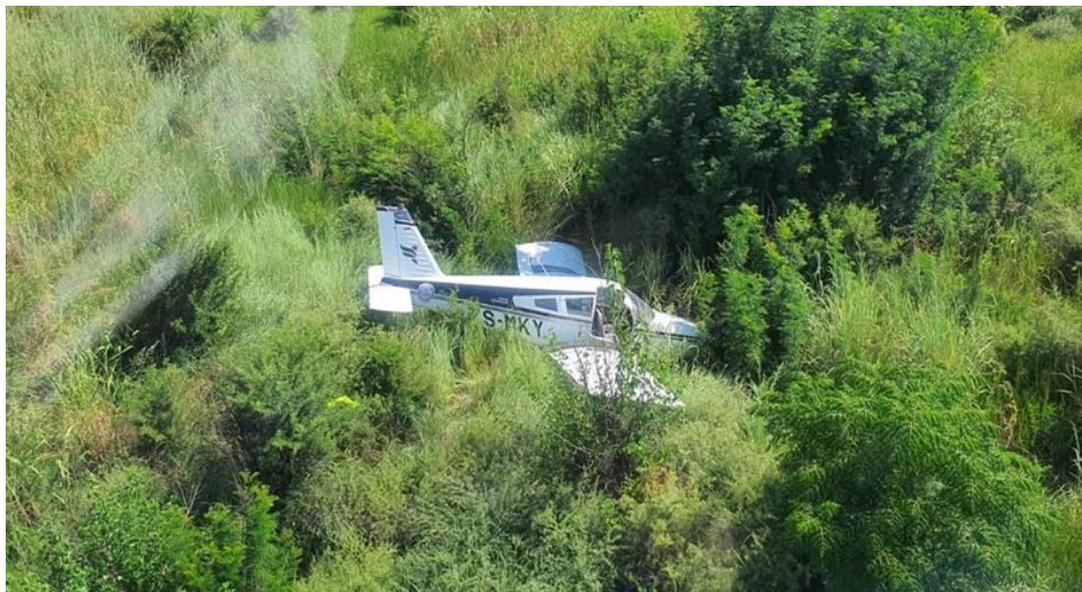
1.12.1. The flight instructor executed a forced landing in Onderstepoort, Pretoria, approximately 7 kilometres west of Runway 29. The aircraft landed in a densely vegetated area.

Figure 5: The aircraft at the accident side. (Source: Operator)

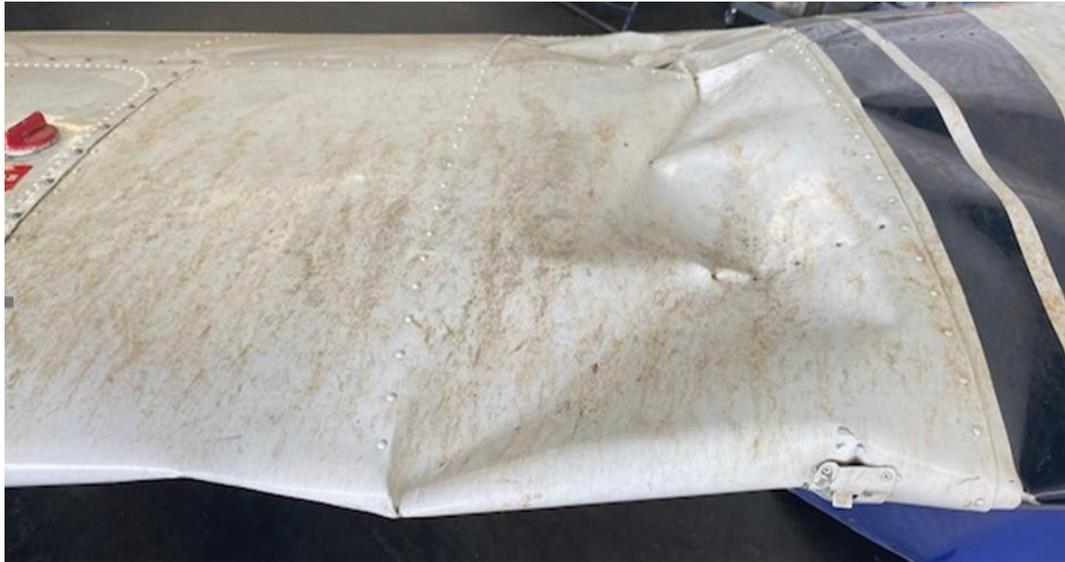
1.12.2. The left wing and the propeller were damaged during the forced landing. The aircraft was retrieved in its entirety without being disassembled. It remained structurally intact as it was found, ensuring that all components were preserved in their original condition for further examination.

Figure 6: The damaged left wing.

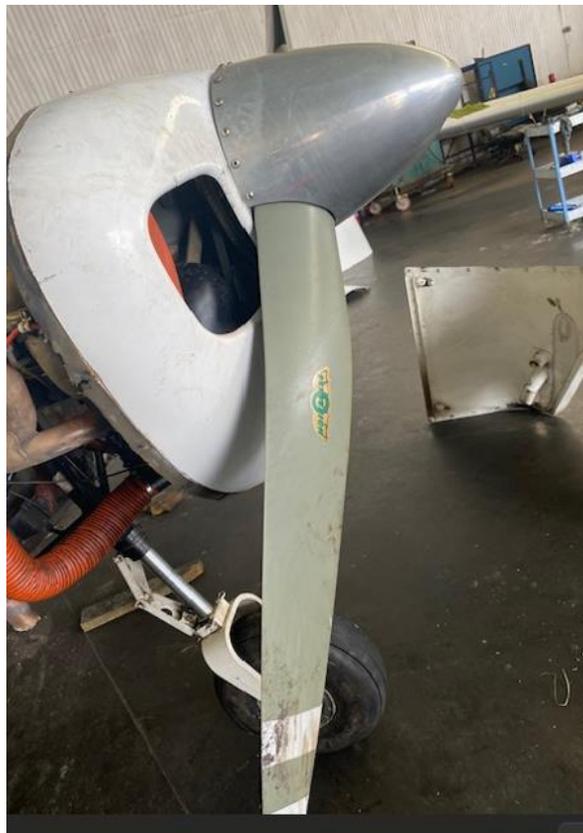
Figure 7: The bent propeller blade.

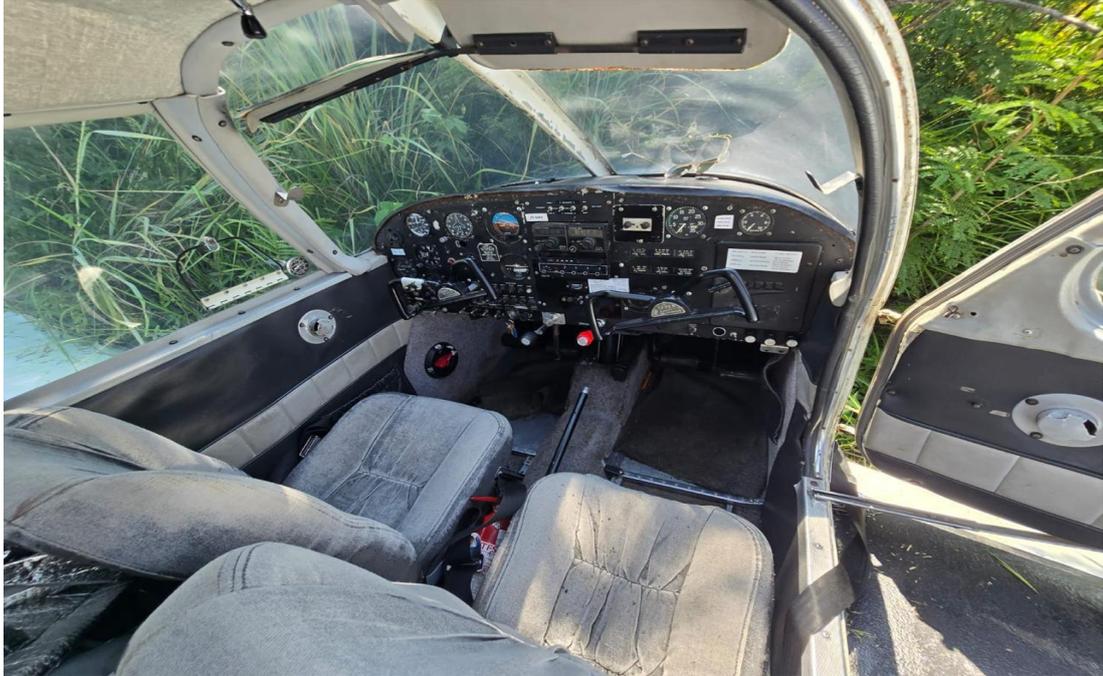
1.15.1. The accident was considered survivable as there was no damage to the cockpit and cabin areas that would have caused serious injury to the crew. The crew had their safety harnesses on during the flight, and they did not fail during the accident sequence.

Figure 8: A view of the cockpit after the accident. (Source: Operator)
