PRELIMINARY ACCIDENT REPORT

Accident and Incident Investigations Division

Accident  
- Preliminary Report -  
AIID Ref No: CA18/2/3/10587

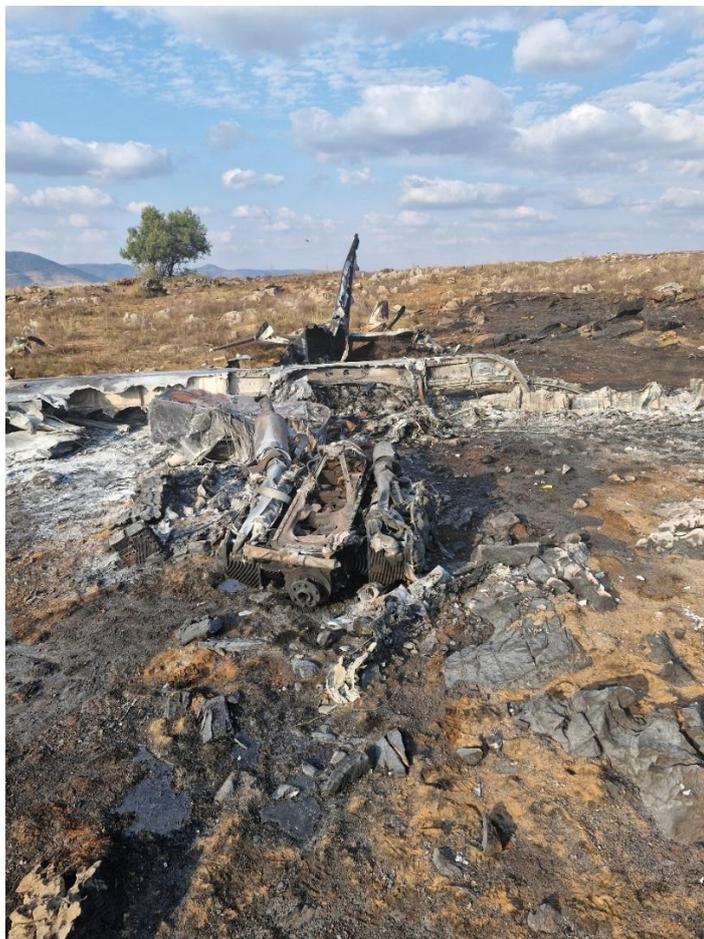
1.3.1. The aircraft was destroyed by impact forces and the post-impact fire.

**Figure 3:** The wreckage post-accident.

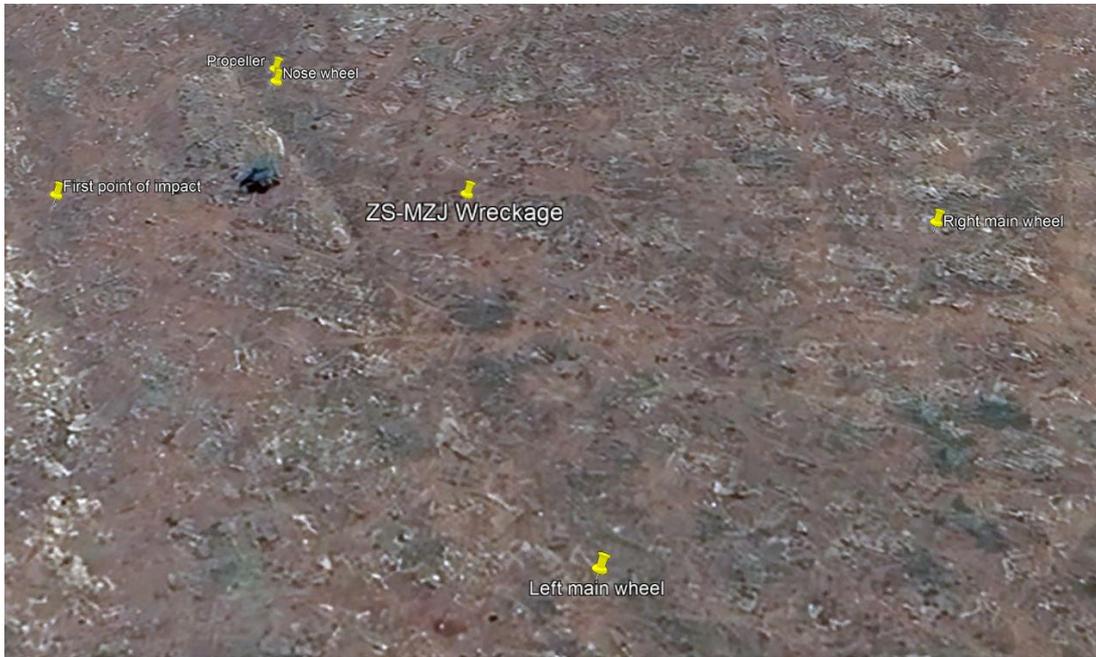
1.12.1. The accident occurred on a rocky terrain within the Lion and Safari Park Nature Reserve. The main wreckage and the detached components were located within a 75-metre (m) radius. The wreckage faced north-westerly; the wings, vertical and horizontal stabilisers were still attached to the fuselage. Most of the fuselage was consumed by the post-impact fire. Impact damage was observed on the left wing. The tail section was found intact. The flight control cables were also found intact and still secured to their respective control surfaces. The landing gear was extended; all three wheels were recovered from the accident site.

**Figure 4:** Wreckage distribution.

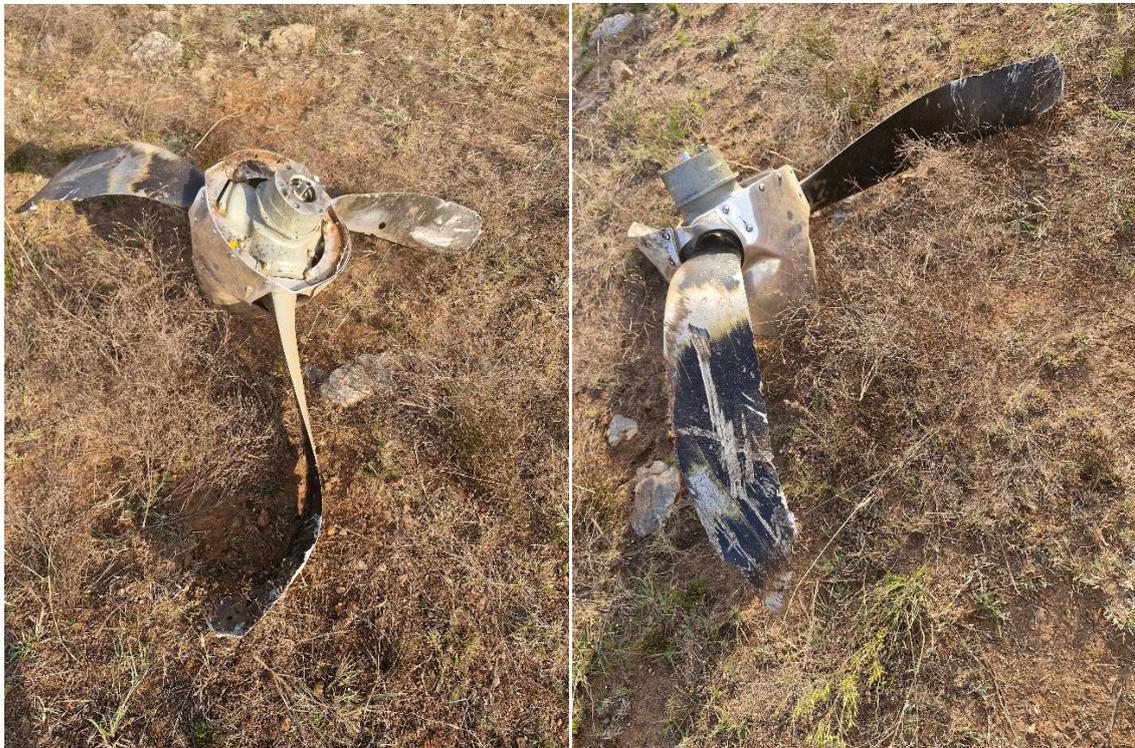
1.12.2. The engine was found in the cradle and still secured. The propeller blades were found twisted and slightly bent. The propeller dislodged from the engine; it was found approximately 42m north-west of the wreckage.

**Figure 5:** The damaged propeller blades.
