PRELIMINARY ACCIDENT REPORT

Accident and Incident Investigations Division

Accident
- Preliminary Report -
AIID Ref No: CA18/2/3/10564

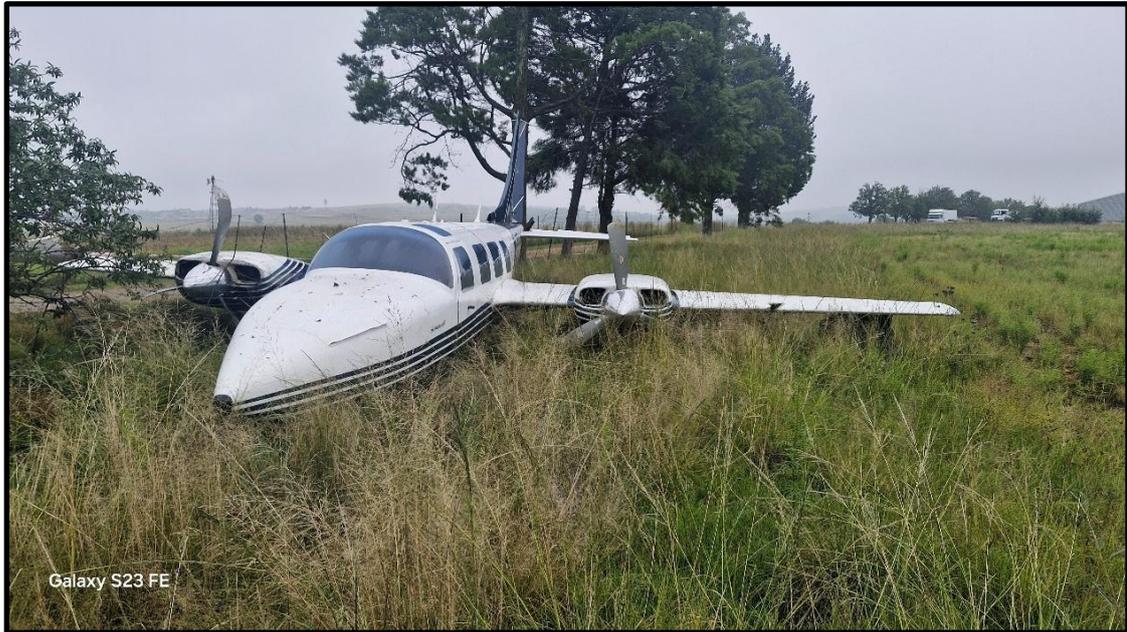
1.3.1. The aircraft sustained damage to the under fuselage (belly), left and right wings leading edges, engine number 1 and two, and left and right propeller blades.

Figure 3: The aircraft post-accident.

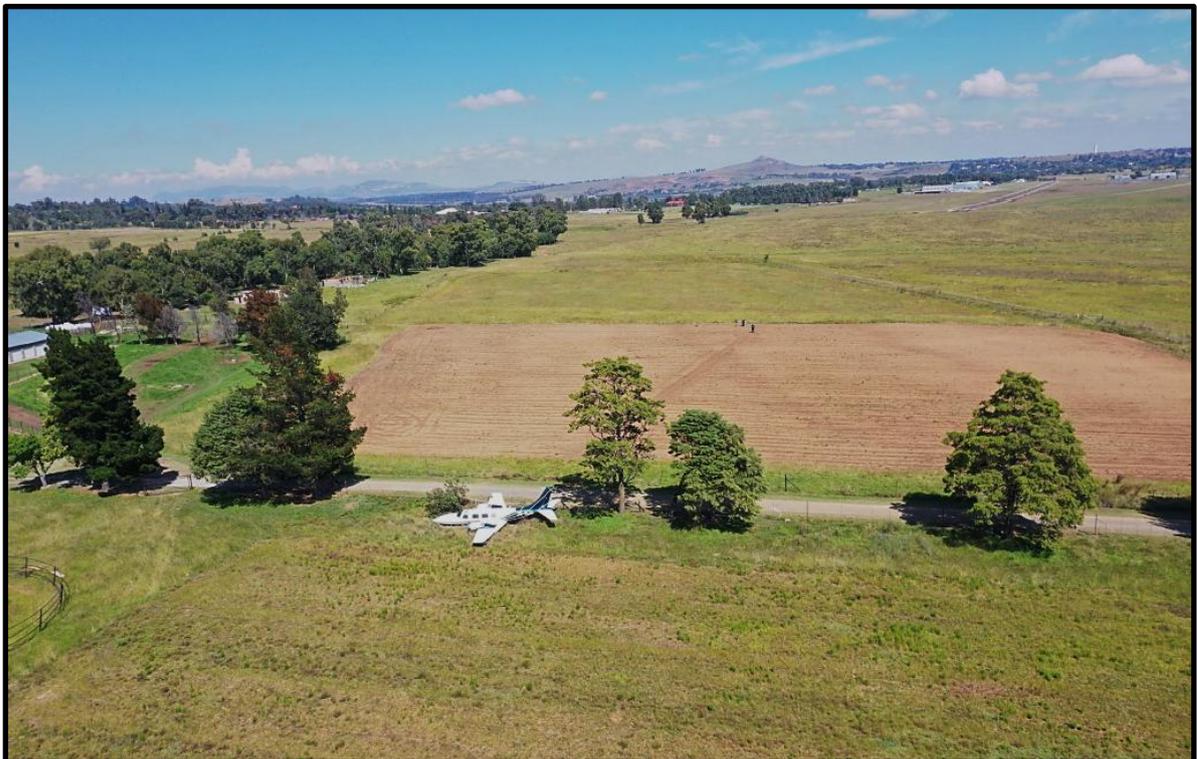
Figure 5: Aerial view of the accident site. (Source: Operator)

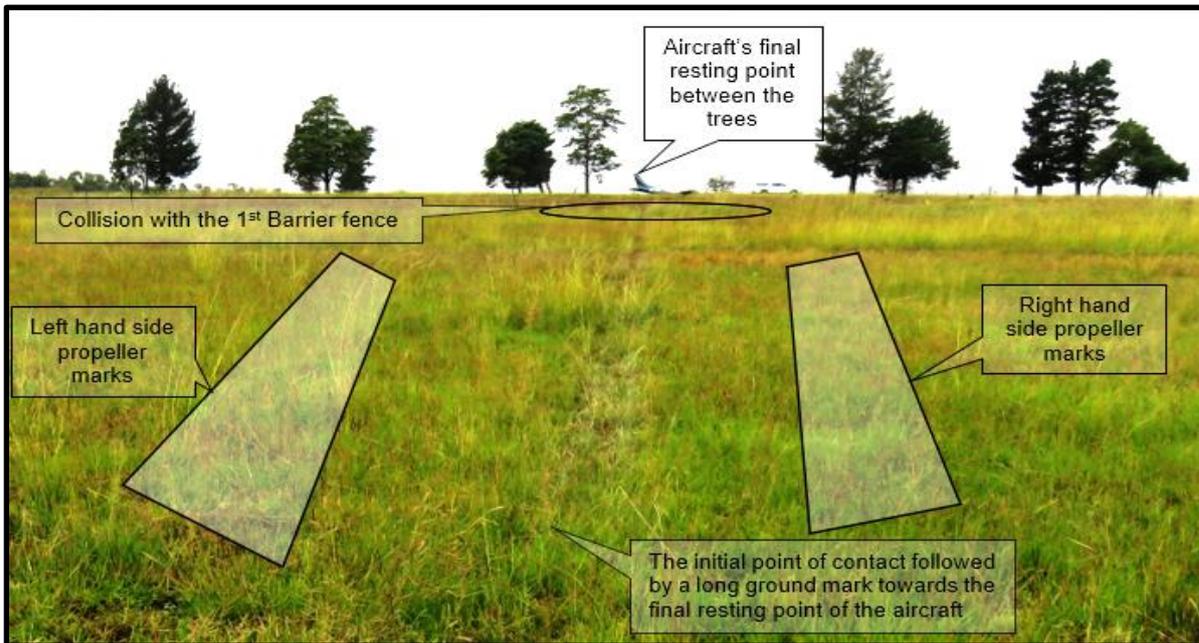
1.12.2. After rotation, the aircraft struggled to gain height and crashed shortly after clearing the aerodrome's barrier fence. The initial impact occurred approximately 500m from RWY 11; the aft section of the aircraft struck the ground first, followed by both propellers.

Figure 6: The point at which the aircraft initially touched down.

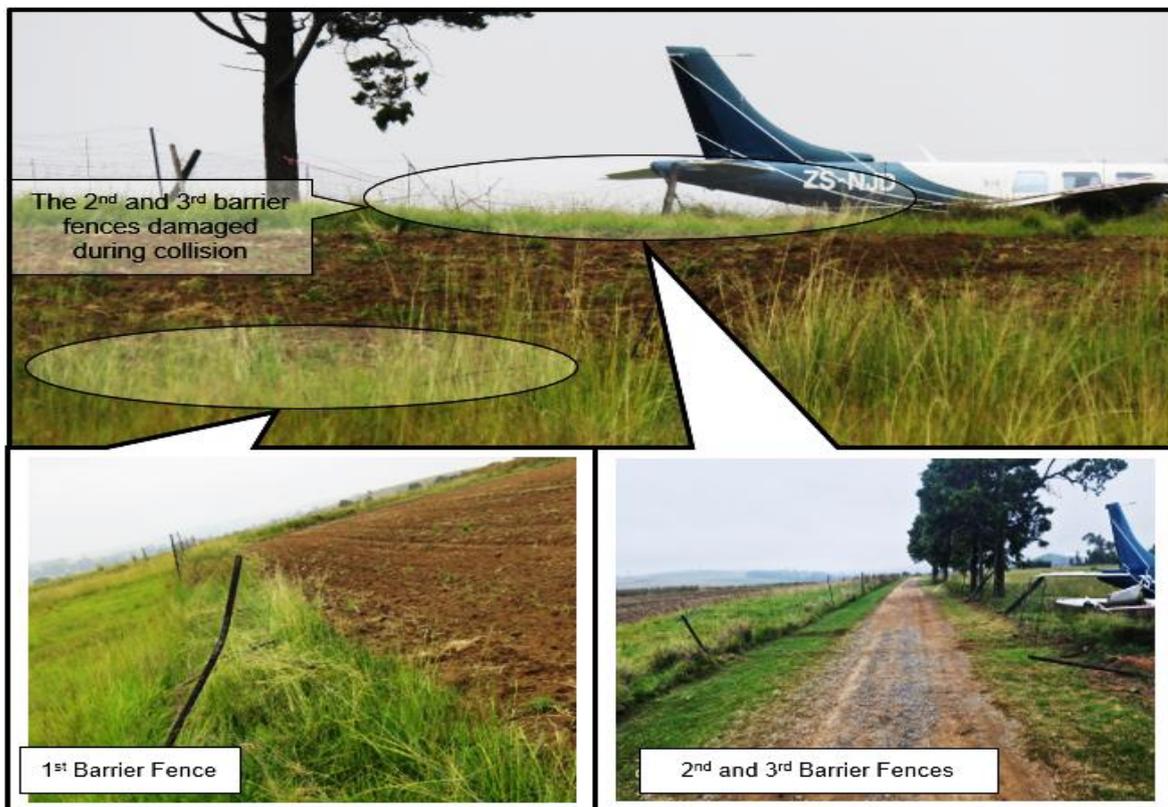
1.12.3. The aircraft slid along the grass surface for approximately 42m until it impacted the first barrier fence.

Figure 7: The pictures show the damage caused to the barrier fences.

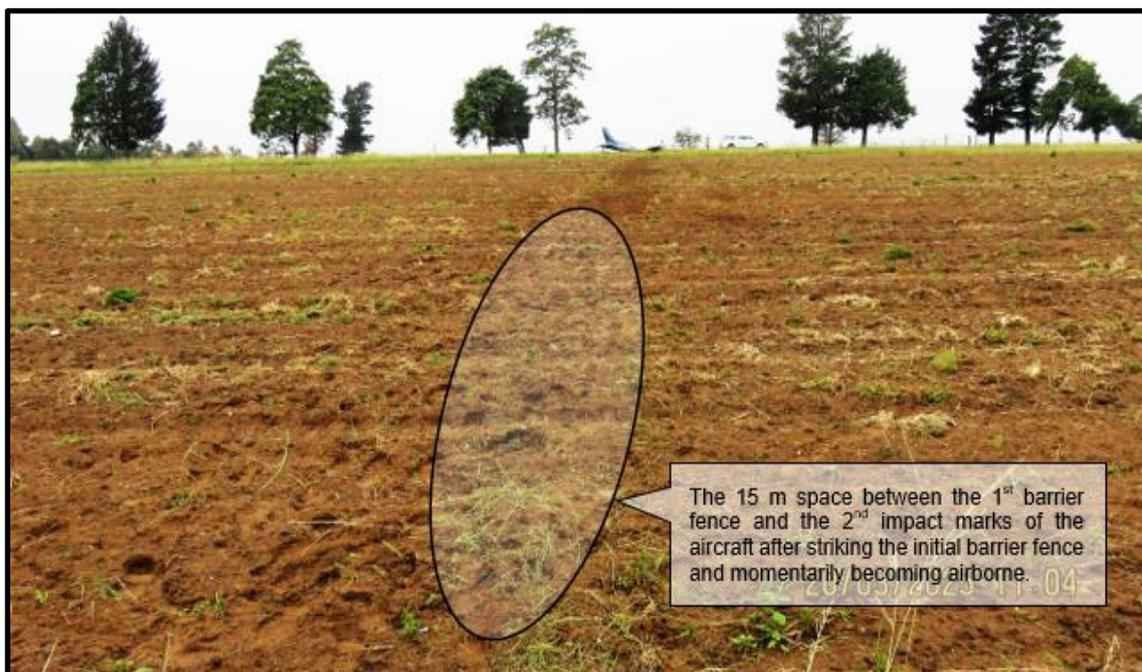
1.12.4. After the impact with the first barrier fence, the aircraft became momentarily airborne for approximately 15m before it touched down again.

Figure 8: The space between the barrier fence and the second impact marks.

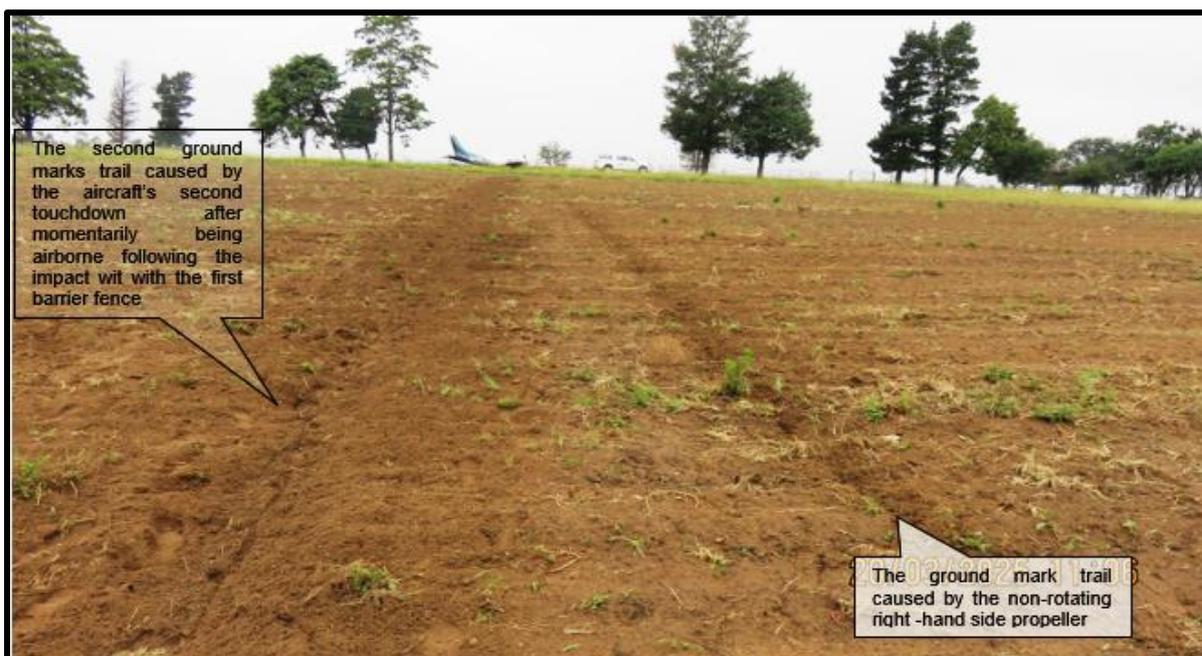
After touching down on the ground for the second time, the aircraft continued to scrape along the ground and the right propeller (that had stopped turning) left a distinguishable line for approximately 181m before the aircraft impacted the second barrier fence and the subsequent third barrier fence, as well as the tree across the road (the tree was located 12m from the road).

Figure 9: Impact marks caused by both the fuselage and the right-side propeller.

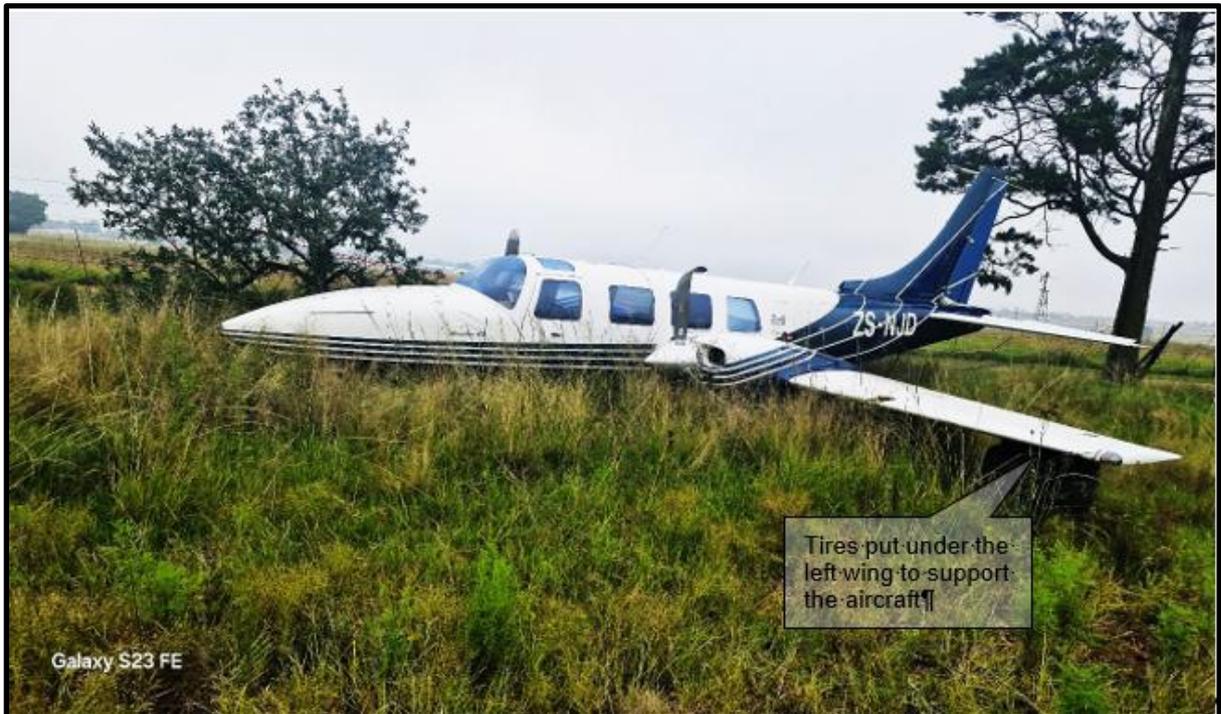
1.12.5. The investigator found the aircraft resting on its belly between the trees. Four tyres were positioned under the left wing to support it.

Figure 10: The aircraft as it was found.

The tyres were placed by the pilot and the eyewitness (who was near the hangars at the aerodrome) to prevent fuel from leaking out of the damaged left wing. Both the left and the right wings sustained damage due to impact with the barrier fences. The right wing sustained impact damage from the barrier fences and the tree.

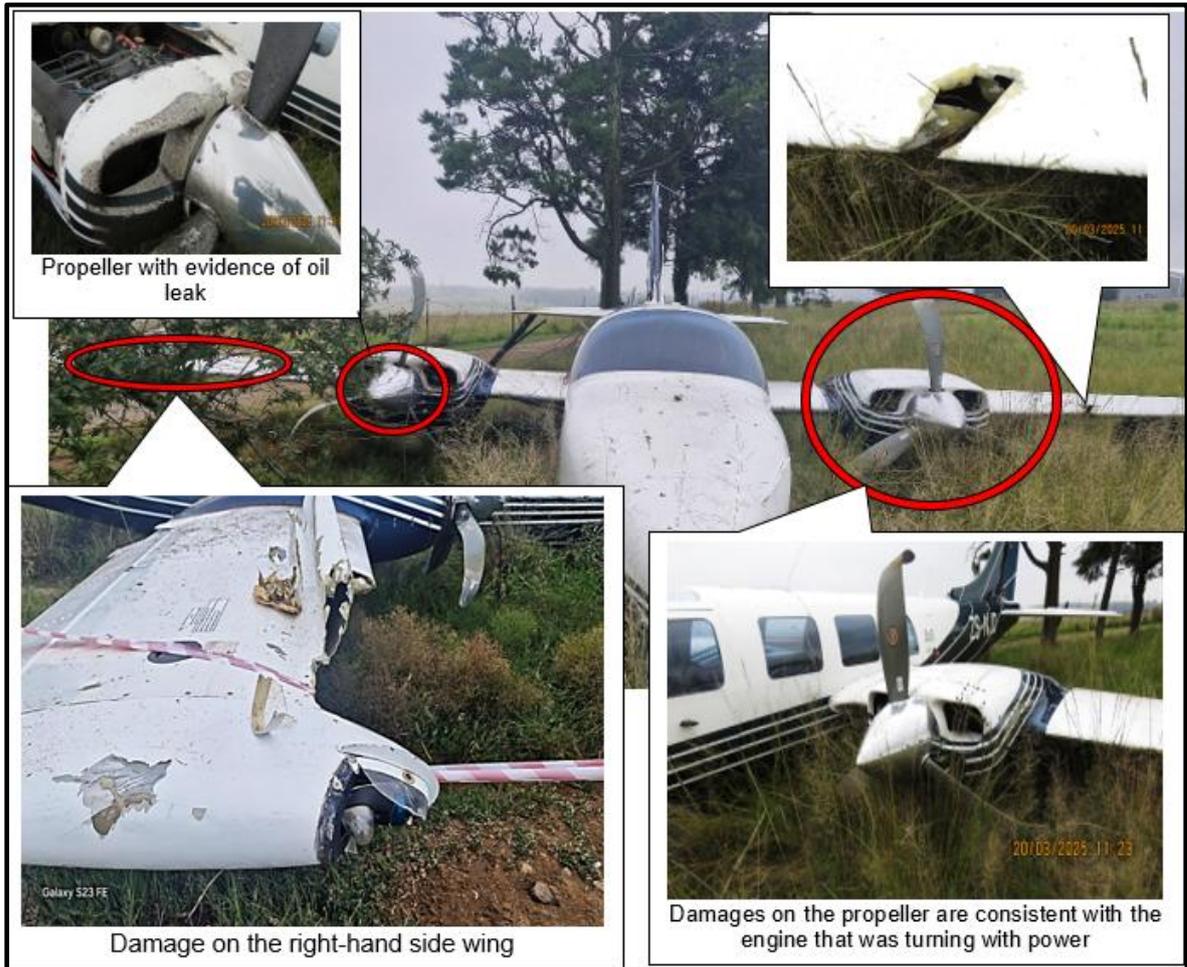
1.12.6. The aircraft structure was fairly intact; both wings and the propeller blade had damage that was visible to the eye.

Figure 11: Damage on both the left- and right-side of the propellers and the wings.

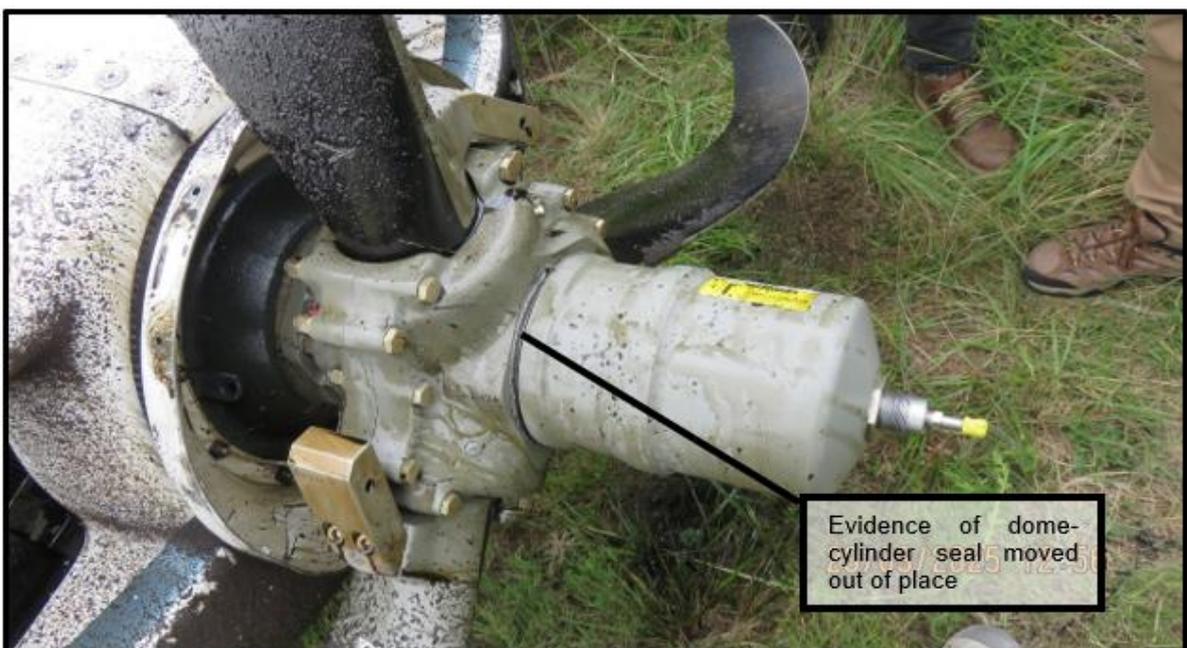
1.12.7. The propeller's variable pitch mechanism housing dome-cylinder was found loosened. The oil escaped from it and caused a significant oil loss from the engines and propellers.

Figure 11: The propeller dome-cylinder mounting was found loose and showed evidence of oil leak.

1.16.1. The on-site investigation determined that the propeller pitch-changing mechanism housing cylinder had detached from its mounting position which caused oil to leak. The propeller was disassembled by a qualified propeller specialist on 26 March 2025 at an AMO facility. Upon inspection, the ON switch screwing threads were damaged. A metallurgical analysis has been commissioned to establish the root cause of the failure, and the results will be discussed in the final report.

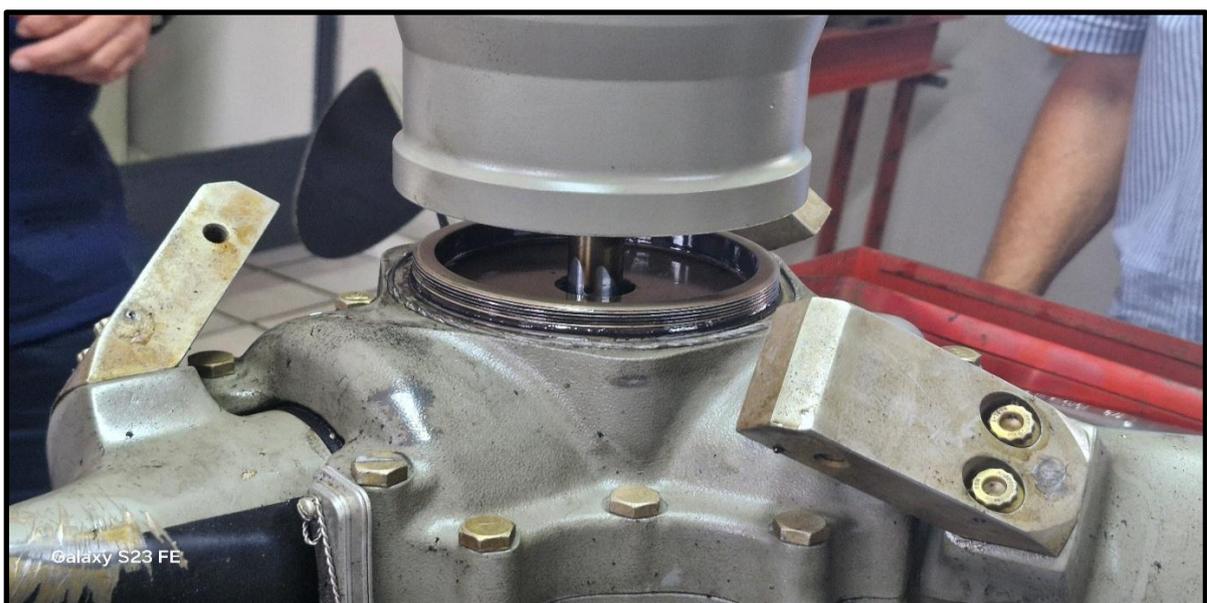
Figure 13: The disassembly of the propeller dome-cylinder.

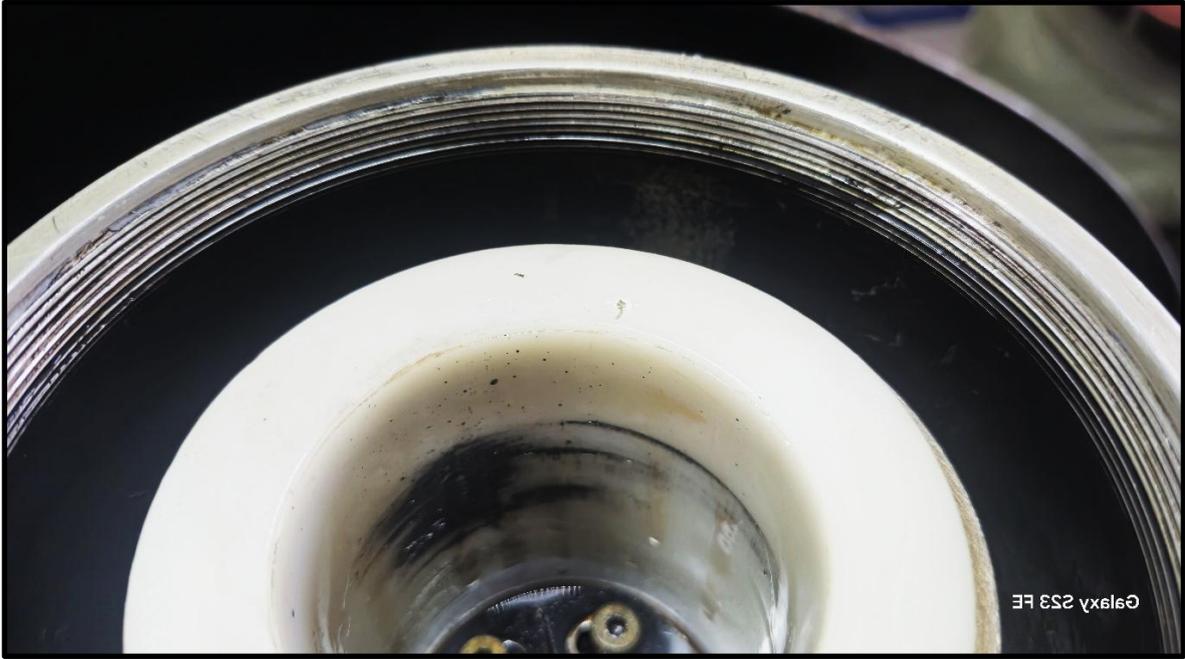
Figure 14: The damaged front threads of the dome-cylinder.
