**PRELIMINARY ACCIDENT REPORT**

**Accident and Incident Investigations Division**

Accident  
- Preliminary Report -  
AIID Ref No: CA18/2/3/10387

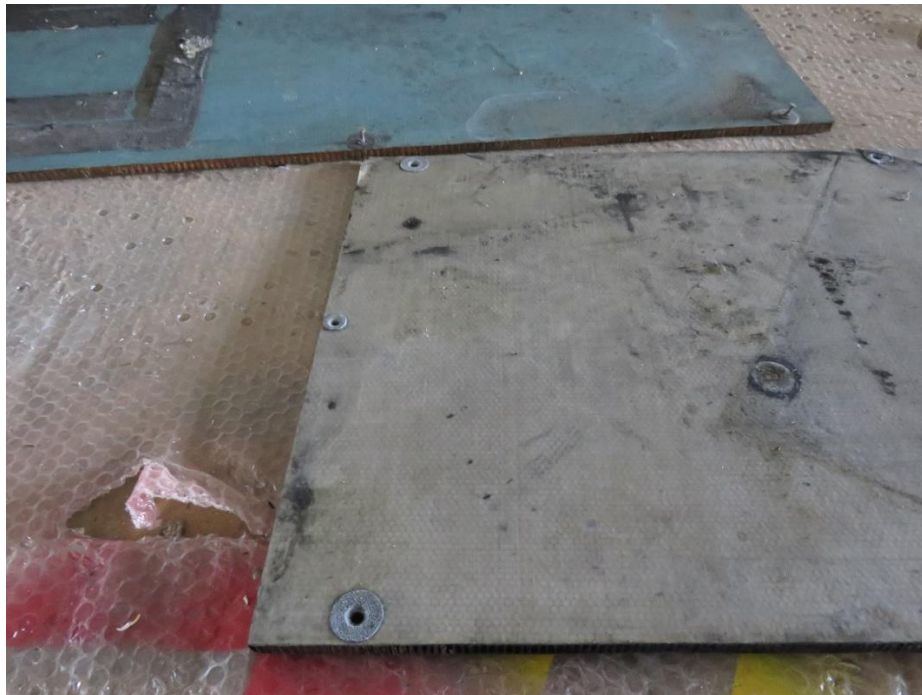
1.3.1 The aircraft's floor boards were damaged by the spilt chemical. The chemical reaction with the metal occurred a few days after the chemical was cleaned off the floor boards. The chemical corroded the metal on the belly of the aircraft where it was most concentrated. The operator grounded the aircraft whilst awaiting the outcome of the consultation with the manufacturer.

**Figure 3:** Floor boards damaged by the spilt chemical.

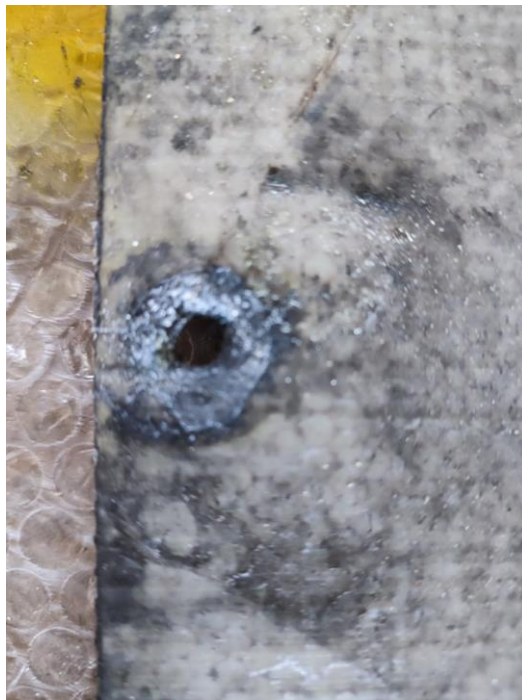
1.12.1 The aircraft was loaded with cargo of corrosive fluid that leaked onto the floor boards and seeped into the bays below it. The bays were cleaned but the fluid had already reacted with the metal which became apparent a few days after the cleaning. The reaction with the metal corroded the belly of the aircraft where it had concentrated.

**Figure 4.** Close-up view of parts of the corroded floor board.

2.2.13 The aircraft started corroding after the spill was cleaned up. The corrosion made holes on the belly of the aircraft.

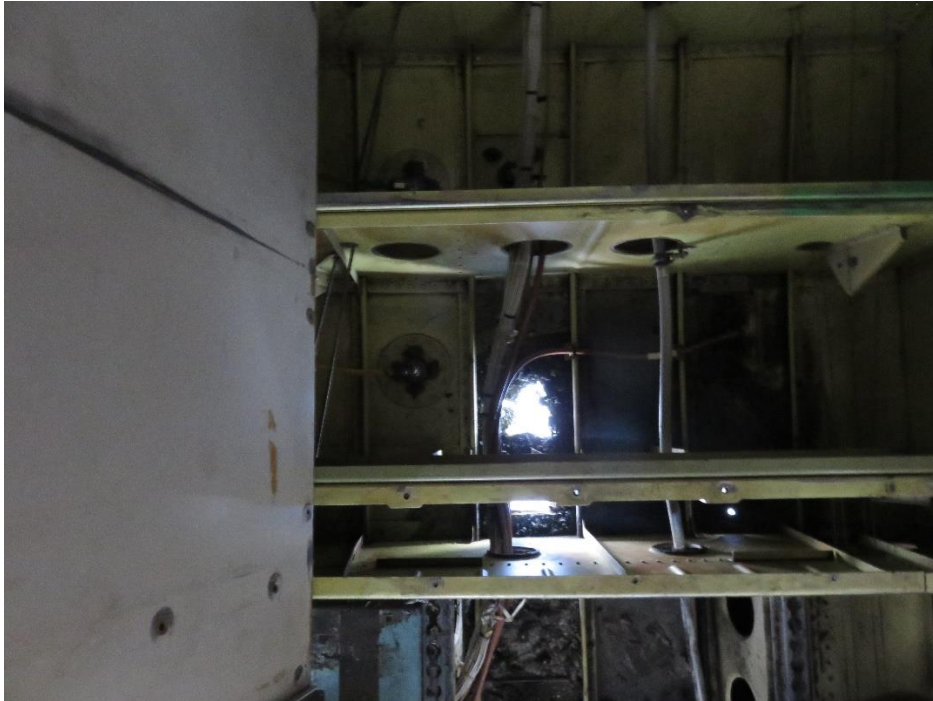
**Figure 5:** One of the affected bays.

2.2.12 The corrosive liquid leaked because of a DZUS Fastener that pierced the bottom of the plastic container.
