PRELIMINARY SERIOUS INCIDENT REPORT

Serious Incident
- Preliminary Report -
AIID Ref No: CA18/3/2/1408

Figure 1: Beechcraft 1900D ZS-PKB aircraft. (Source: www.moneyweb.co.za)

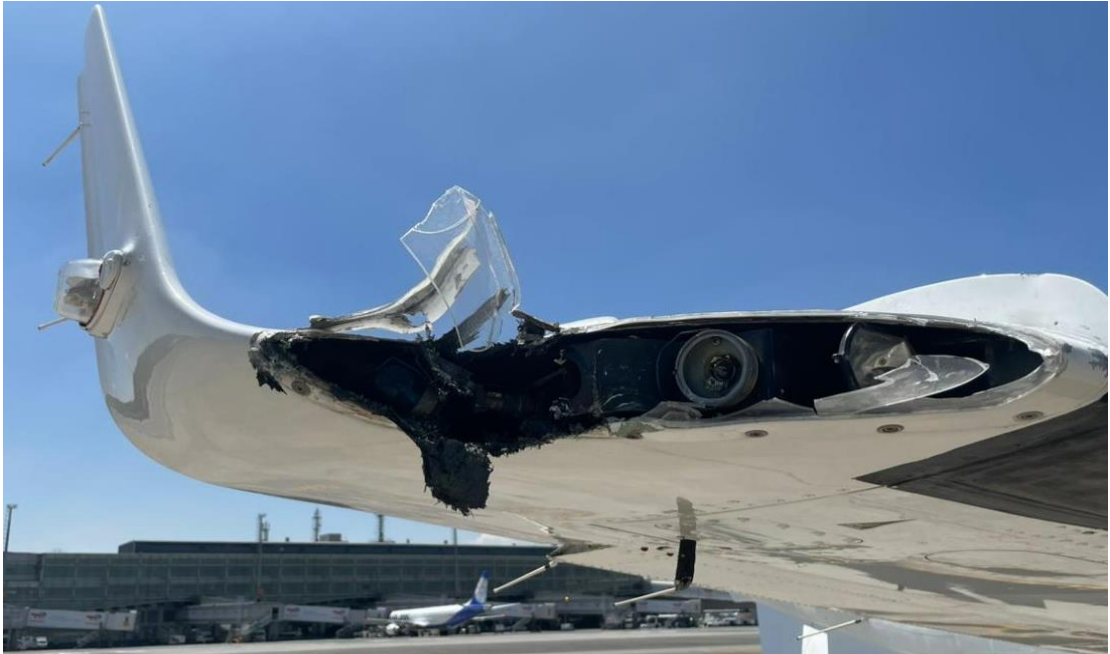
- 1.1.6. The aircraft sustained damage to the right-wing tip and the underside of the right wing.

Figure 2: The damaged wing tip.

- 2.2.13. The aircraft was pushed back from parking bay C19 to taxiway India, thereafter, the towbar was disconnected from the aircraft and reconnected to the tug. The aircraft taxied into a stationary tug that was in front it. The aircraft’s right leading-edge tip was substantially damaged. Following the serious incident, the aircraft was grounded for inspection and repairs.

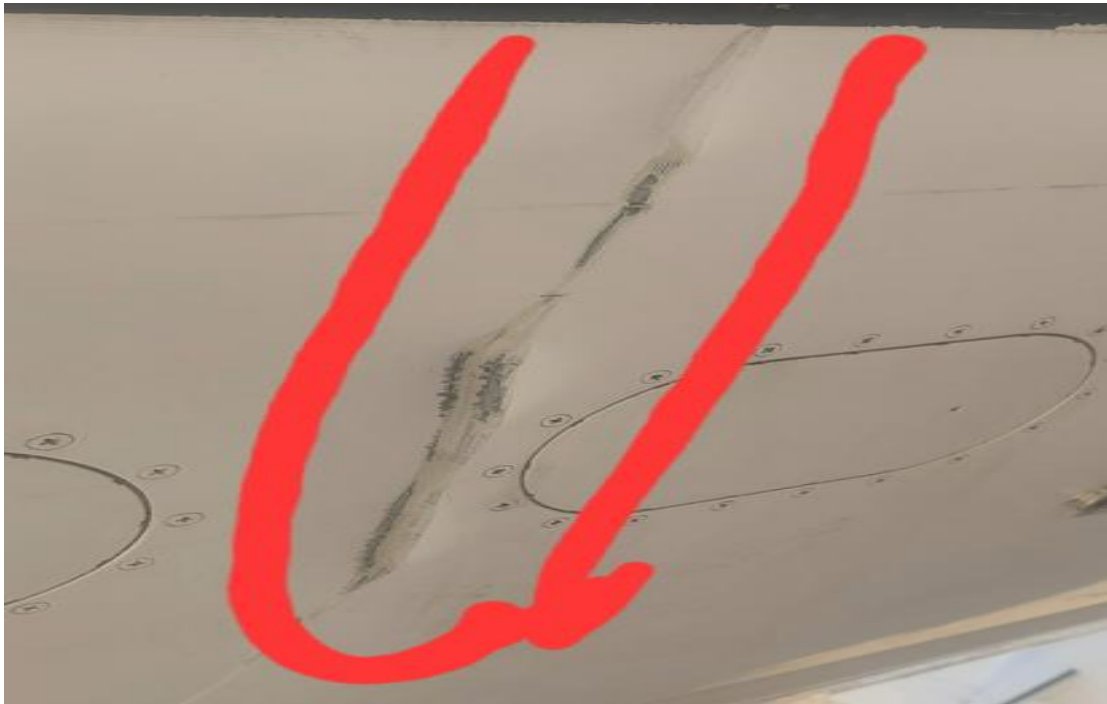
Figure 3: Damage on the underside of the right-wing tip.

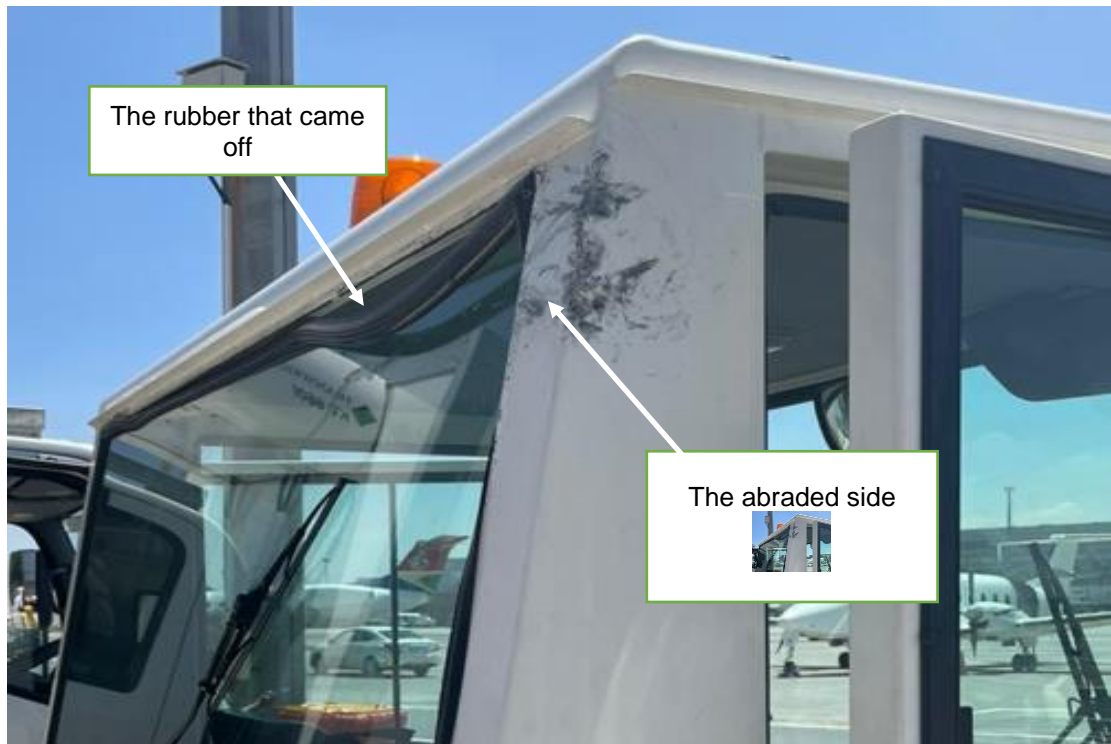
- 1.4.1. The upper right back side of the tug was abraded, and the rubber lining on the window was partly detached.

Figure 4: The abraded side of the tug.

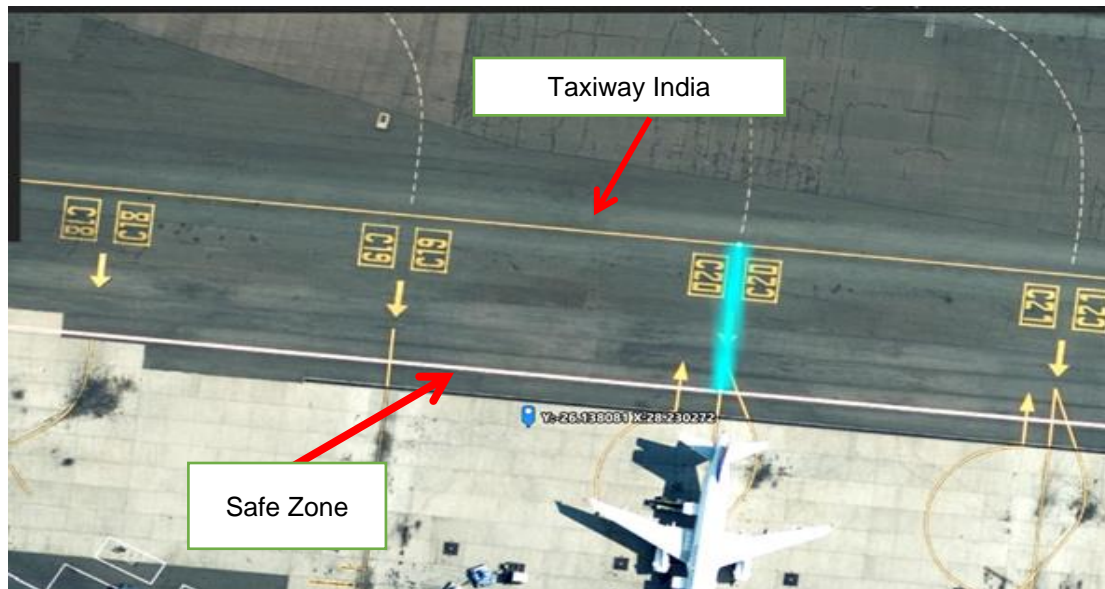
1.10.1. Taxiway India has a yellow centreline which runs through to the safe zone, approximately 24 metres. The distance from the centreline to where the tug was parked (in front of the aircraft) was approximately 6.5 metres (inside the box marked C19).

Figure 5: C19 layout at FAOR.

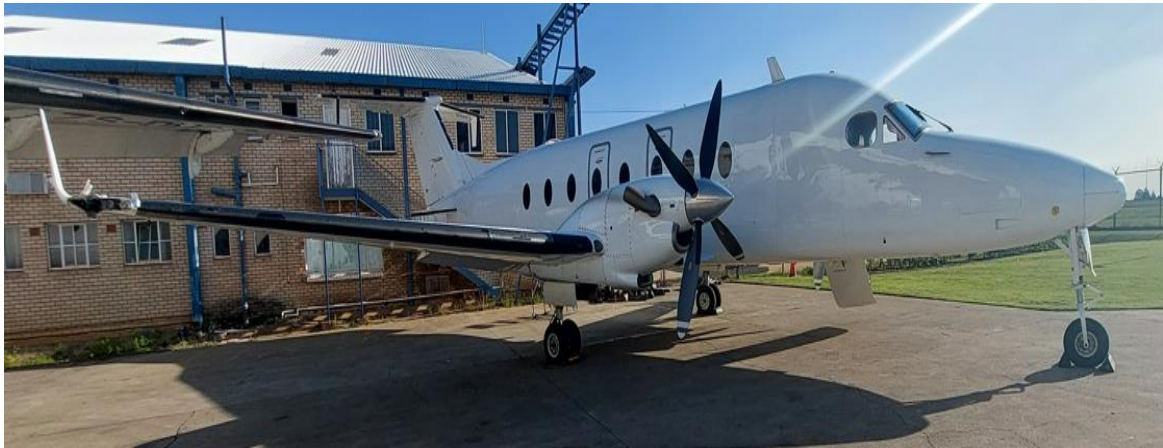
1.12.1. During the second turnaround, the aircraft was parked at C19, and both engines were started whilst it was being pushed back to taxiway India. The aircraft faced a heading of 198°. After the tow bar was disconnected and the tug was still parked in front of the right wing, the aircraft was taxied (started to move) at a ground speed of 7 knots (kts) and collided with the right back corner of the stationary tug with its right-wing tip. It came to a full stop facing a heading of 225°. The aircraft's right wing and the tug were substantially damaged.

Figure 6: The aircraft after the serious incident.

1.12.2. Following the serious incident, the operator grounded the aircraft for inspection and repairs.
