PRELIMINARY ACCIDENT REPORT

Accident and Incident Investigations Division

Accident
- Preliminary Report -
AIID Ref No: CA18/2/3/10249

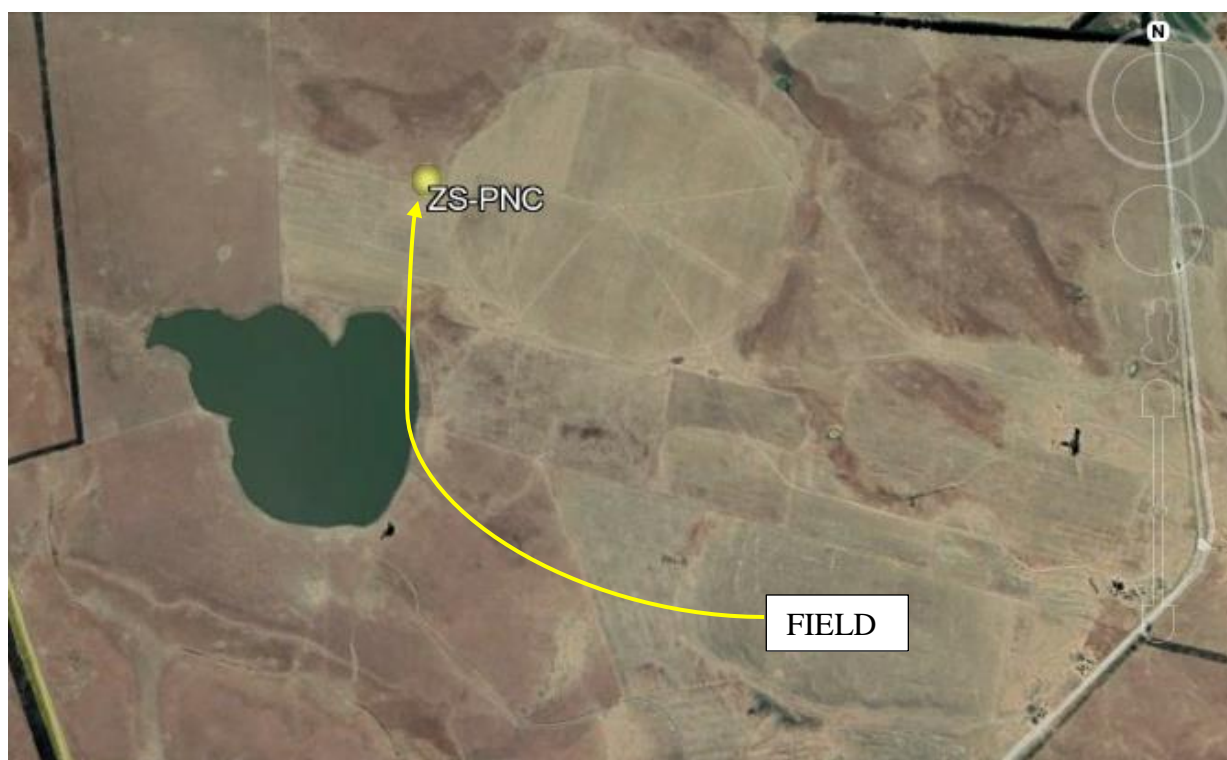
- 1.1.2 The pilot stated that he had been spraying fungicide on the field, and during a turn to the right at approximately 700 feet (ft) above ground level (AGL), the aircraft lost power. This was followed by a decrease in inter-turbine temperature (ITT) and a change in engine sound. The pilot levelled the aircraft and configured it for a forced landing ahead of his flight path. He switched on the igniters and the starter and feathered the propeller blades to increase the gliding distance. The aircraft touched down on uneven terrain. It impacted a fence and, approximately 300 metres (m) after touchdown, it rolled over a ditch and bounced back into the air. Upon touchdown again, the wheel support struts broke off, which caused the main undercarriage to bend and the propeller blades to strike the ground. After the aircraft came to rest, the pilot shut down the engine and disembarked from the aircraft. The pilot was not injured during the accident sequence; however, the aircraft was substantially damaged.

Figure 2: The yellow line shows the flight path of the aircraft when it experienced power loss.
(Source: Google Earth)

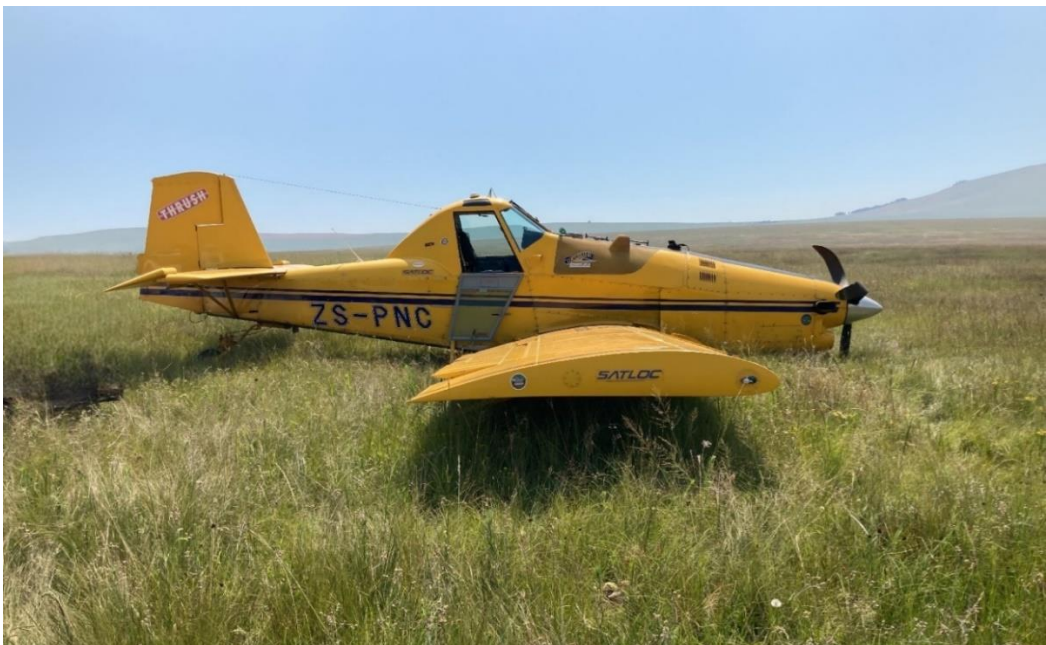
1.3.1. The aircraft sustained damage to the propeller and the main undercarriage.

Figure 3: The aircraft on-site post-accident. (Source: Operator)

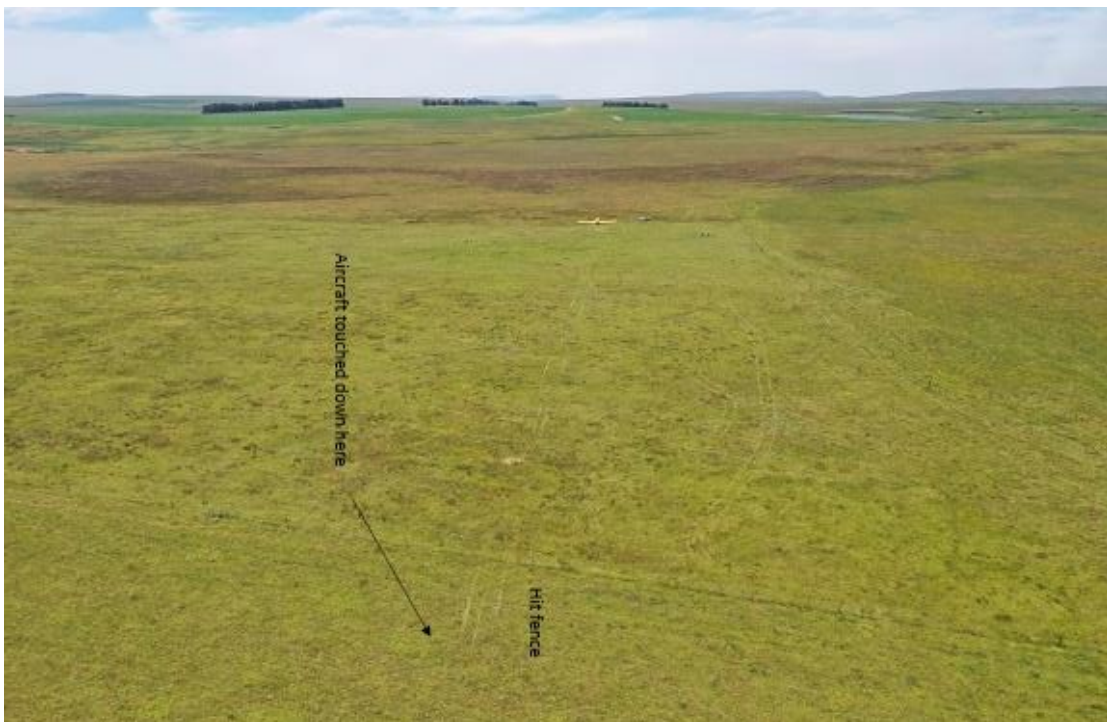
1.12.1. The aircraft successfully touched down after the forced landing and rolled on an uneven terrain before the propeller blades impacted a perimeter fence, flattening it. The aircraft continued to roll over the fence for a further 300m; it then bounced which caused the main undercarriage to buckle and the propeller blades to strike the ground. The propeller blades dug into the soft ground, causing damage to all three blades. The aircraft came to a stop with the nose facing north.

Figure 4: An aerial photograph of the aircraft's ground roll after the forced landing. (Source: Operator)

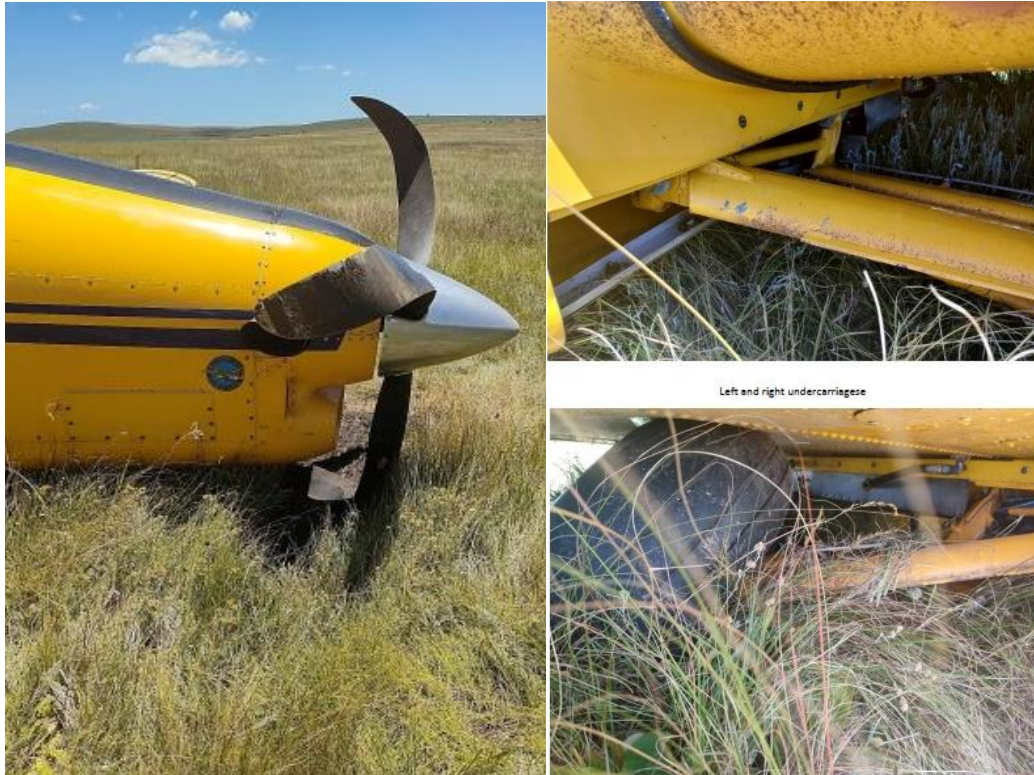
Figure 5: The pictures above depict the propeller and main undercarriage damage.
(Source: Operator)
