PRELIMINARY ACCIDENT REPORT

Accident and Incident Investigations Division

Accident
- Preliminary Report -
AIID Ref No: CA18/2/3/10391

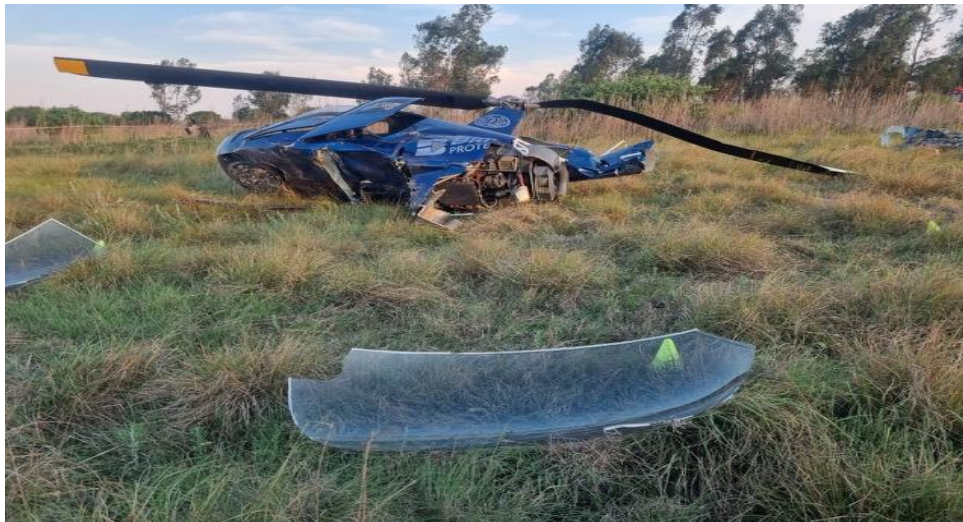
1.3.1 The helicopter was destroyed by impact forces.

Figure 3: The helicopter at the accident site. (Source: Operator)

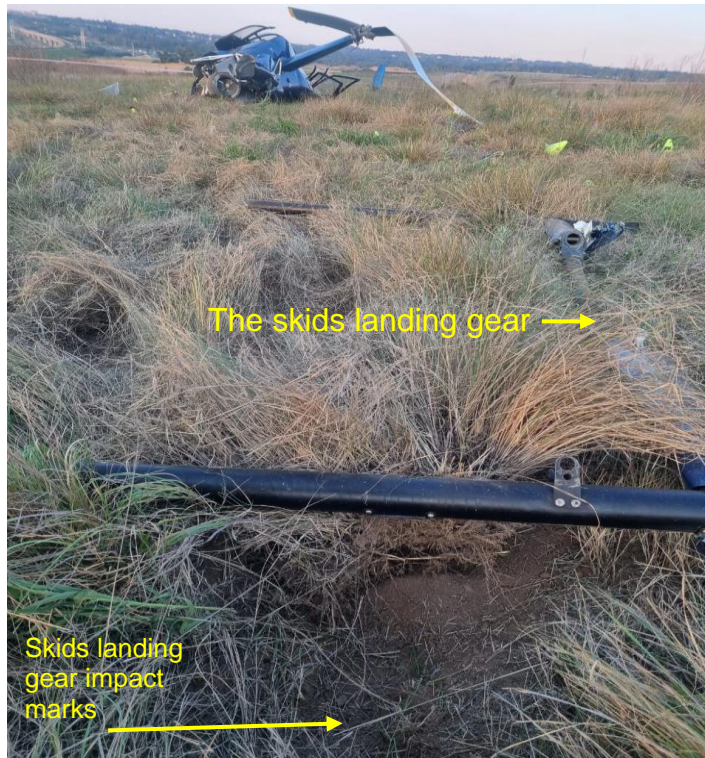
1.12.1 The accident site was inspected, and all major components were present, indicating that nothing of significance broke off from the helicopter prior to impact. The fuel bladder tanks were intact and contained sufficient fuel that was consistent with Avgas 100LL. There was no evidence of fuel leaks. The helicopter impacted the ground hard which resulted in the skids landing gear breaking off. One of the main rotor blades with serial number 7282 severed the tail boom during the accident sequence. The vertical stabiliser, tail rotor guard and tail skid were damaged and disrupted. The helicopter's fuselage seemed to have bounced after impact, consequently coming to rest approximately 10m from the broken skids landing gear.

Figure 4: The wreckage and the broken skids landing gear.

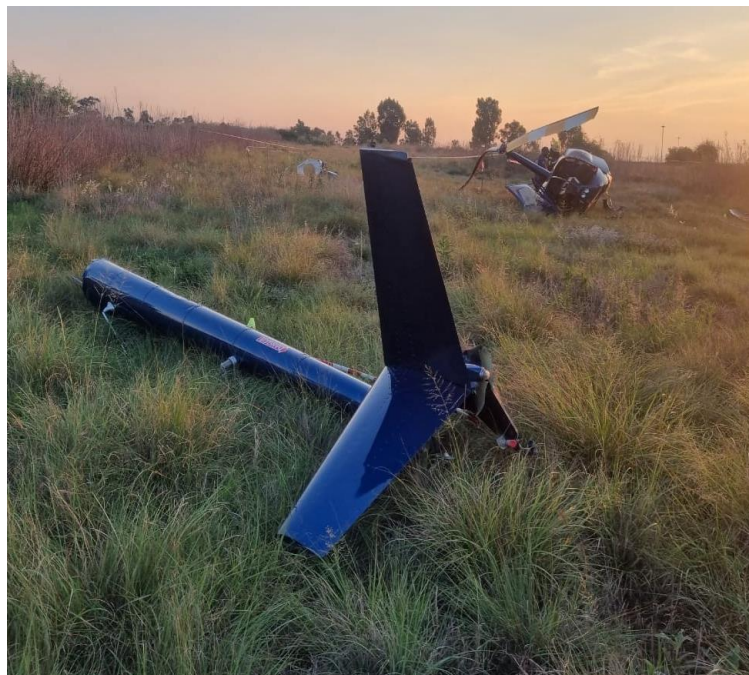
Figure 5: The main wreckage and the severed tail boom.

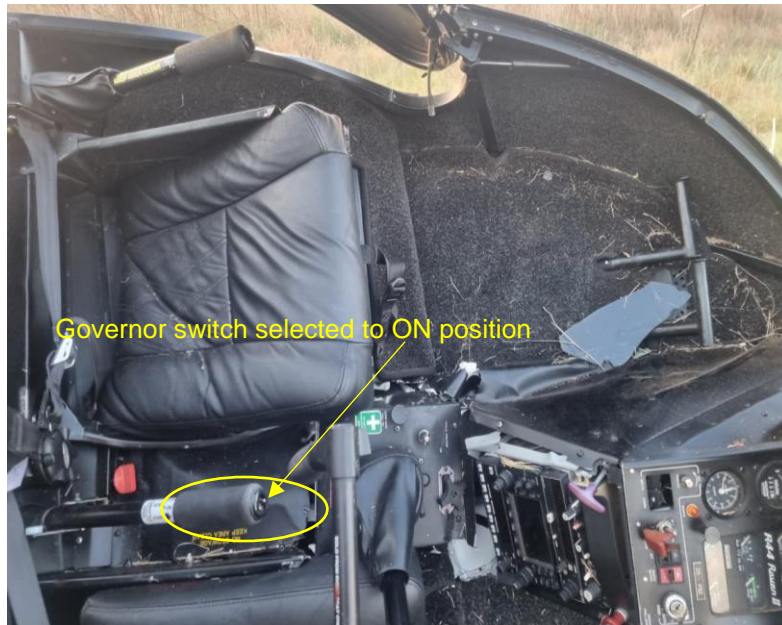
1.12.2 Examination of the cockpit revealed the rotor brake in a 'pulled' position. None of the circuit breakers (CBs) popped. The right-side throttle/twist grip was in a position close to idle. The pilot and co-pilot throttles/twist grips both moved in unison when the pilot's (right side) throttle was activated. The collective pitch lever was found in the UP position and the governor switch was selected to the ON position, consistent with a normal flight.

Figure 6: The pilot's collective pitch control stick in the UP position and the governor switch in the ON position.

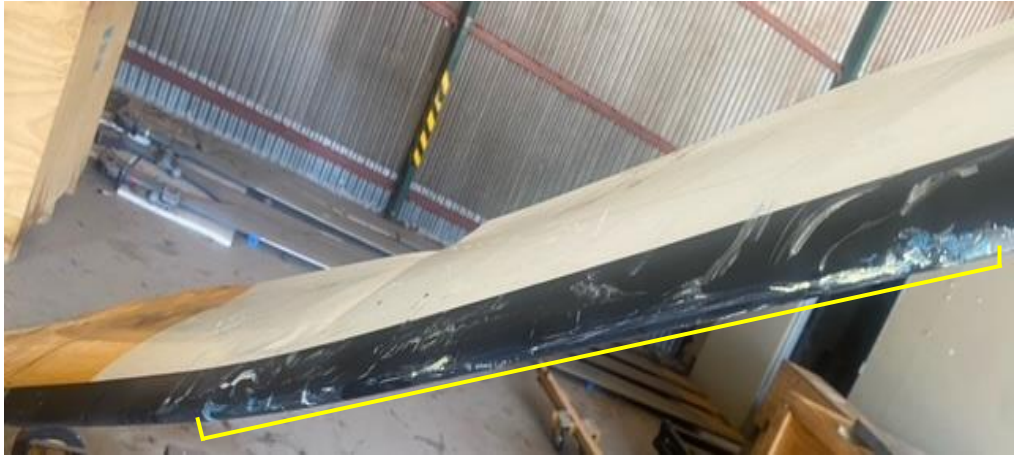
1.12.4 The engine and the main transmission remained mounted on the airframe and all the main rotor blades were secured to their respective grips, which remained attached to the main rotor head and mast. Drive train to the main and tail rotors could not be established. The main gearbox housing was intact and attached to the bottom of the main rotor mast and the centre frame. The main gearbox rotated freely and exhibited continuity from input to the main rotor drive shaft, and the free-wheeling sprag clutch operated as expected. One of the pitch links broke at the adjusting course area; it displayed signatures consistent with compression loads emanating from impact. The main rotor blade with serial number 7282 had dents and scratches on the leading-edge inboard area (white painted portion), which indicated impact damage with the tail boom structure.

Figure 7: The main rotor blade leading edge area showing the impact print.

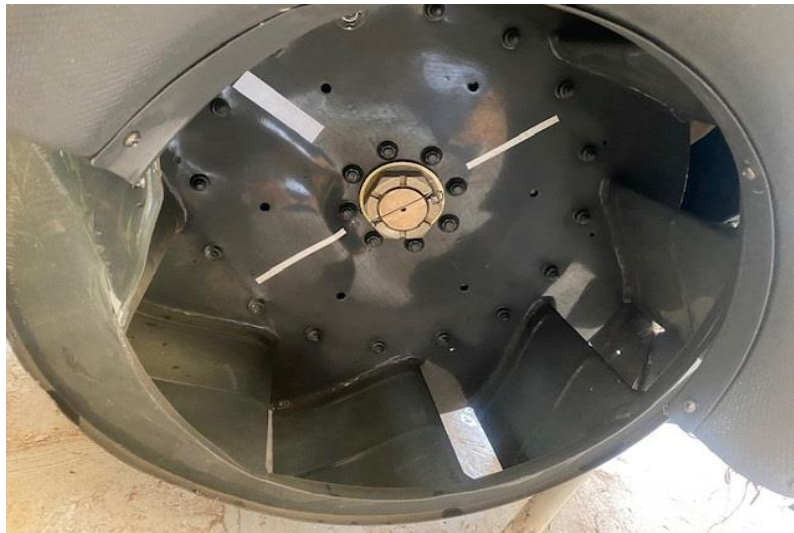
1.12.5 The main rotor blades showed little to no damage along their respective spans towards the blade tips, which was consistent with low rotor revolutions per minute (RPM) at the time of impact. Also, the thin white markings inside the engine cooling fan were aligned, which indicated that the engine was producing little to no power at the time of impact.

Figure 8: The engine cooling fan.

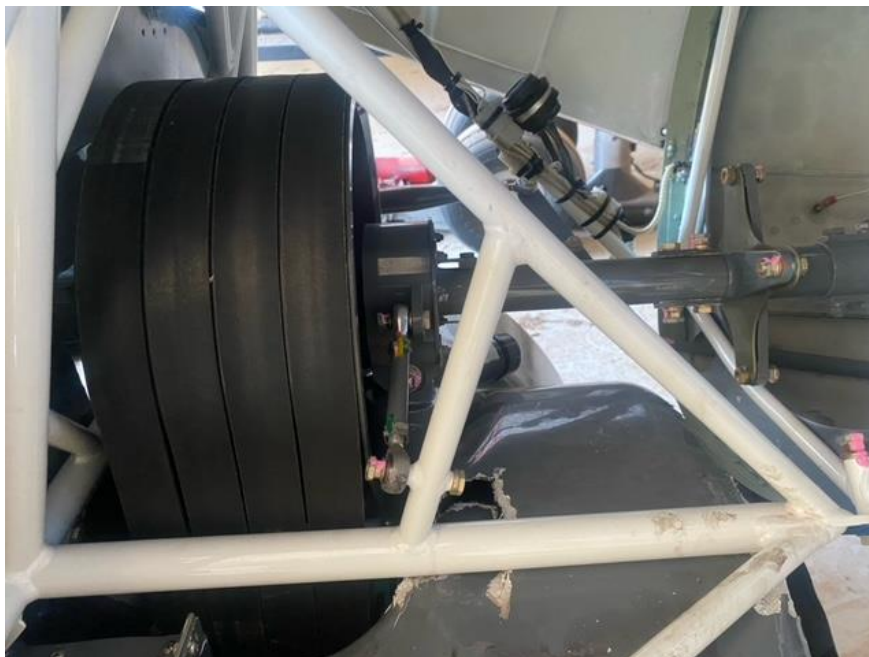
1.12.6 The v-belts on the engine output shaft were in place and intact. The long tail rotor drive shaft was severed; however, the tail rotor gearbox shaft was intact and it rotated freely. The tail rotor gearbox housing was also intact. The inspection sight gauge (glass) indicated a sufficient lubrication oil level.

Figure 9: The v-belts on the engine output shaft.
