PRELIMINARY ACCIDENT REPORT

Accident
- Preliminary Report -
AIID Ref No: CA18/2/3/10419

Reference Number	: CA18/2/3/10419
Occurrence Category	: Accident (Category 1)
Type of Operation	: Training (Part 141)
Name of Operator	: National Airways Corporation (NAC)
Aircraft Registration	: ZS-RLS
Aircraft Make and Model	: Bell 407
Nationality	: South African
Place	: Runway 35, at Grand Central Aerodrome (FAGC)
Date and Time	: 15 February 2024 at 1820Z
Injuries	: None
Damage	: Substantial

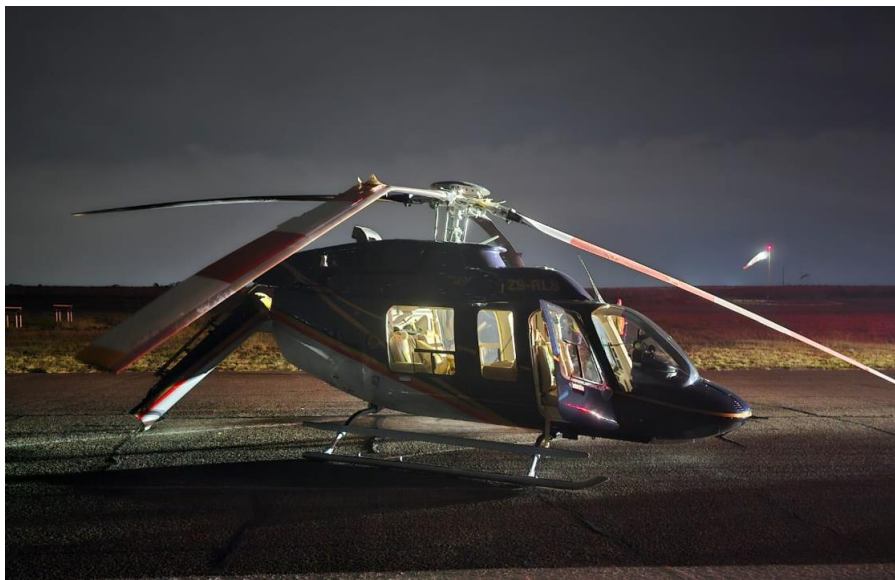
1.3.1. The helicopter sustained substantial damage.

Figure 3: The damaged helicopter after the accident.

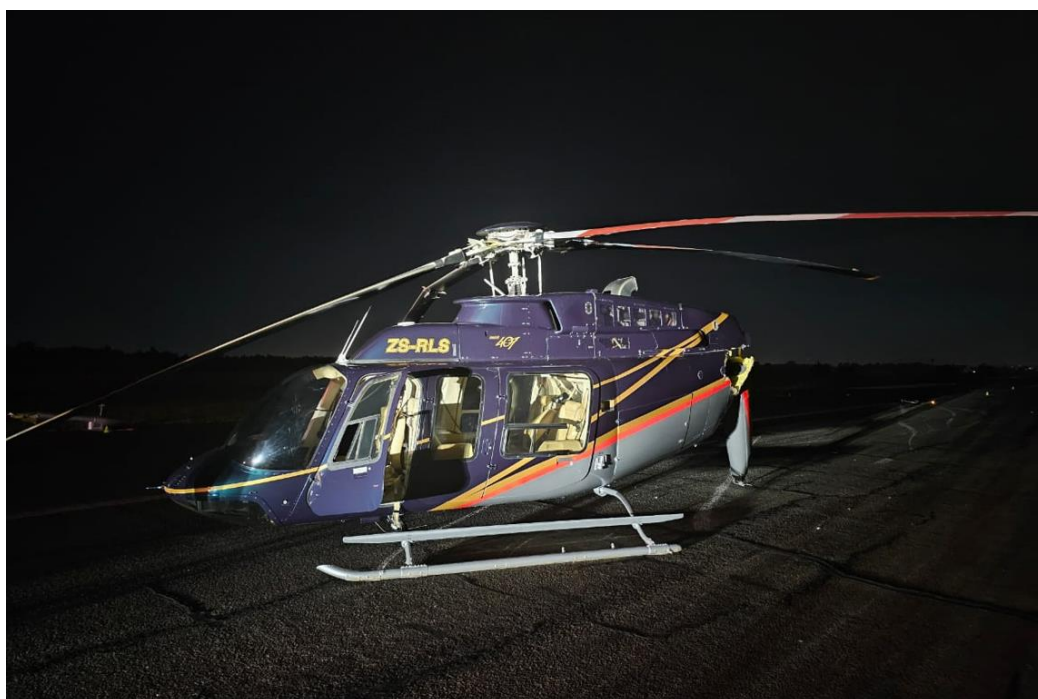
1.12.1. The helicopter came to rest 475 metres (m) from the threshold of Runway 35, facing north. The cabin and the cockpit structures were intact. The skid gear showed signs of deformation, but it was still attached to the fuselage. The tail boom separated from the

airframe; it was severed at two points which meant that there were three structural pieces of the tail boom on site, namely: the tail cone, horizontal stabiliser and the front section of the tail boom. The severed structural pieces of the tail boom were located on the edge of the runway and on the right side of the main wreckage. There were scrape marks on the runway that spanned 45m from the point of impact.

Figure 4: The helicopter post-accident.

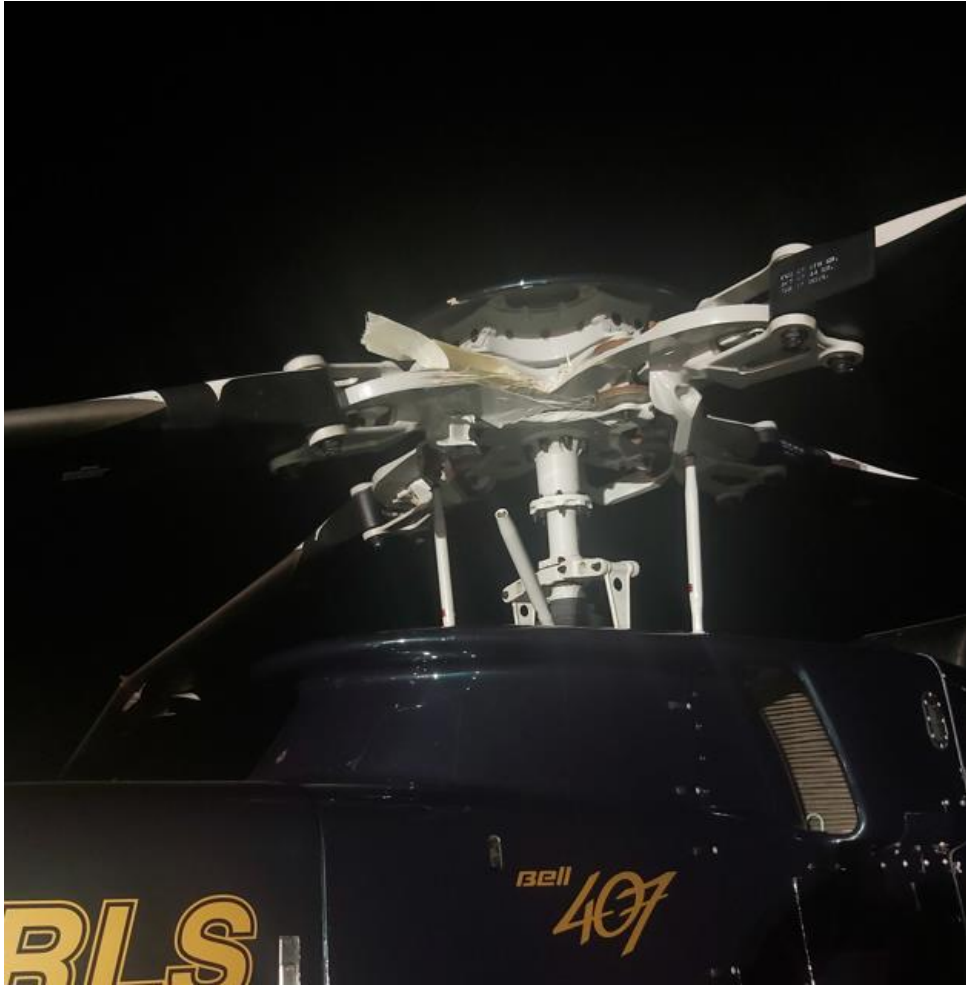
All four main rotor blades exhibited signs of impact damage on the mid-sections and on the tips. The main rotor head had fractured. The attachment points of the white pitch change link had fractured and separated; the white pitch change link was located approximately 3m forward of the nose section. Three of the pitch change control tubes were still attached to the main rotor head; one of the pitch change control tubes near the clevis attachment had failed. The rotating and non-rotating swashplates were still secured.

Figure 5: Damage to the main rotor head.

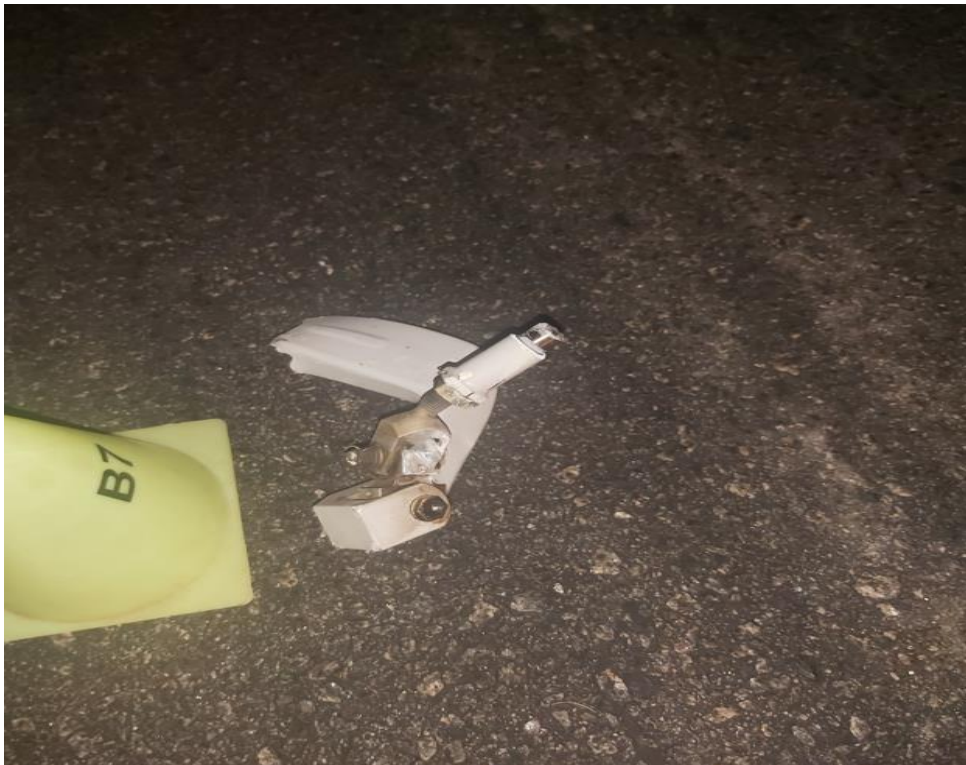
Figure 6: The damaged pitch change link attachment.

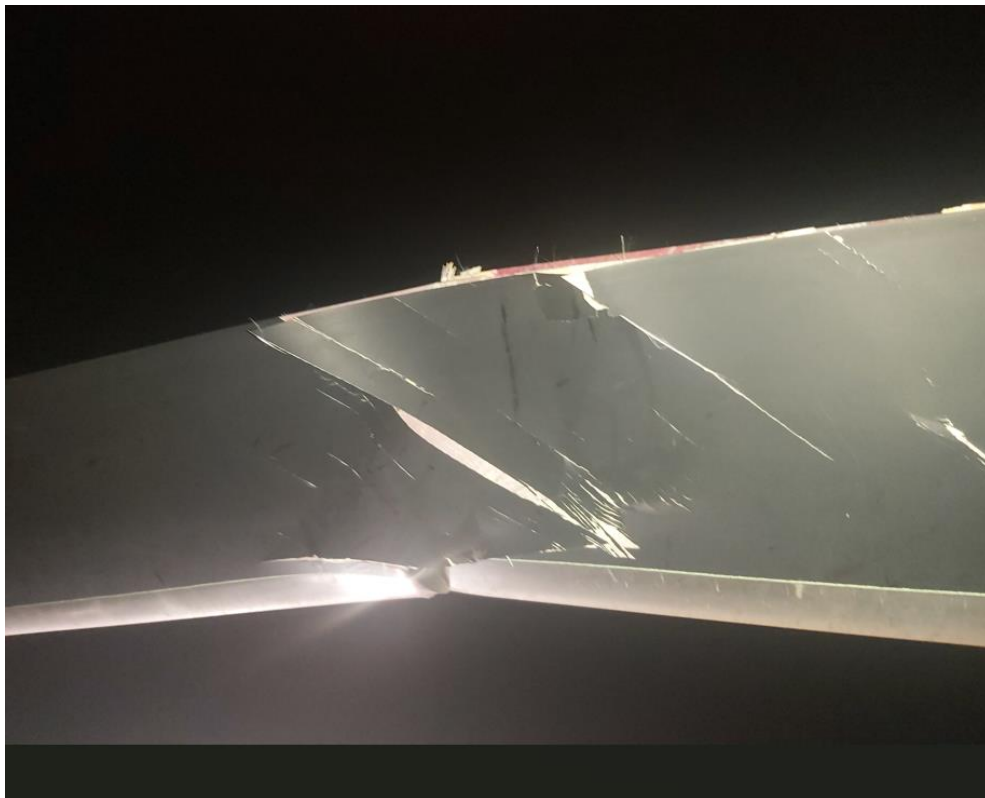
Figure 7: Damage sustained to one of the main rotor blades.

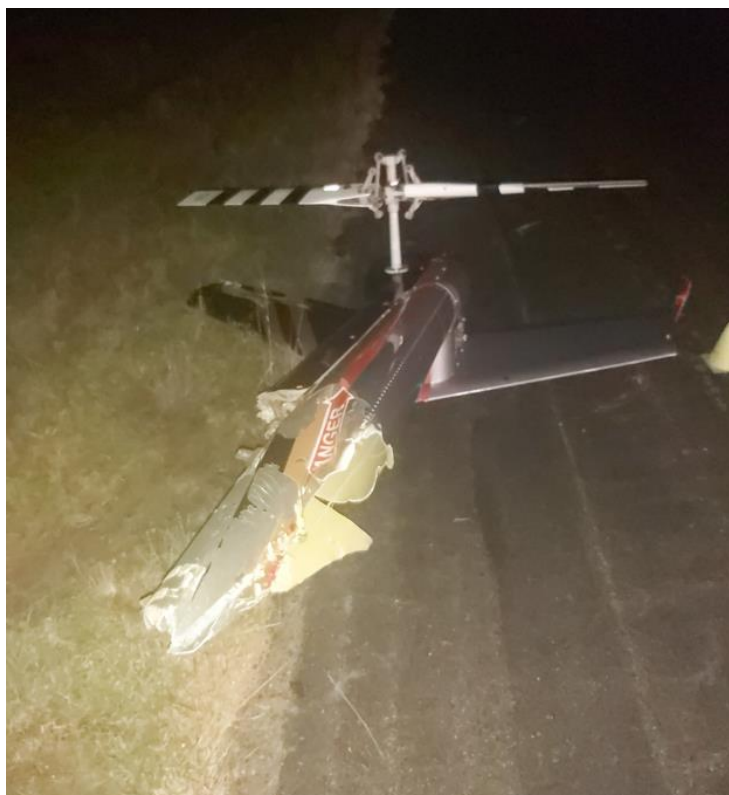
The main rotor blades severed the tail boom where it attaches to the fuselage. The horizontal stabiliser and tail cone exhibited signs of damage after they contacted the main rotor blades. The tail cone skin had an imprint that matched the profile of the main rotor blade leading edge paint. Scrape marks were found on the underside of the tail rotor guard; but the tail rotor guard was not bent. The vertical stabiliser exhibited signs of contact with the tail rotor blades on the inner surface.

Figure 8: The tail cone at the accident site.

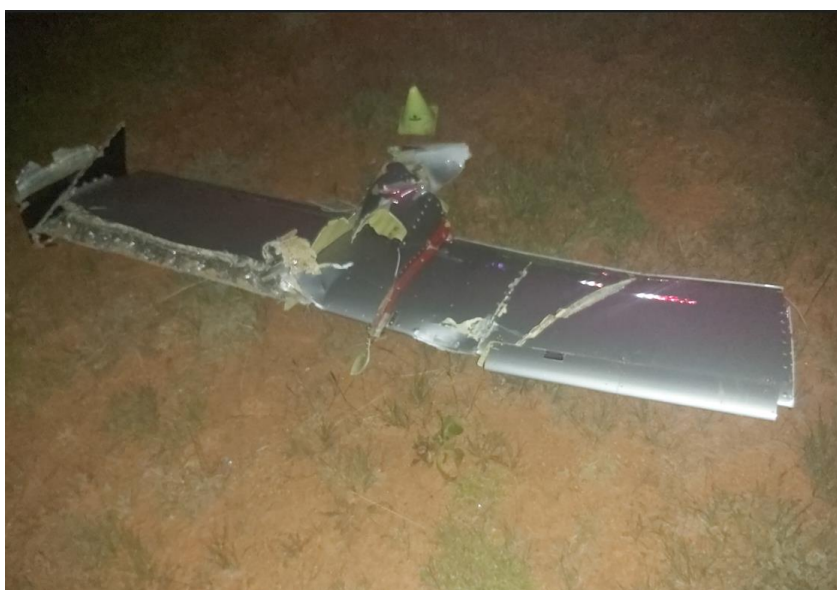
Figure 9: The severed horizontal stabiliser.

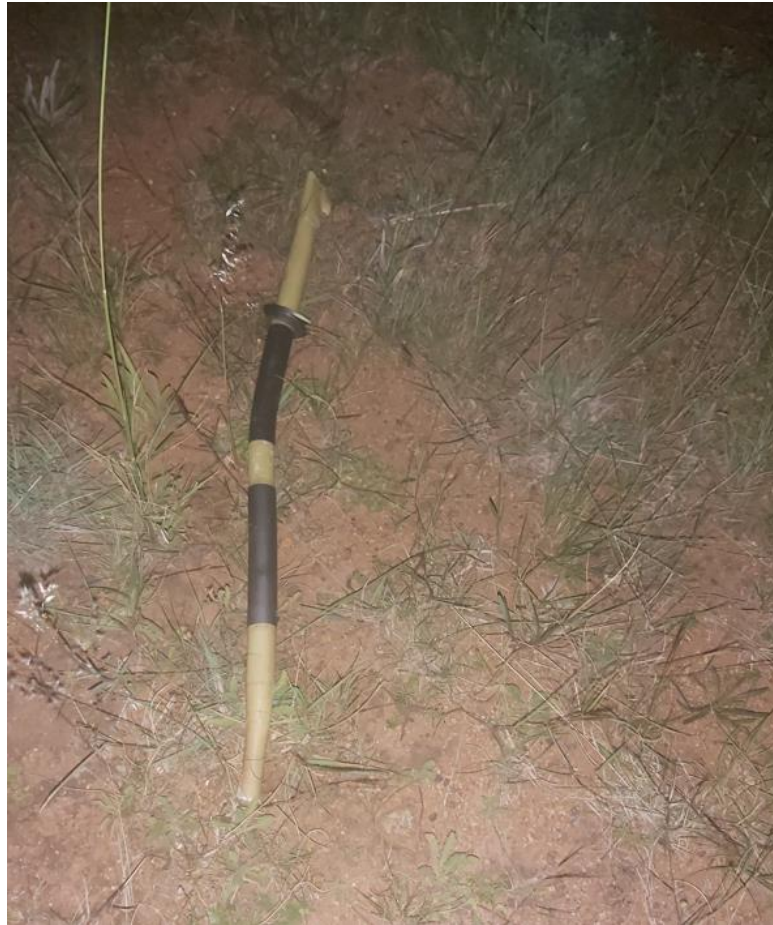
Figure 10: A section of the tail rotor drive shaft at the accident site.

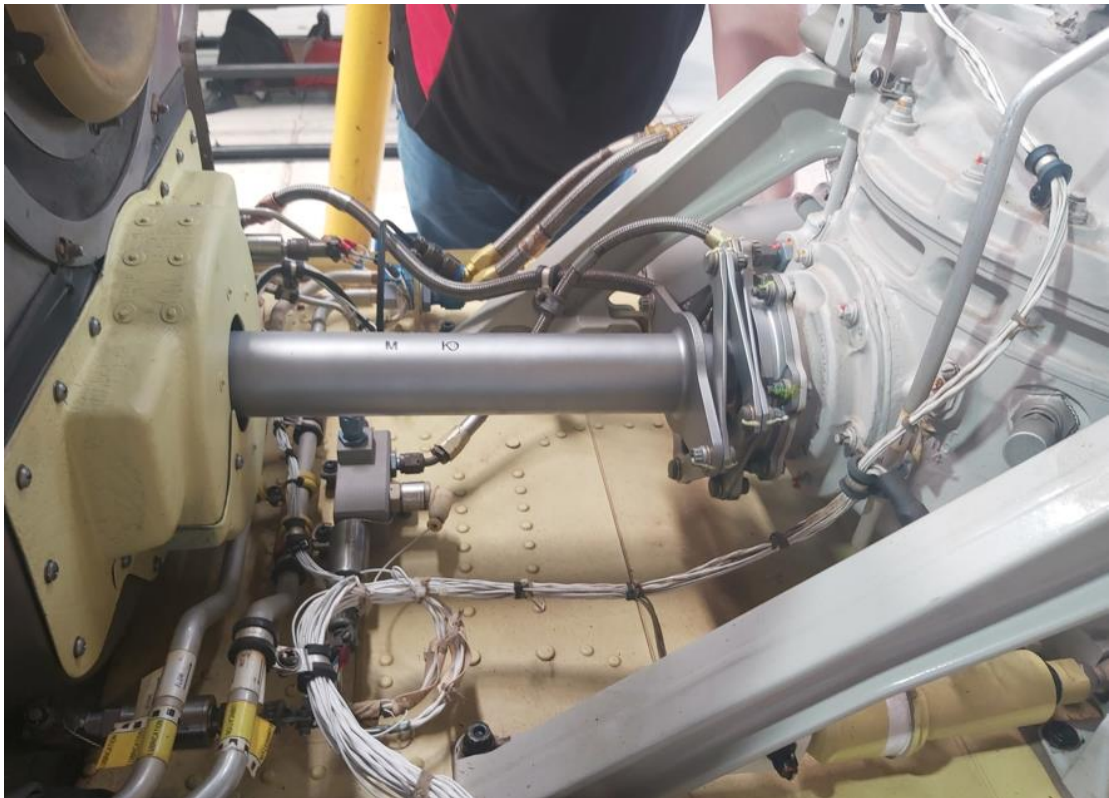
Figure 11: The engine drive shaft.

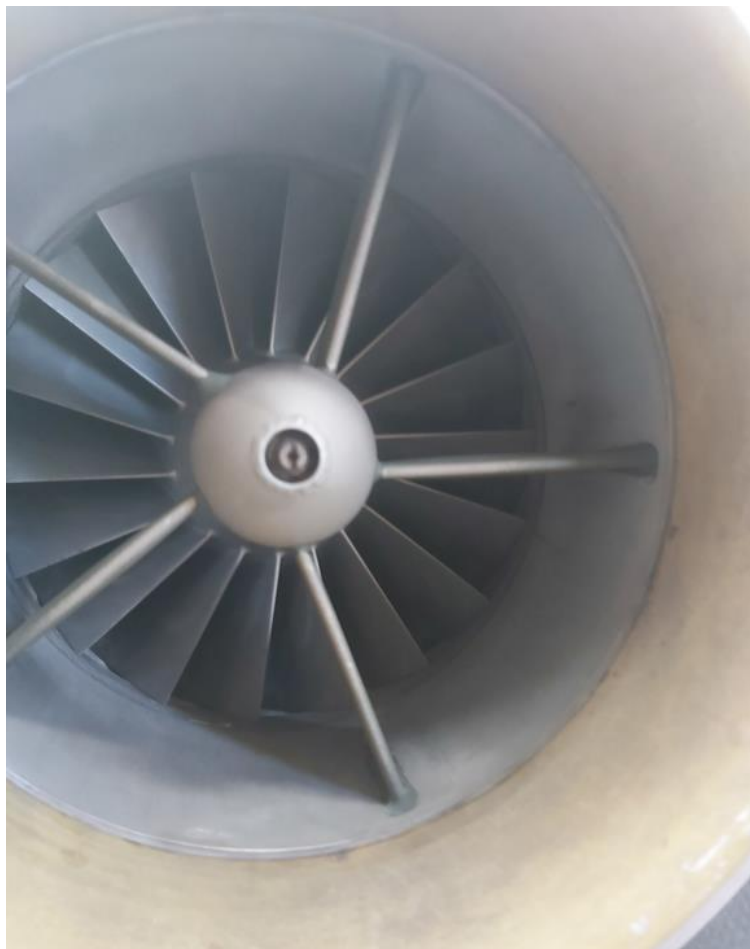
The external condition of the engine was in good condition. There were no leaks found around and on the underside of the engine. The outside surface of the compressor blades was in good condition. The compressor was turned by hand and it rotated smoothly. The exhaust section had no signs of debris, and the turbine blades were not damaged. There were no signs of fuel pipe and oil pipe rupture or dislocation. The forward and lower chip detectors were removed and checked for metal chips; they were found clean. Fuel sample from the forward and rear tanks was collected; the fuel was of the correct grade (Jet A1) and had no sediments or impurities.

Figure 12: The undamaged engine inlet compressor blades.
