**PRELIMINARY ACCIDENT REPORT**

**Accident and Incident Investigations Division**

Accident  
- Preliminary Report -  
AIID Ref No: CA18/2/3/10526

**Reference Number** : CA18/2/3/10526  
**Occurrence Category** : Category 1  
**Type of Operation** : Surveillance (Part 127)  
**Name of Operator** : Ultimate Heli  
**Helicopter Registration** : ZS-RWG  
**Helicopter Make and Model** : Airbus AS350B3  
**Nationality** : South African  
**Place** : Open field near Midstream, Centurion, Gauteng Province  
**Date and Time** : 21 November 2024 at 0923Z  
**Injuries** : None  
**Damage** : Substantial

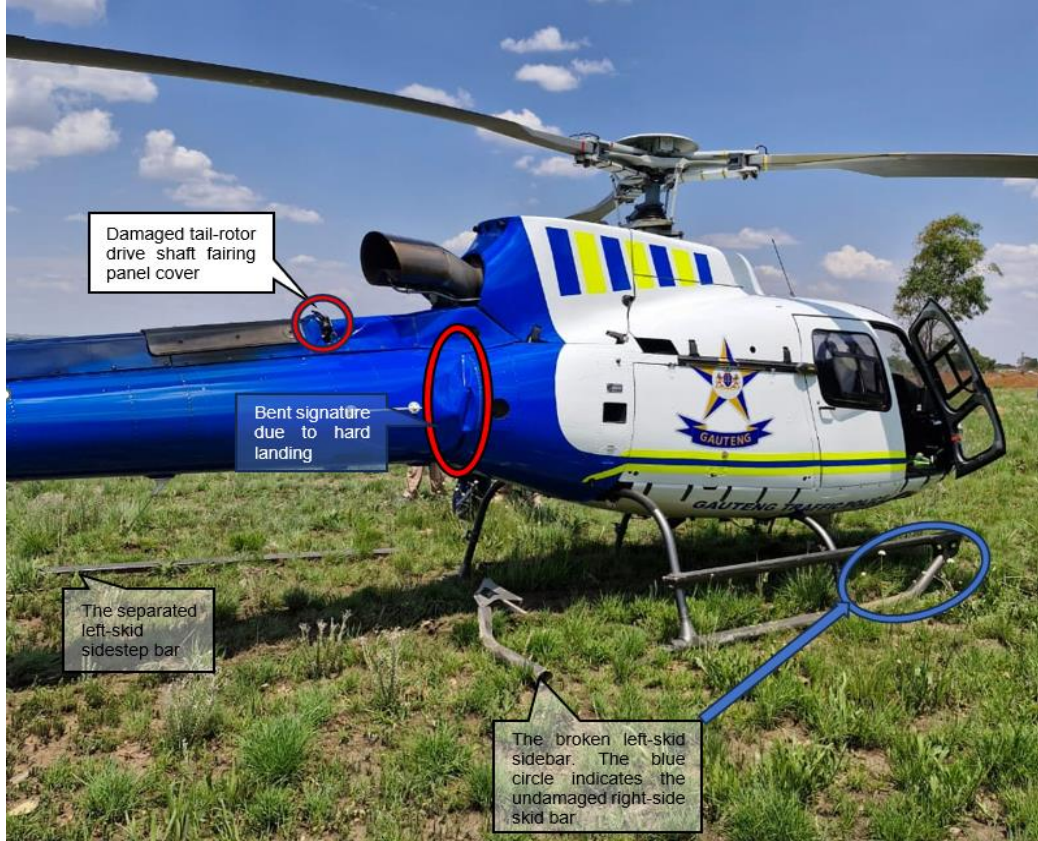
1.3.1. The left landing skid, tail boom and the left side of the nose section were substantially damaged.

Figure 3: The helicopter post-accident.

1.12.2. Post-accident, the helicopter was found to be relatively intact except for the damage on the left landing skid, as well as the separation of the sidestep bar. The operator and the GTP requested the removal of the official police livery and markings on the helicopter to mitigate attention (see Figure 3).

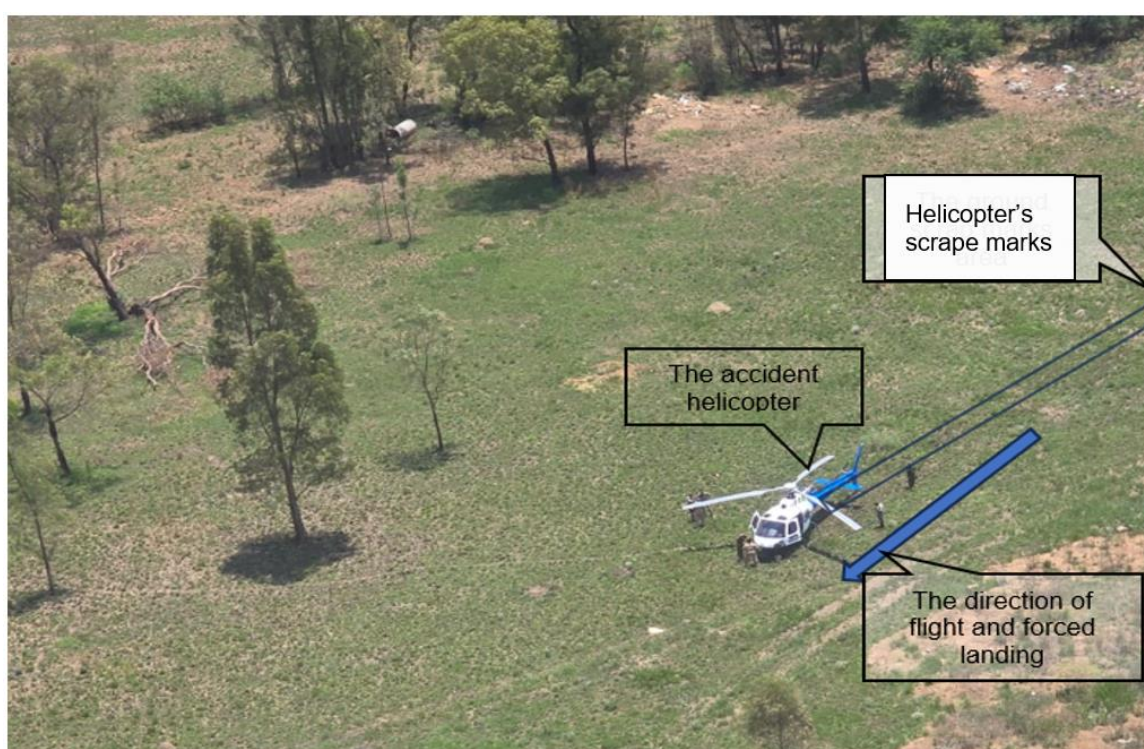
1.12.1. The accident occurred on a field, approximately 200m from the industrial and residential areas. The accident site had potential obstacles, including tall trees to the north (direction of approached) and high-tension electrical power lines (see Figures 4 and 5).

**Figure 4:** Aerial view of the accident site showing the surrounding obstacles and the ground scrape marks. (Source: Operator)

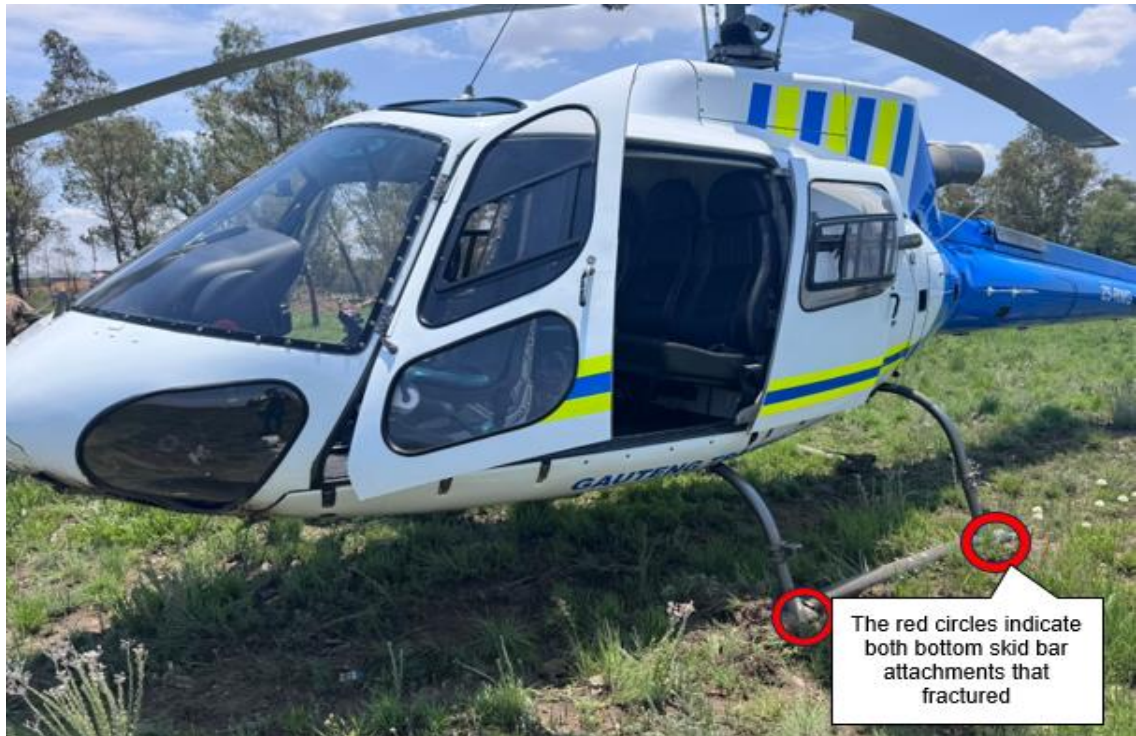
1.12.3. The bottom skid bar broke into three pieces (segments) during the accident sequence. The damage pattern suggested that it was subjected to significant impact forces, likely from a heavy object, which resulted in the structural failure (see Figure 5).

**Figure 5:** Damage on the left skid.

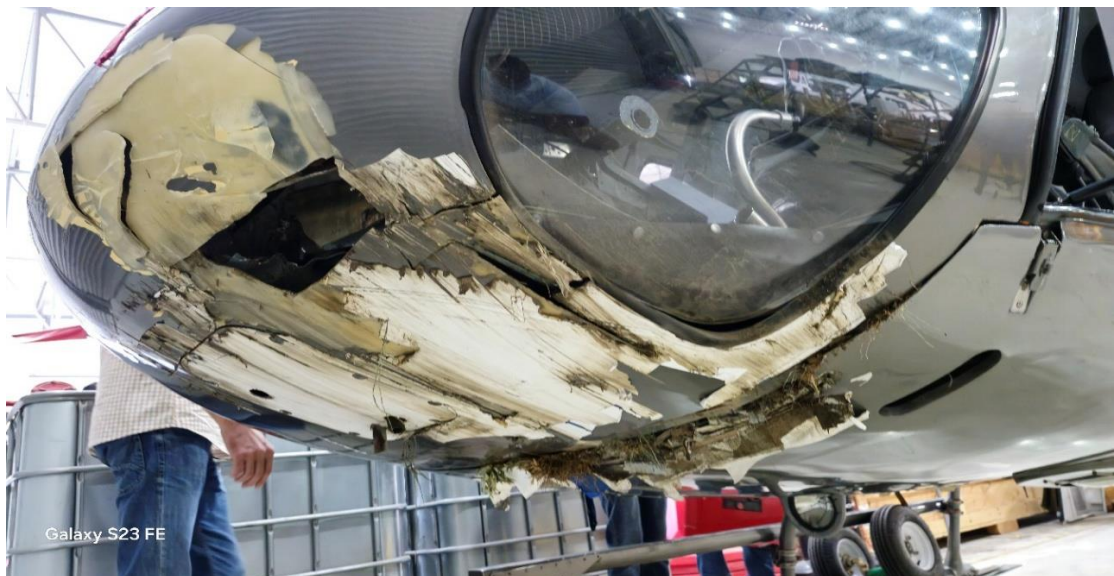
- The bottom of the nose section towards the left side had damage consistent with contact with the ground whilst the helicopter skidded and, possibly, subjected to heavy, momentary forces (see Figure 6).

**Figure 6:** Damage to the bottom nose section.

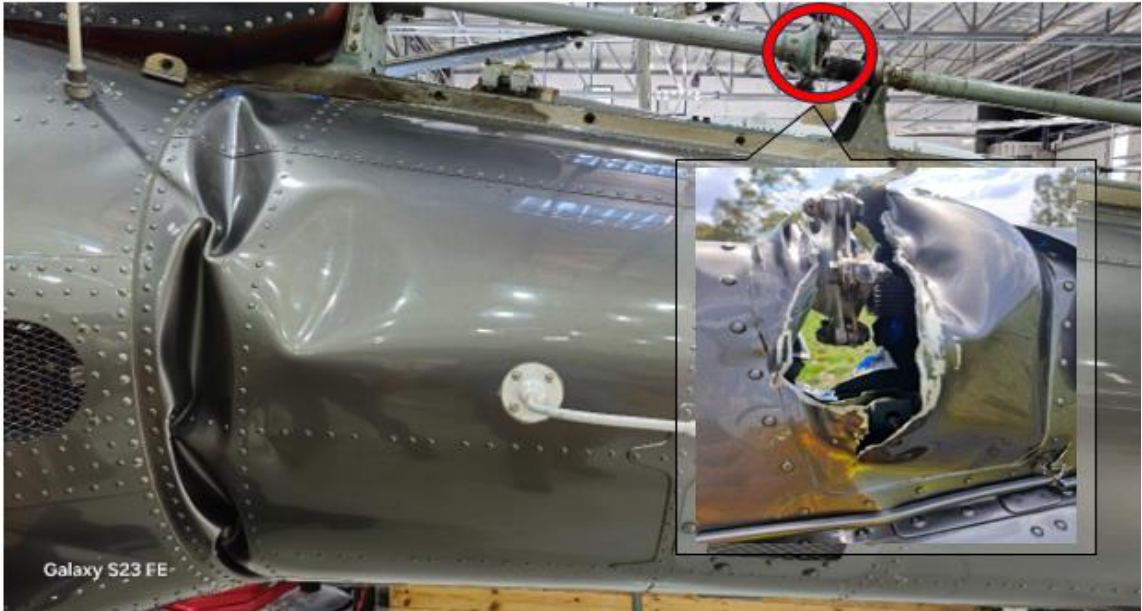
The helicopter's tail boom had bent near the attachment points which led to the tail rotor shaft decoupling. Both components (coupler and the shaft) sustained minor damage during decoupling whilst the helicopter was rotating. The coupling caused damage to the tail rotor shaft covering fairing panels (see Figures 7 and 8).

**Figure 7:** Damage to the tail boom attachment section and the decoupled tail rotor shaft. (Photo was taken after the helicopter was recovered).

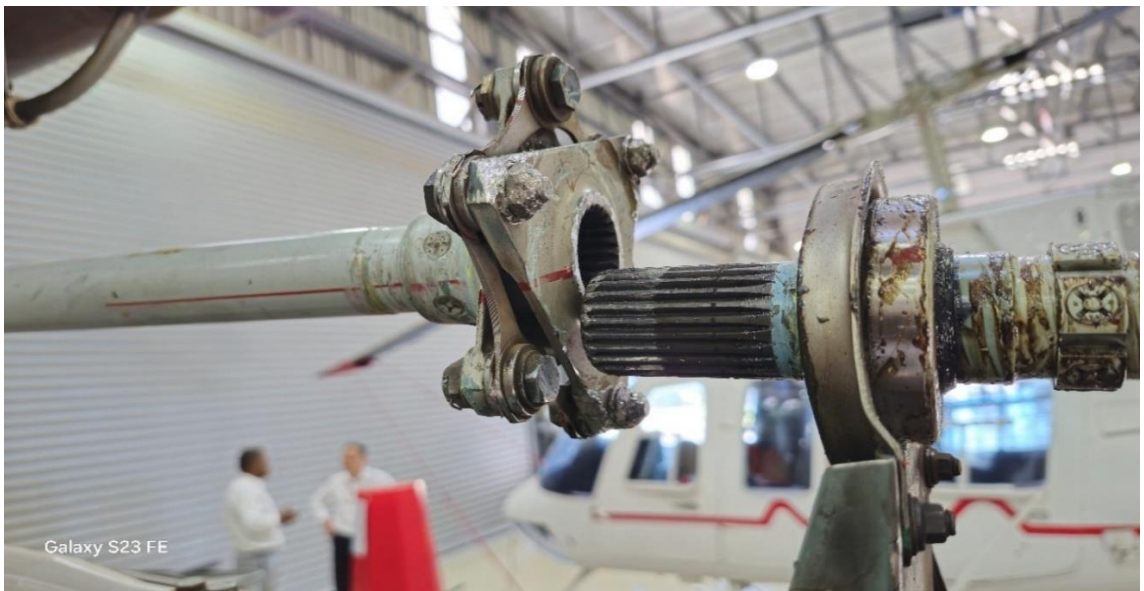
**Figure 8:** Decoupled tail rotor drive shaft.
