PRELIMINARY SERIOUS INCIDENT REPORT

Serious Incident
- Preliminary Report -
AIID Ref No: CA18/3/2/1468

Approximately 38 minutes into the flight at flight level (FL) 220 and 40 nautical miles (nm) east of FAPN, the aircraft's door opened and the cabin decompressed rapidly. The crew descended to FL090 and diverted to Lanseria International Airport (FALA) where the aircraft landed safely. The aircraft sustained minor damage during the serious incident. None of the occupants on-board was injured.

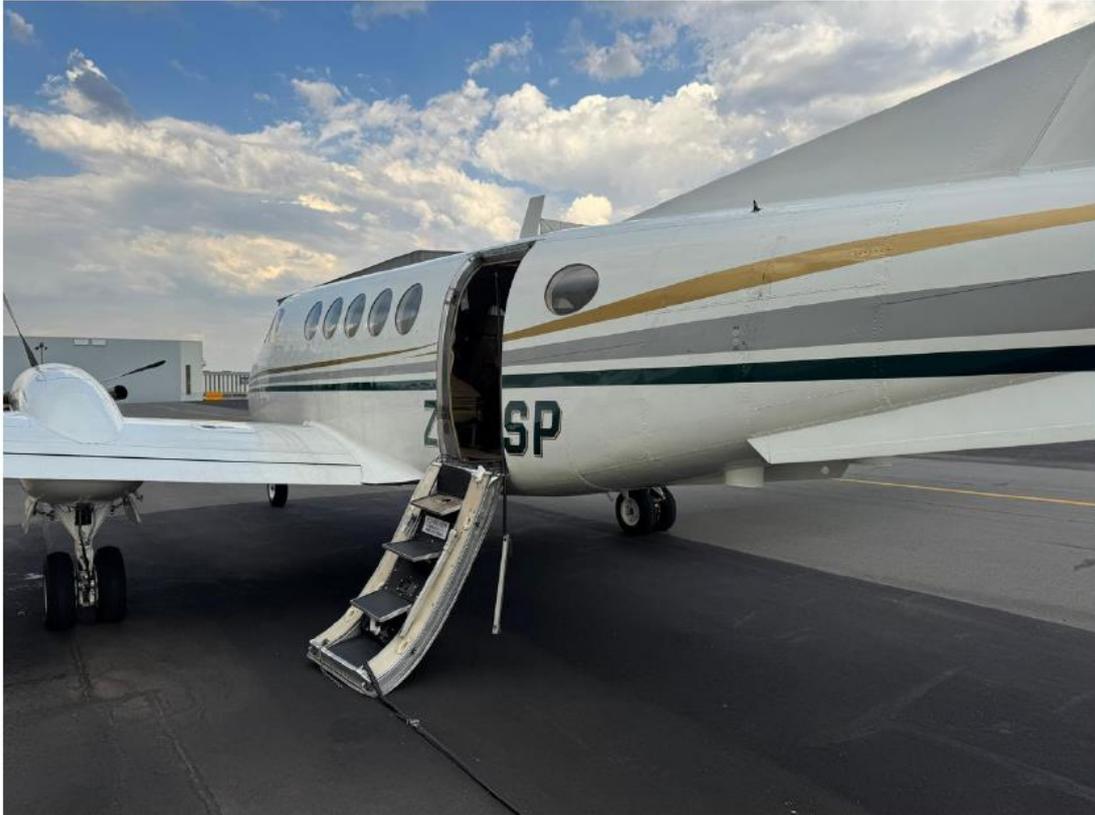
Figure 2: The aircraft after it had landed. (Source: Operator)

1.12.1. The aircraft (open) door impacted the runway during touchdown. The aircraft was taxied with the door open.

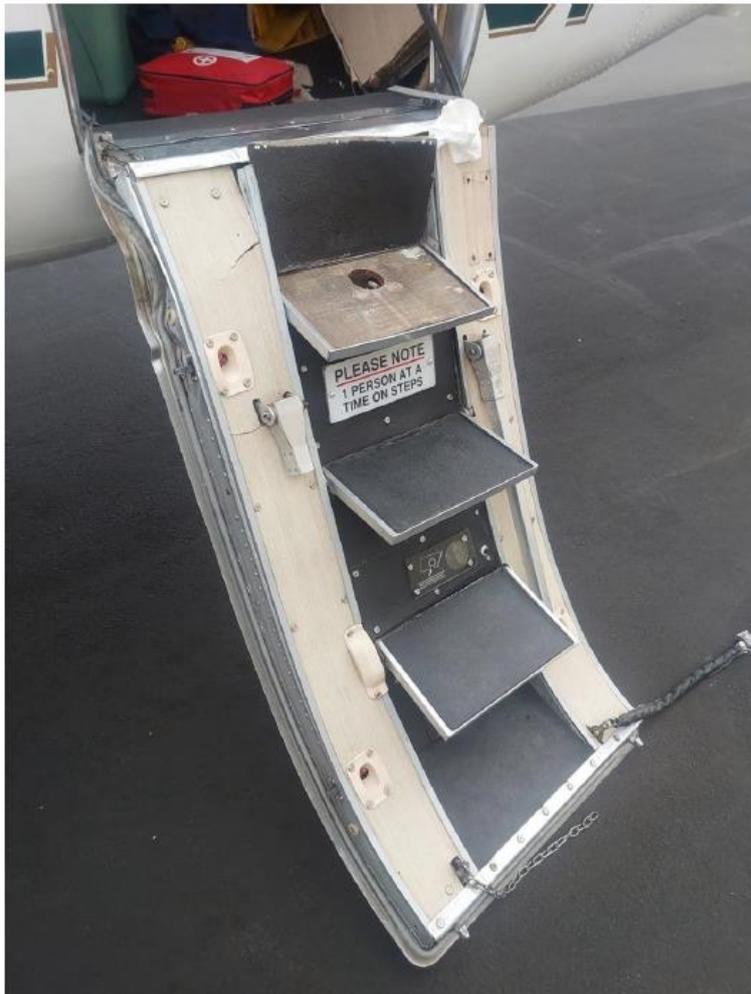
- 1.1.2. The pilot reported that approximately 38 minutes into the flight whilst en route to FAPN at flight level (FL) 220, the aircraft's door unlocked and opened fully, and the cabin decompressed rapidly. The pilots declared an emergency by broadcasting a PAN PAN PAN on frequency 126.7-Megahertz (MHz). The pilot followed the emergency procedure and descended to FL090. The crew was not sure if the door was still attached to the fuselage; therefore, they decided to divert to Lanseria International Airport (FALA), the operator's home base. The air traffic control (ATC) officer at FALA alerted the fire and rescue services to be on standby when ZS-SSP was landing. The aircraft landed without further incident at 1451Z. There was no need for assistance from the fire and rescue service.

- 1.1.3. None of the occupants was injured; the aircraft sustained damage to the aircraft door and one of the rear right-side windows which was damaged by the staircase handrail chain strap when the door opened in-flight

Figure 3: The damaged door. (Source: Operator)

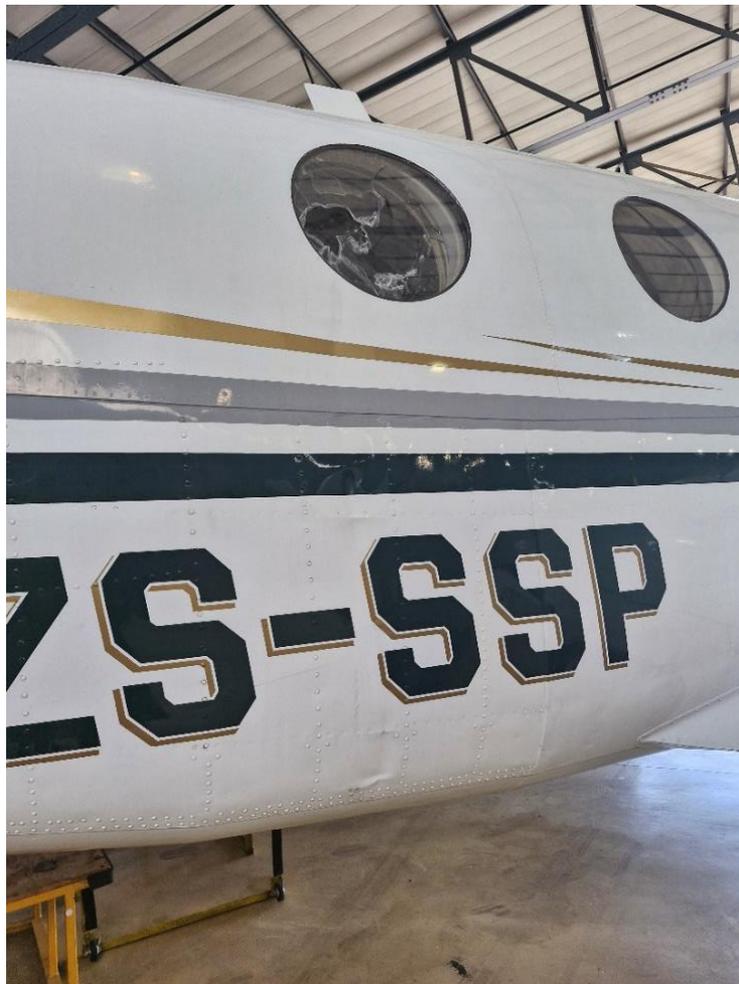
Figure 4: The damaged window.
