## PRELIMINARY ACCIDENT REPORT

### Accident and Incident Investigations Division

Accident  
- Preliminary Report -  
AIID Ref No: CA18/2/3/10407

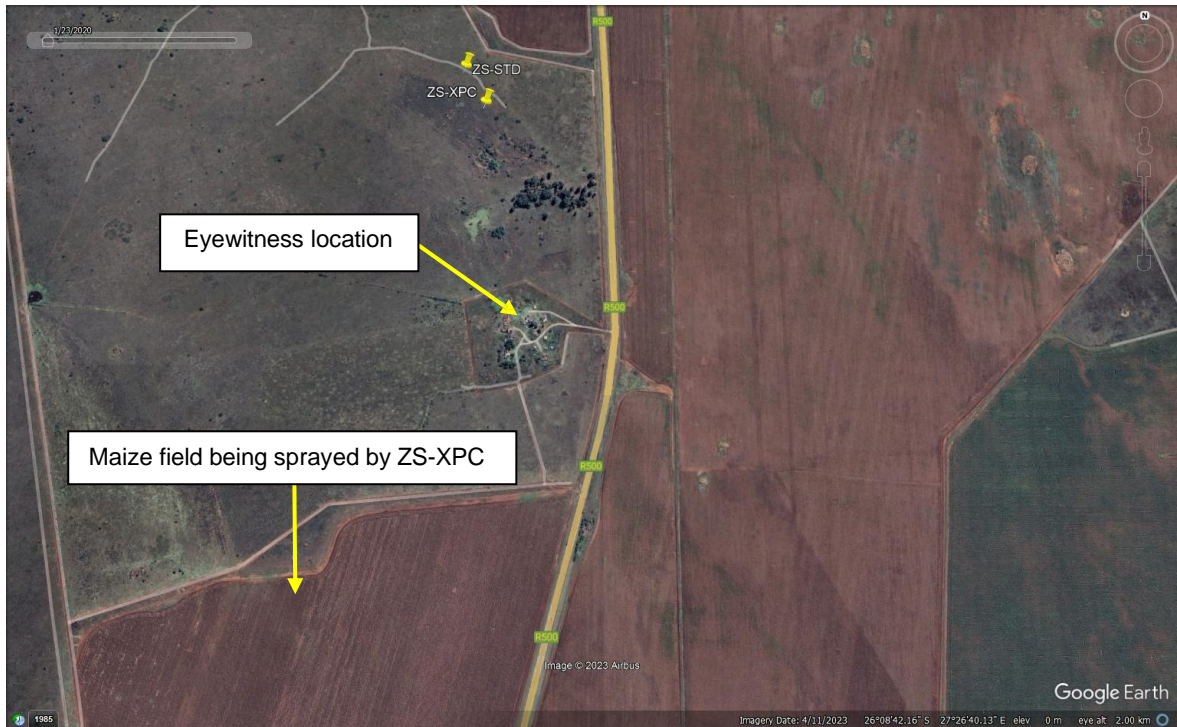
**Figure 3:** Position of the two main wreckages (yellow pins). (Source: Google Earth; investigators)

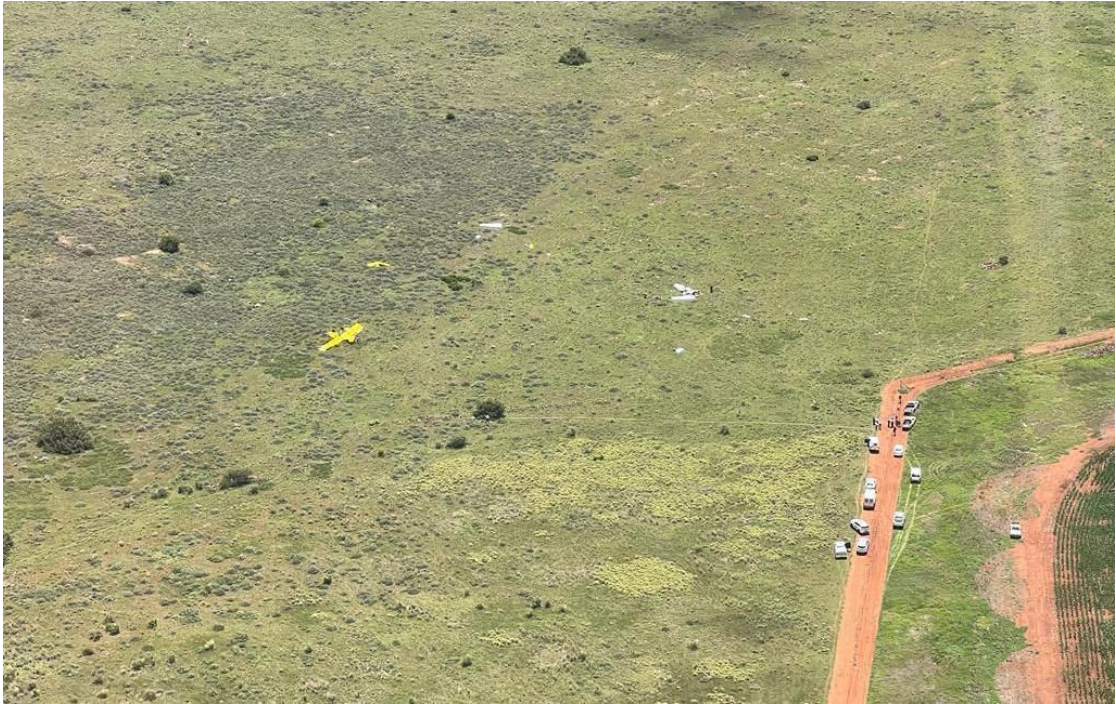
**Figure 4:** An aerial view of the accident site.  
(Source: A person on-board an aircraft)

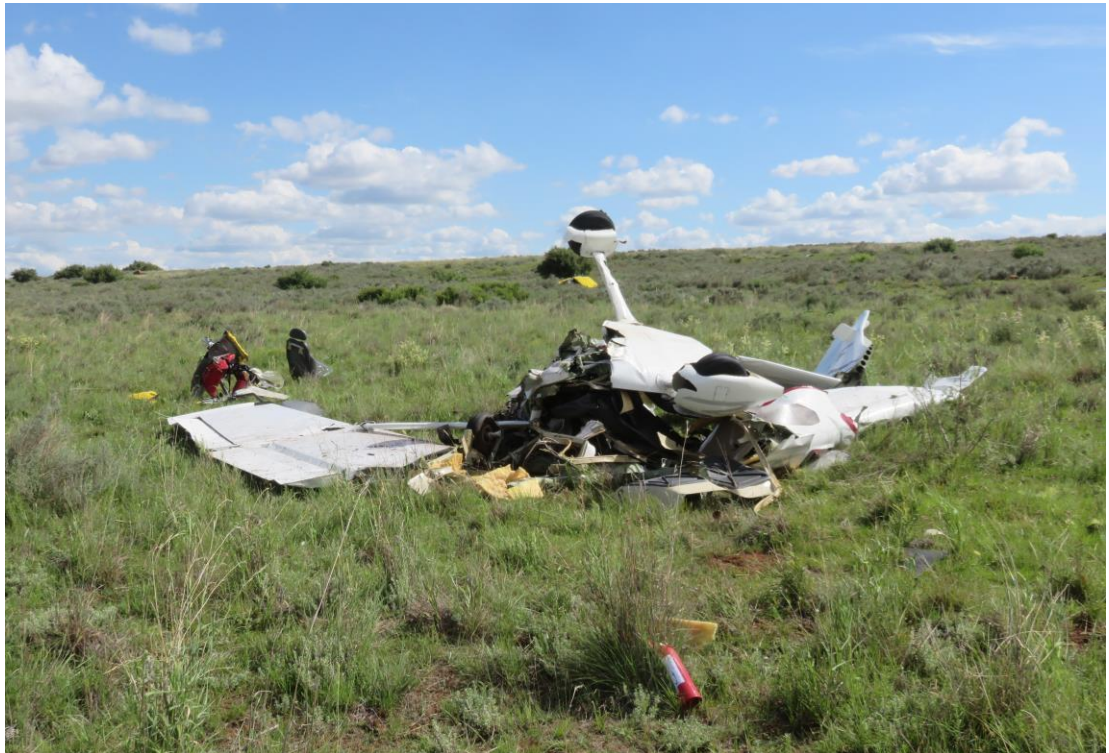
1.12.1 The accident site radius of 110 metres (m) was covered by debris. The main wreckage of ZS-STD, which came to rest in an inverted attitude, faced north-easterly. The entire left wing had separated from the fuselage and was lying approximately 40m from the main wreckage. The pilot (left front) seat was lying next to the right wing, and the other seat was still in the cockpit/cabin area. The aircraft was severely damaged.

**Figure 5:** The main wreckage of ZS-STD.

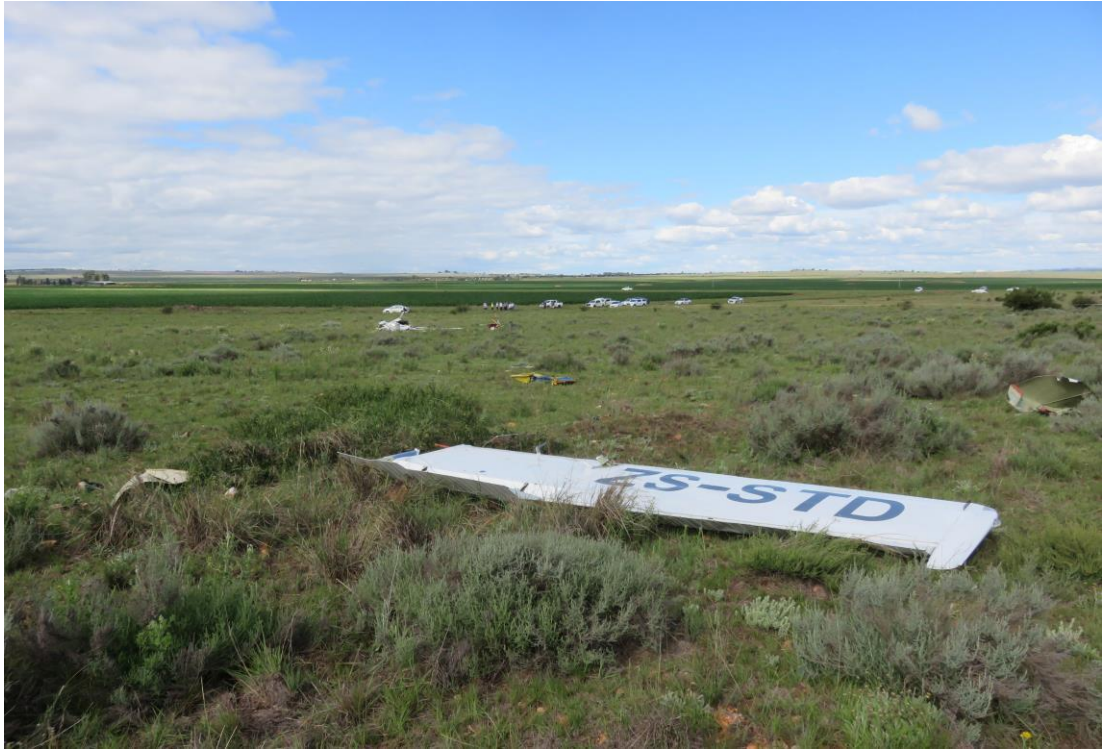
**Figure 6:** The left wing of ZS-STD.

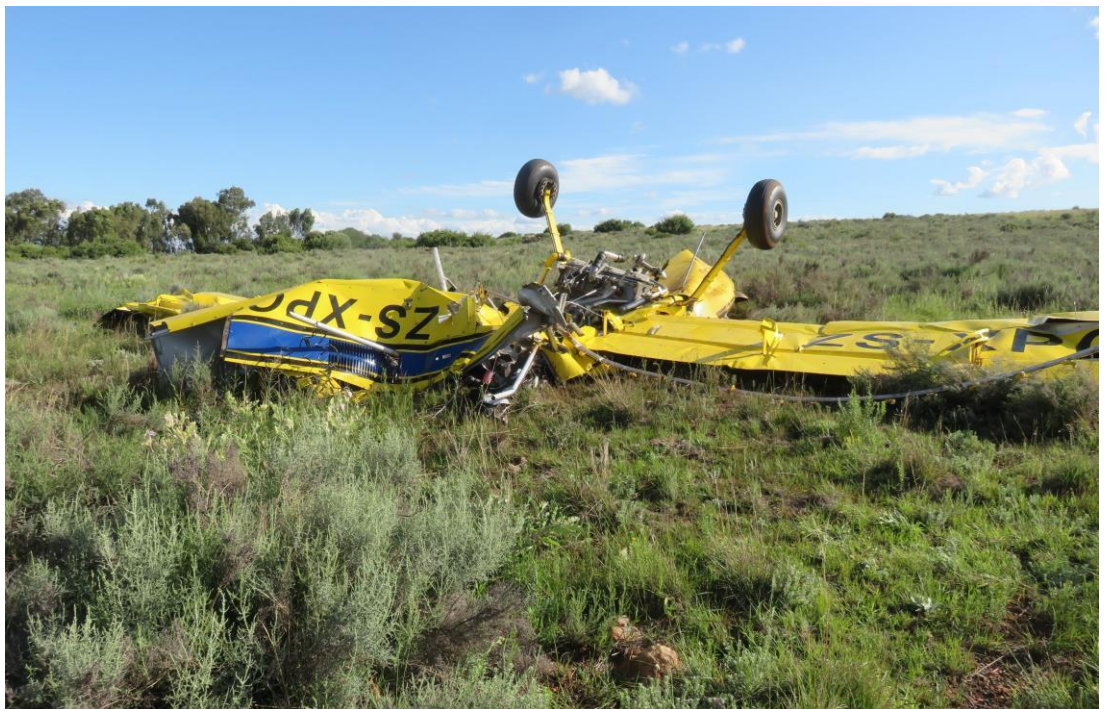
1.12.2 The main wreckage of ZS-XPC also came to rest in an inverted attitude facing south approximately 100m from the main wreckage of ZS-STD. The empennage of the aircraft was found separated from the main fuselage. The vertical stabiliser and rudder were found separated from the aft fuselage. One of the four propeller blades was severed from the hub assembly, with the three remaining blades sustaining extensive deformation. The deep groove mark on the ground indicated that the propeller was turning under power on impact. The cockpit/cabin area of the aircraft was also severed from the fuselage and the pilot seat, including the floor structure it was attached to, which had ripped off of the fuselage and was lying next to the right wing of the main wreckage of ZS-STD. The propeller gear drive, which is part of the engine, had separated from the rest of the engine and was still secured to the propeller hub assembly; the rest of the engine was undamaged and still secured to the fuselage. The spraying equipment, although deformed, had remained attached to the fuselage. The aircraft was equipped with an emergency locator transmitter (ELT); the unit remained intact and was flung off of the fuselage during the impact sequence.

**Figure 7:** The main wreckage of ZS-XPC.

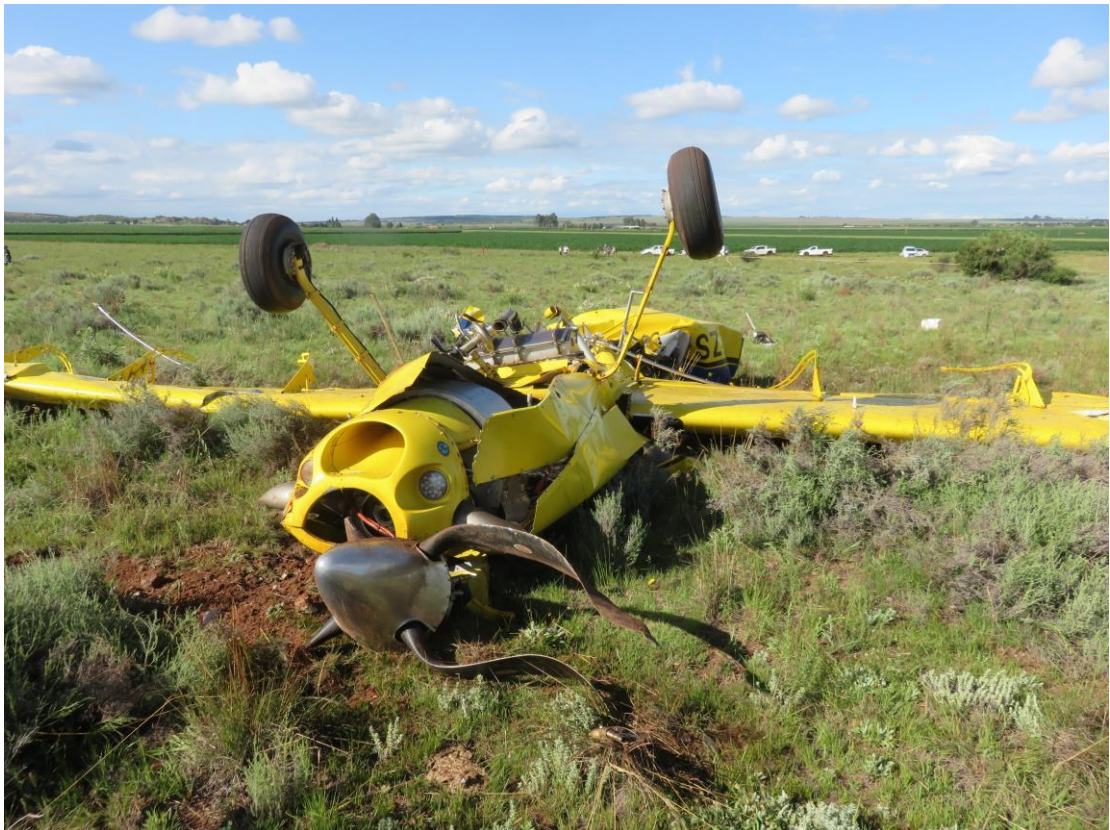
**Figure 8:** Deformed propeller blades, with one broken off.

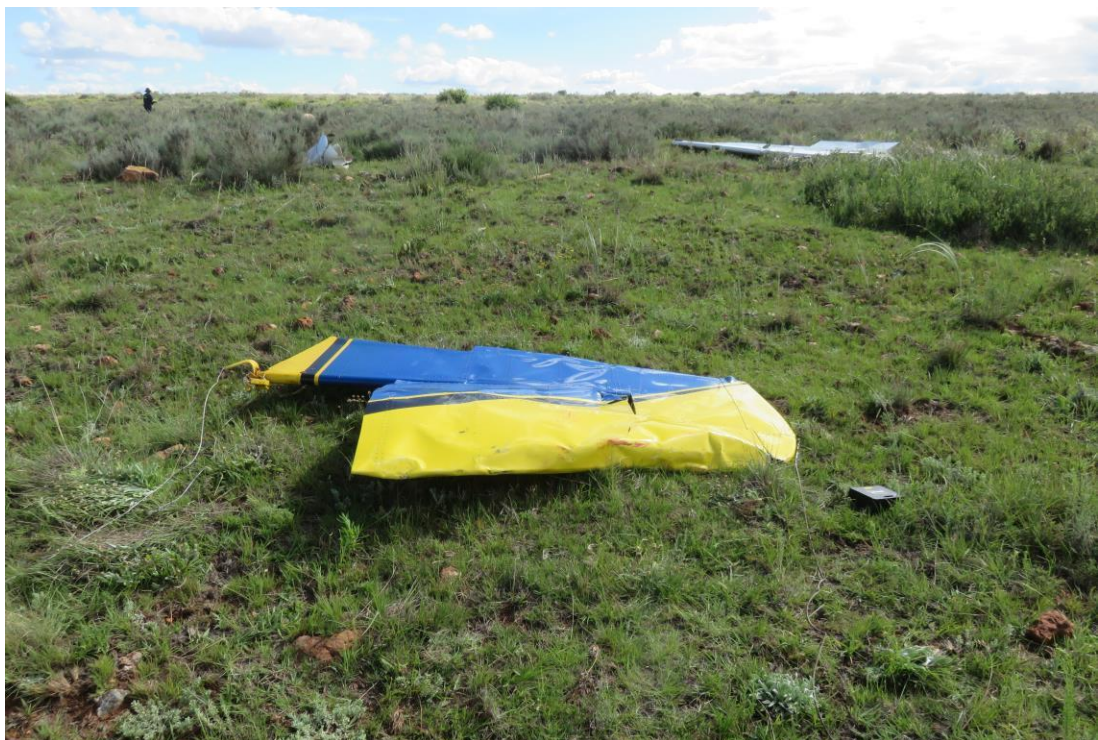
**Figure 9:** The vertical stabiliser and rudder assembly near the left wing of ZS-STD.

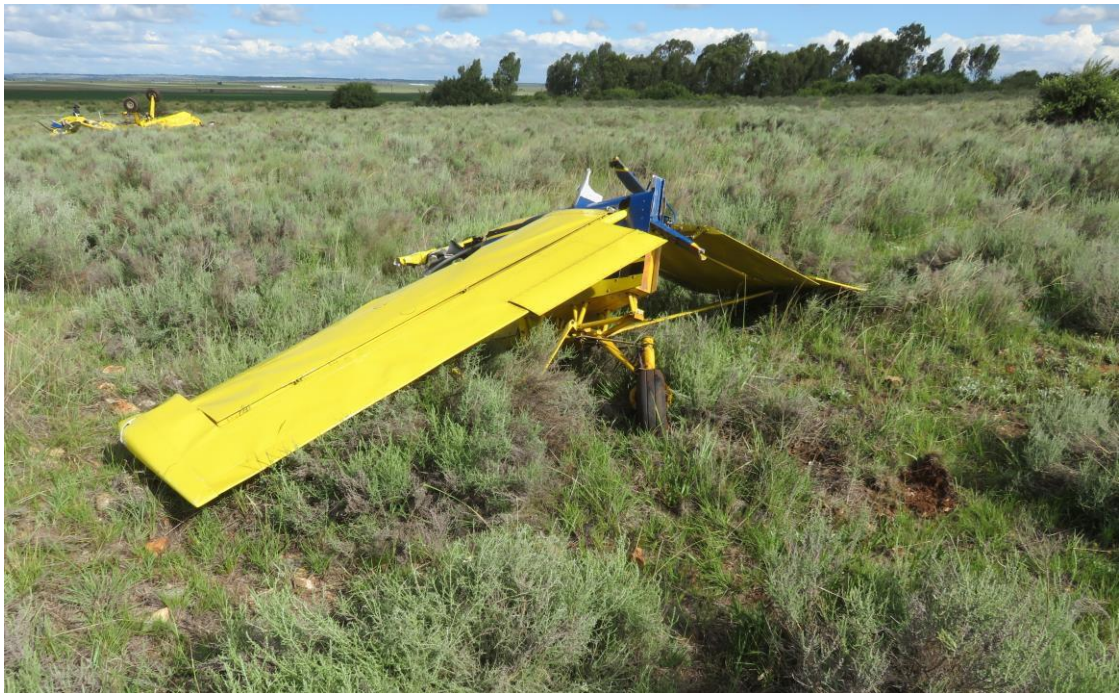
**Figure 10:** The aft fuselage and empennage with the two horizontal stabilisers still attached.

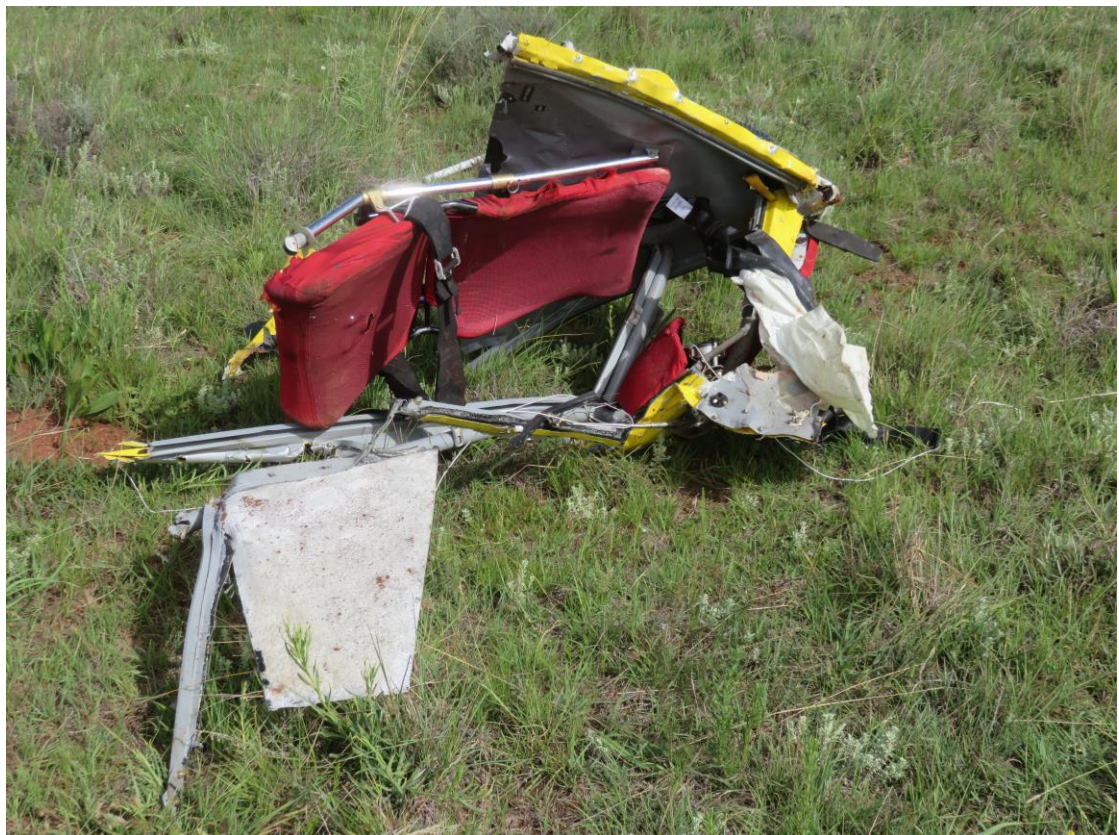
**Figure 11:** The pilot seat and floor structure of ZS-XPC.

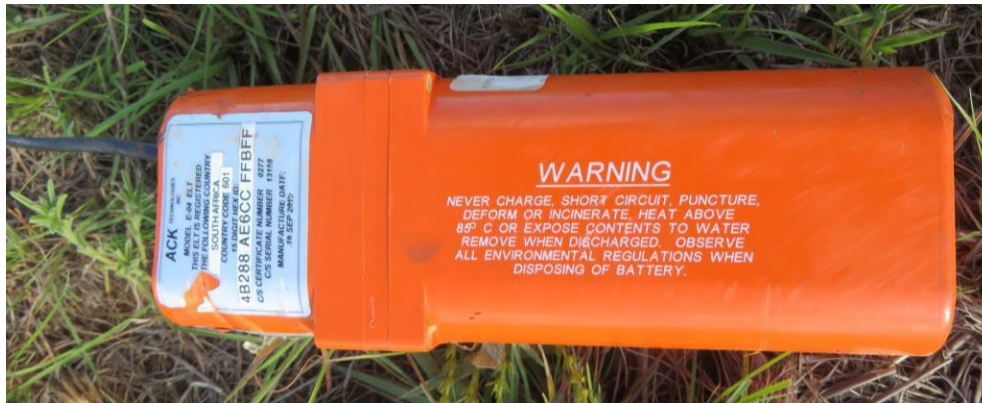
1.18.1 The ZS-XPC aircraft was equipped with a 406 MHz ELT. The unit, which remained intact and in an armed position, was flung off of the fuselage during the accident sequence. The South African Mission Control Centre (ASMCC) based in Cape Town did not receive any coded distress signal (HEX ID: 4B288 AE6CC FFBFF) for this aircraft.

**Figure 12:** ELT unit as it was found at the accident site.
