## PRELIMINARY SERIOUS INCIDENT REPORT

Serious Incident  
- Preliminary Report -  
AIID Ref No: CA18/3/2/1550

On 11 May 2026, an Airbus A320 aircraft with registration ZS-SZE, operated as a scheduled passenger flight SA327, departed from O.R. Tambo International Aerodrome (FAOR) to Cape Town International Aerodrome (FACT) with six crew members and 137 passengers on-board.

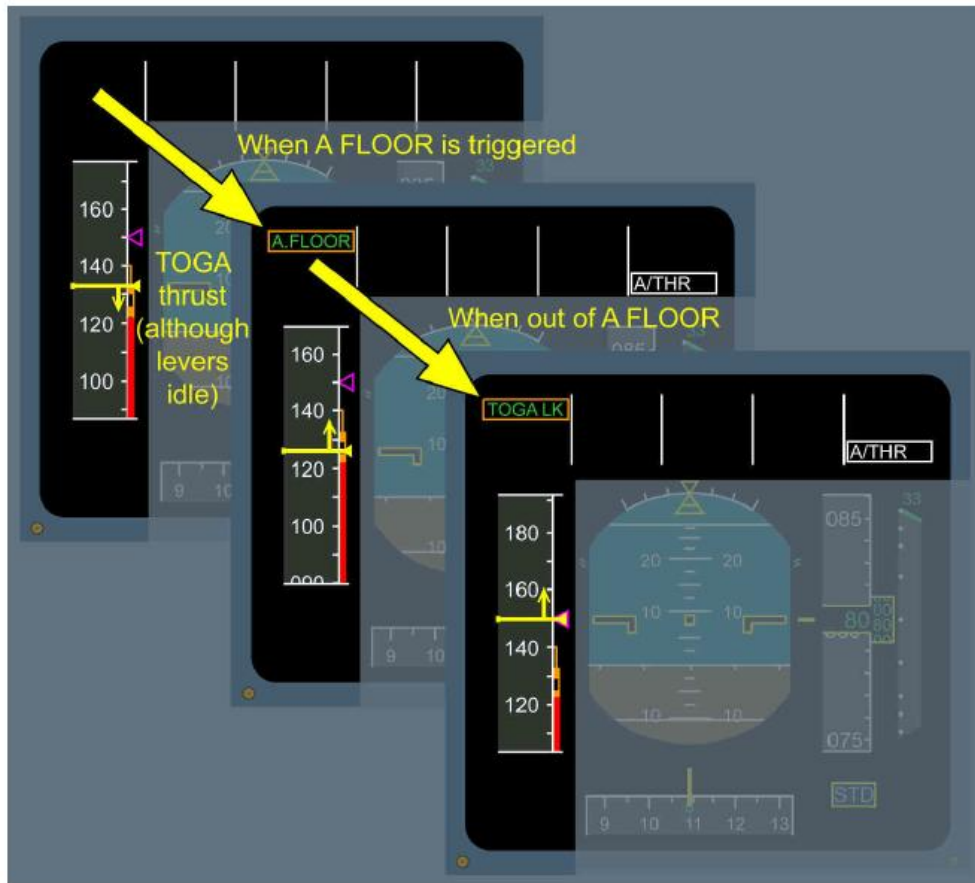
When the speed decreases, so that the angle-of-attack reaches the Alpha Floor threshold, A/THR activates and orders TOGA thrust, even though the thrust levers are at idle. When the aircraft accelerates again, the angle-of-attack drops below the Alpha Floor threshold. TOGA thrust is maintained or locked. This enables the flight crew to reduce thrust, as necessary. TOGA locked (LK) appears on the FMA to indicate that TOGA thrust is locked. The desired thrust can only be recovered by setting A/THR to off, with the instinctive disconnect pushbutton. Alpha Floor is available when the flight controls are in Normal Law, from lift-off to 100ft Resolution Advisory (RA) at landing. It is inhibited in some cases of engine failure.

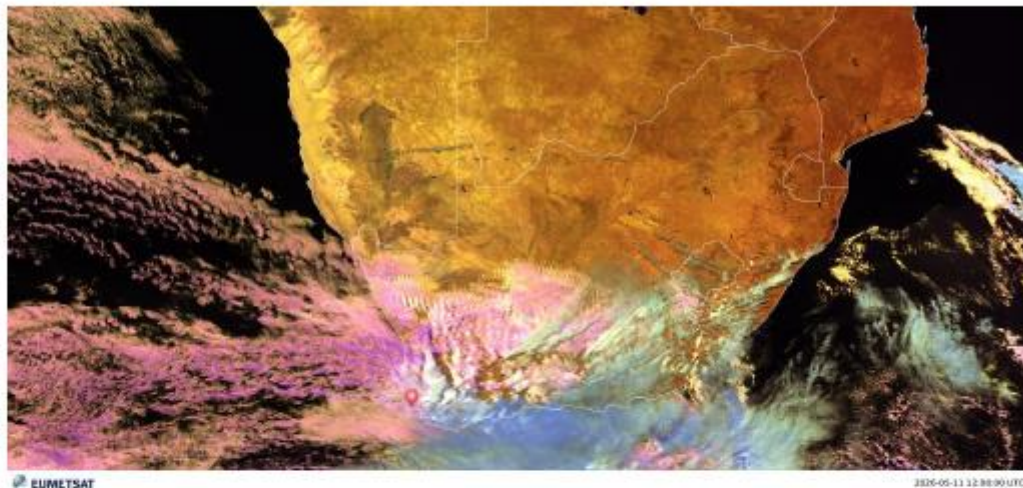
The MeteoSat Third Generation (MTG) Cloud Phase RGB satellite imagery was taken at 12:00 Z on 11 May 2025, which is when the incident has been reported to have occurred. A cold front system was moving past the area of incident resulting in a mixture of clouds around FACT (red location pin). The cloud phase RGB shows pinkish to yellowish clouds in FACT, which are indicative of thick water clouds with a mixture of small and large water droplets (Figure 2). Severe mountain waves can also be observed in the vicinity with corrugated patterns of the clouds.

Figure 2: The MeteoSat Third Generation (MTG) Cloud Phase RBG satellite imagery was taken at 12:00 Z on 11 May 2026 (copyright Eumetsat).

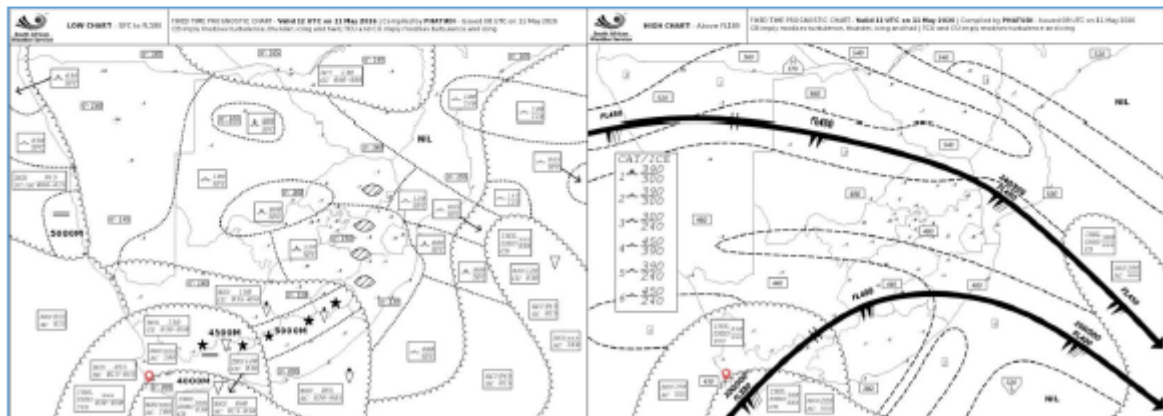
The Significant Weather (SigWx) low-level and high-level charts below are valid for 12:00Z which was when the incident occurred (Figures 4). FACT is in an area where a mixture of significant clouds were expected at 12Z. Broken Stratocumulus clouds with bases as low as 1500-4500 ft were expected, together with broken Altimocumulus (ACs) clouds with bases of 10 000ft and isolated embedded Towering Cumulus (TCUs) clouds as well as isolated embedded Cumulonimbus (CBs) clouds at 3000-5000 ft which inherently pose a hazard of moderate to severe turbulence and icing. Visibility was expected to reduce to 4000 m due to showers and rain while the freezing level was expected to be at 9500 ft.

Figures 4: The 12:00 Z low-level and high level SigWx charts for 11 May 2026.

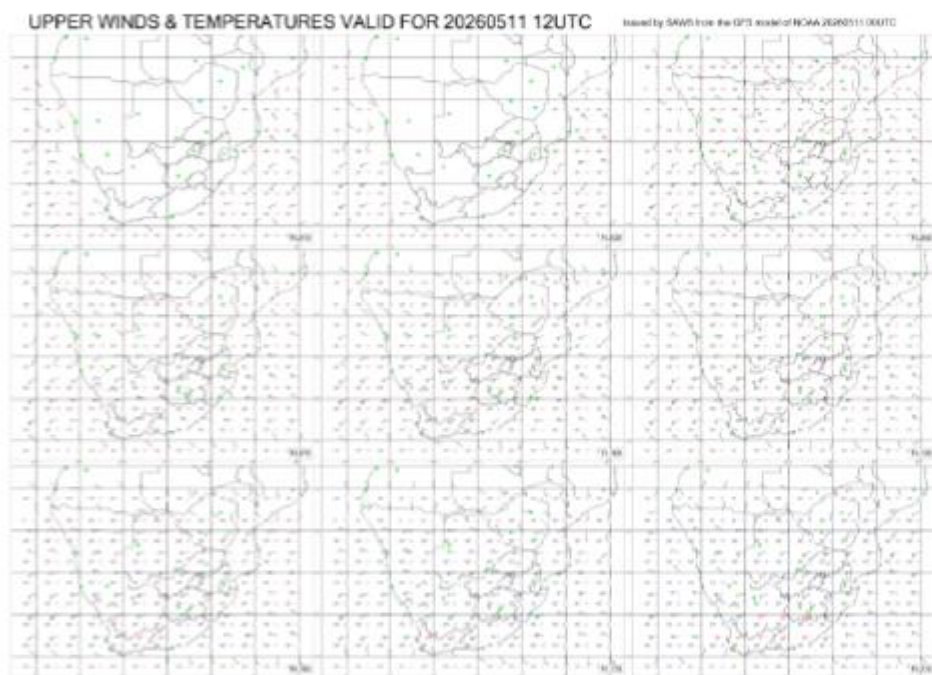
Figure 5: Upper winds and temperature forecasts valid till 12:00Z

Unfortunately there was no afternoon upper air ascent done on this day to verify the wind-flow above the surface.
