PRELIMINARY ACCIDENT REPORT

Accident and Incident Investigations Division

Accident  
- Preliminary Report -  
AIID Ref No: CA18/2/3/10337

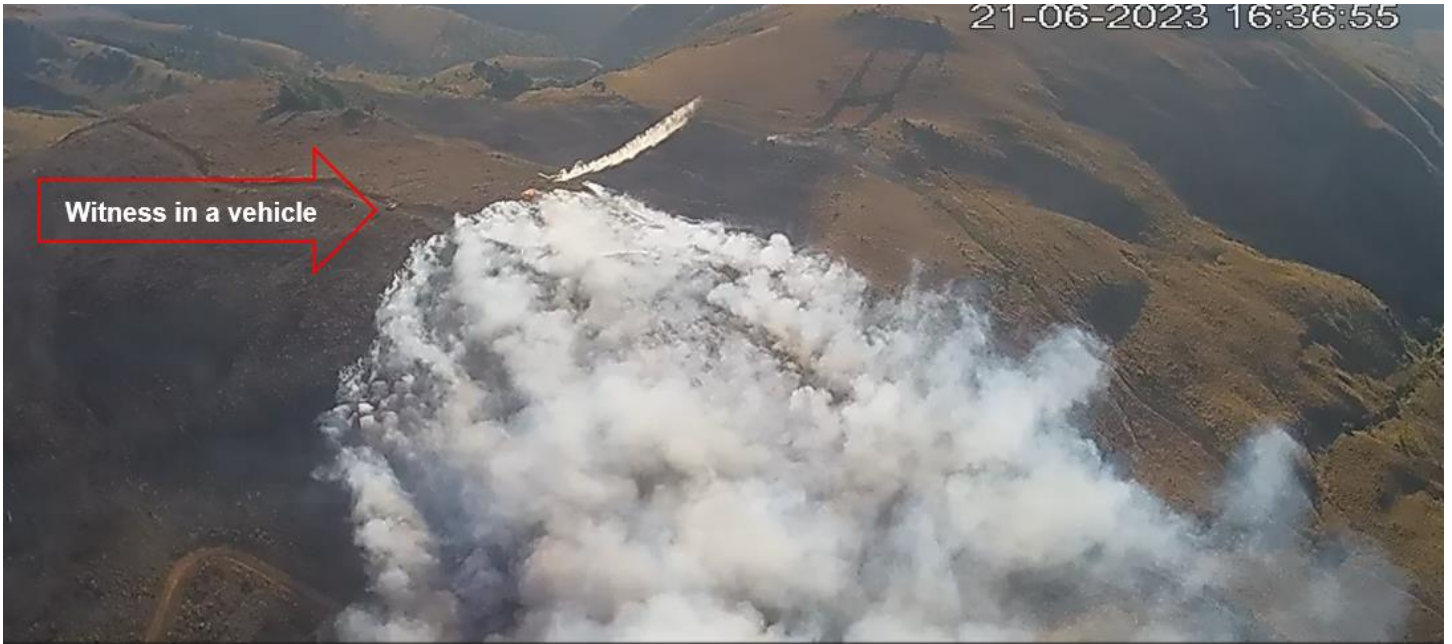
- 1.1.3 The video footage from the spotter aircraft shows *ZS-TFH dropping the second load of water at 1436Z (see Figure 2), about three (3) seconds later, the aircraft is observed impacting the ground hard and it burst into flames whilst catapulting forward. It came to rest in an inverted position on the rising terrain (see Figure 3).* After seeing the ZS-TFH on fire, the other aircraft which were part of the firefighting mission released their water loads on ZS-TFH to extinguish the fire.

Figure 2: ZS-TFH releasing its second load of water. (Source: Operator)

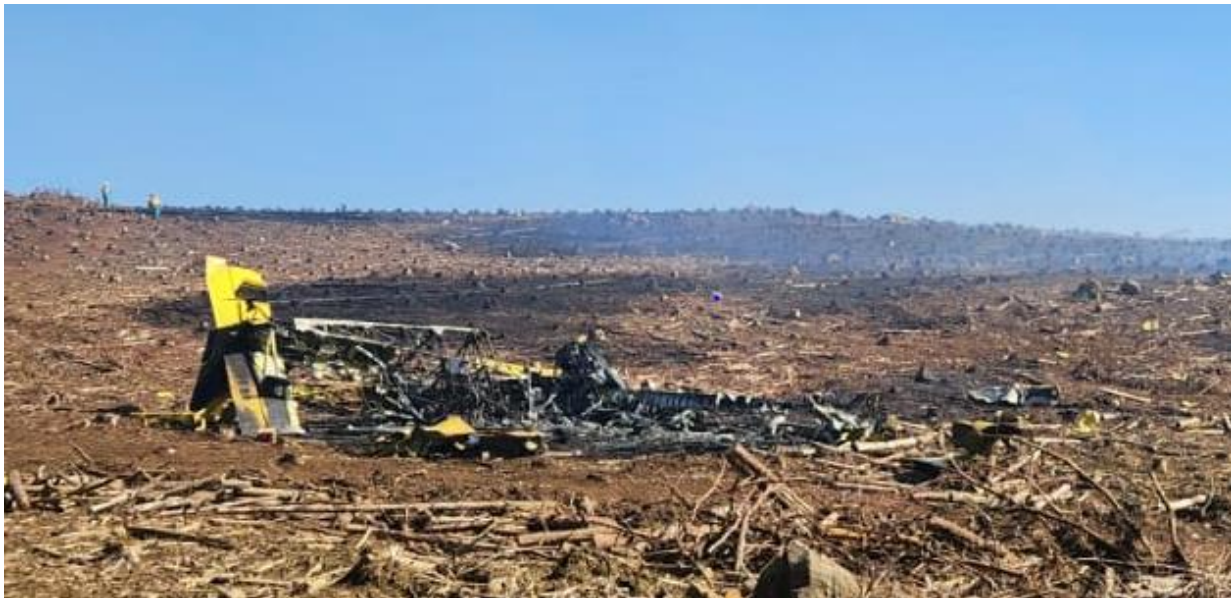
1.3.1. The aircraft was destroyed by post-impact fire.

Figure 4: The wreckage post-accident.

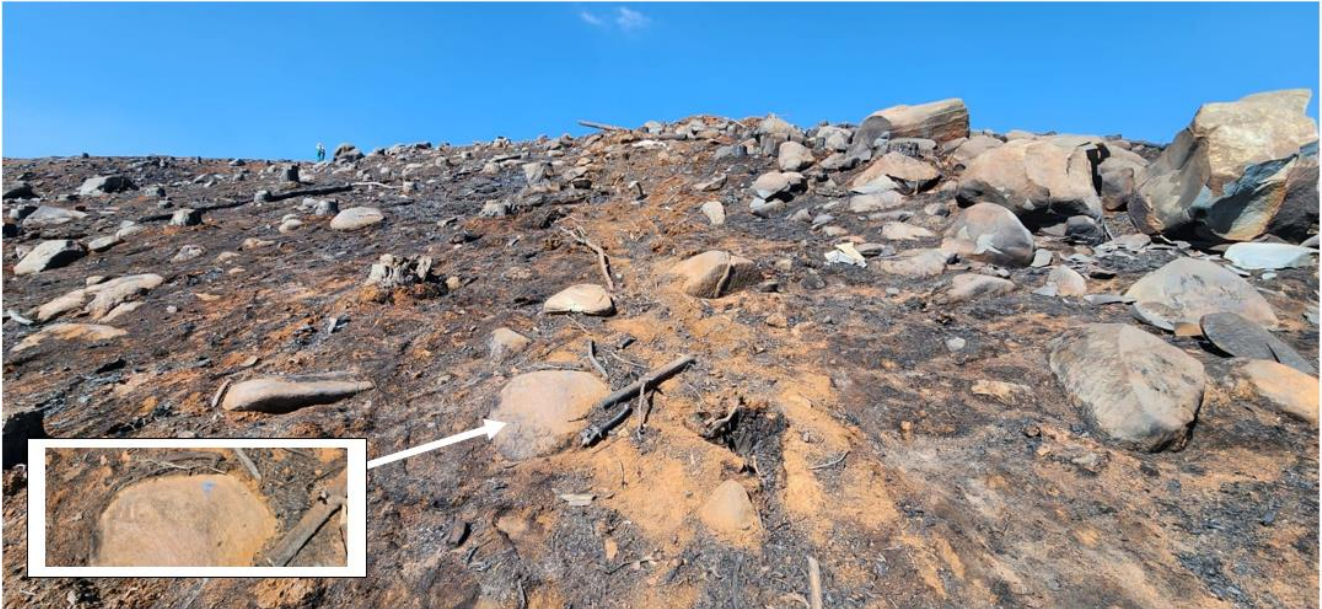
1.12.1. The aircraft impacted the rising terrain and the wreckage dispersed in a radius of 350m. The aircraft impacted the terrain with the left-side main landing gear and the hopper, and then burst into flames and skidded forward for approximately 250m before it came to rest in an inverted position facing north.

**Figure 5:** A rock with blue paint from the aircraft's hopper.

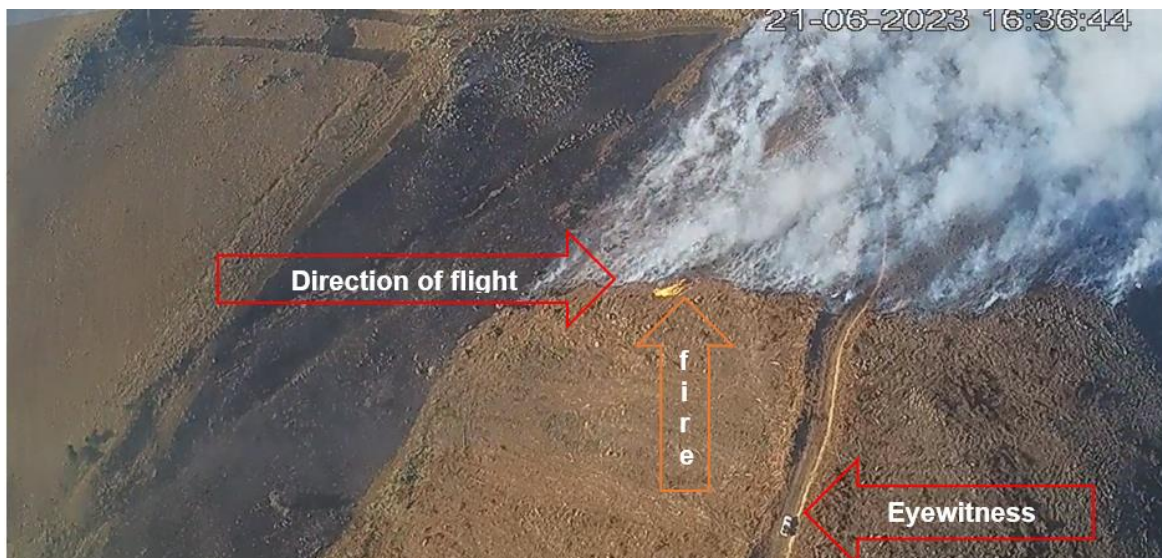
**Figure 6:** Direction of flight, the fire and position of the eyewitness. (Source: Operator)

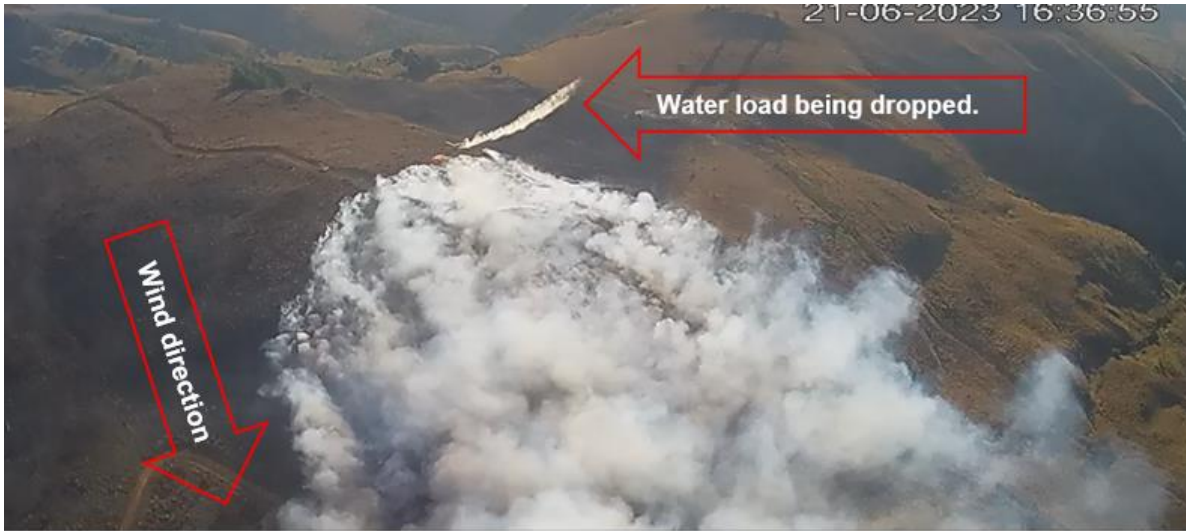
1.12.3 The aircraft was flying perpendicular to the wind direction (see Figure 7).

**Figure 7:** ZS-TFH releasing water. (Source: Operator)

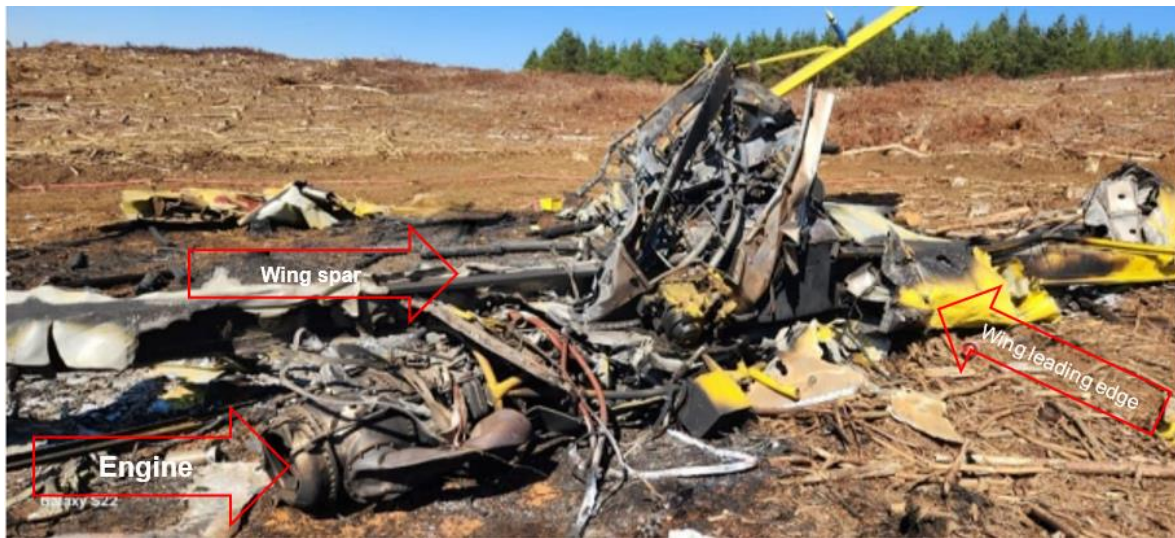
1.12.2 Both the main landing gears and the hopper separated from the fuselage and dispersed in the direction in which the aircraft catapulted and came to rest. The tail wheel remained on the main wreckage. The wings were damaged by impact forces but remained on the fuselage. The flaps and ailerons separated from the wings.

**Figure 8:** The front view of the main wreckage with damaged wings.

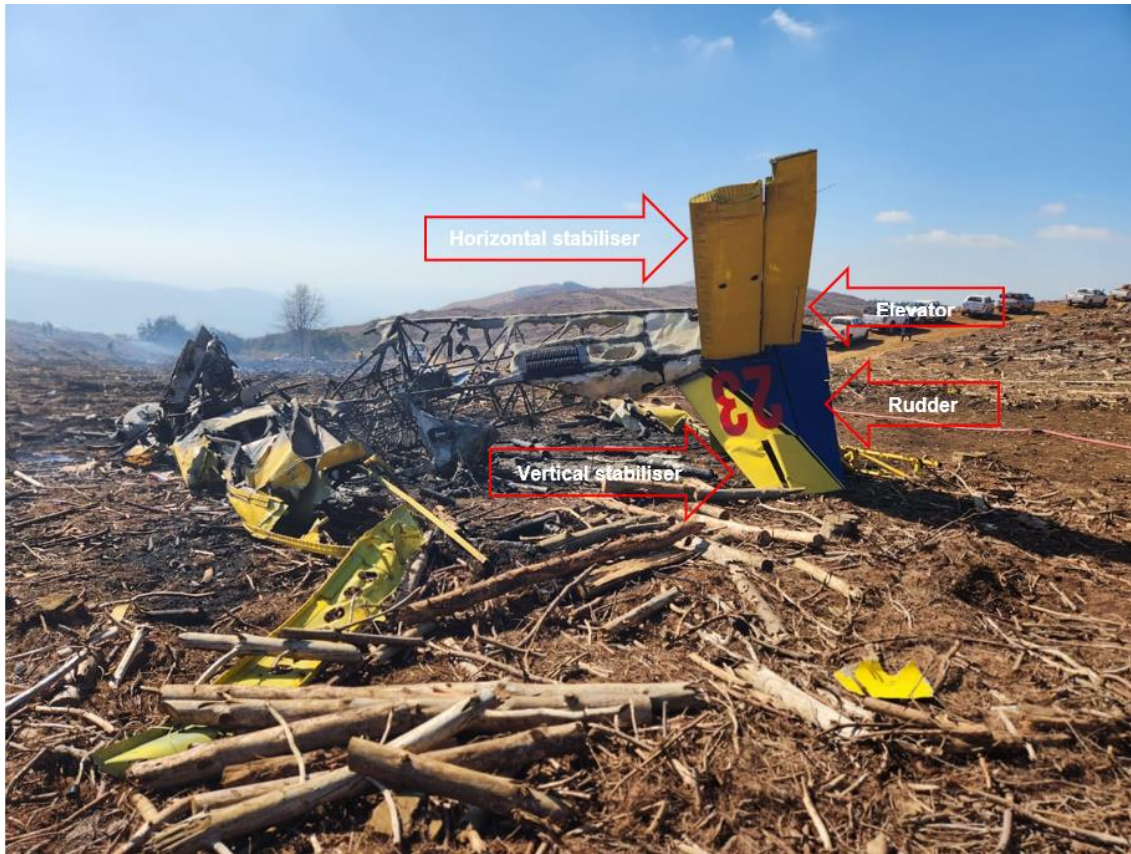
**Figure 9:** Left view of the main wreckage.

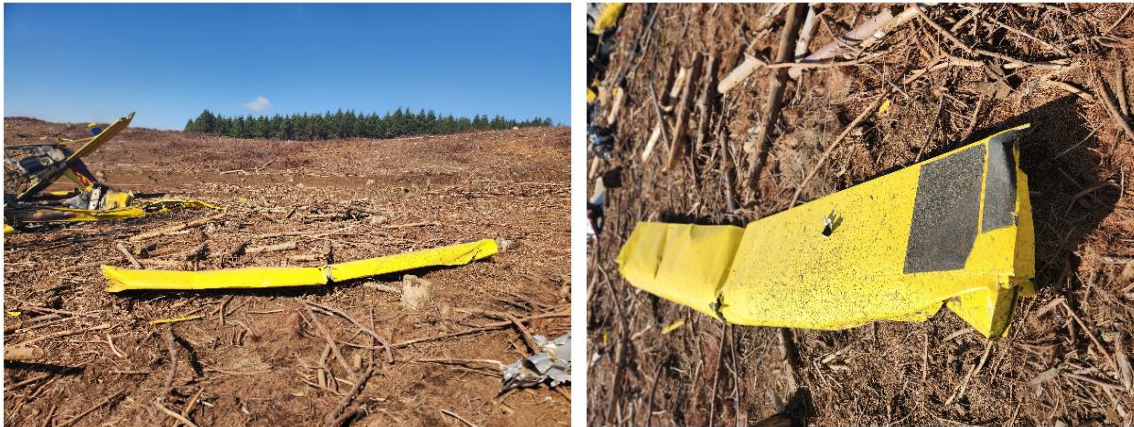
1.12.4 The right-side flap was found approximately 10m from the main wreckage and burnt, indicating that it was severed before the aircraft came to rest.

**Figures 10 and 11:** Shows bottom and top view of the right-side flap.

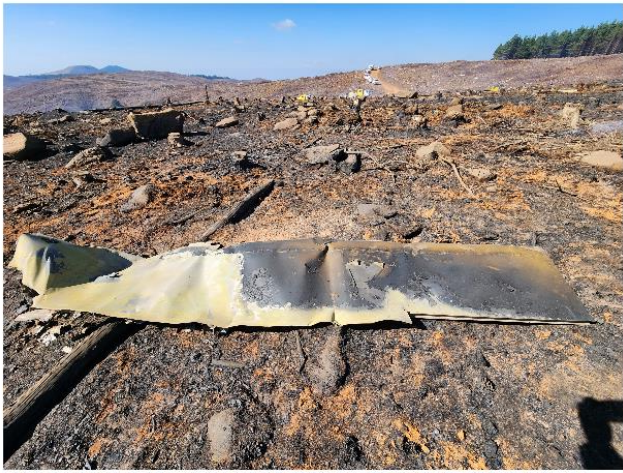
1.12.5 Both the left and right ailerons broke off from the wing trailing edge during the accident sequence.

**Figure 12:** The right-side aileron with the trim tab missing. **Figure 13:** Shows the left-side aileron with the trim tab still attached.

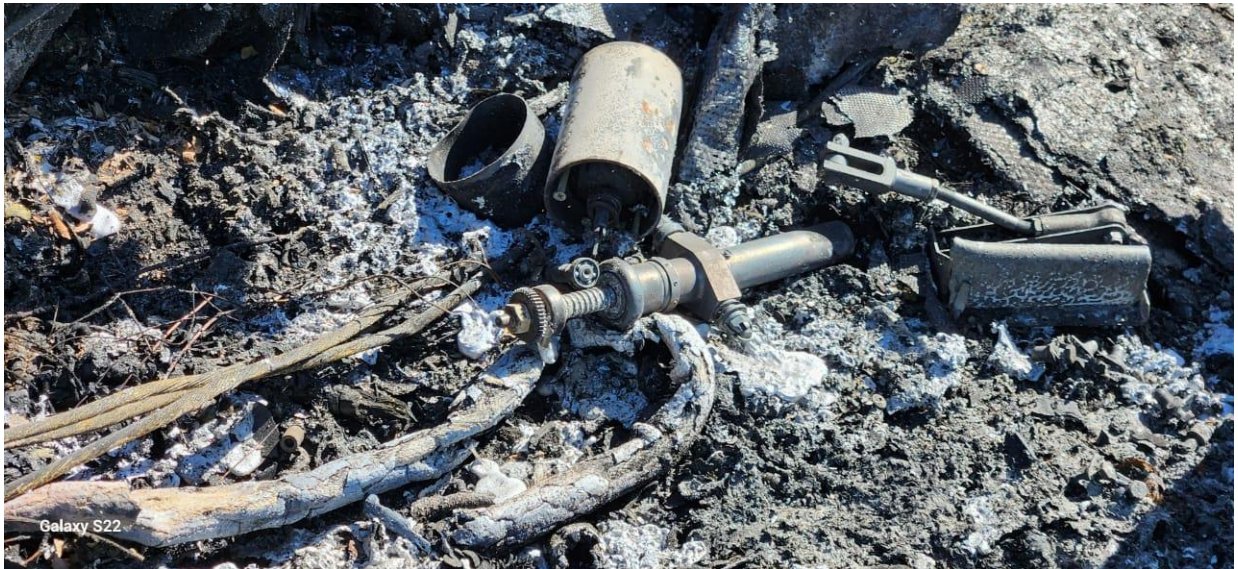
1.12.6 The jackscrew was found in an open position, indicating that the flaps were extended (down).

**Figure 14.** The open flap jackscrew.

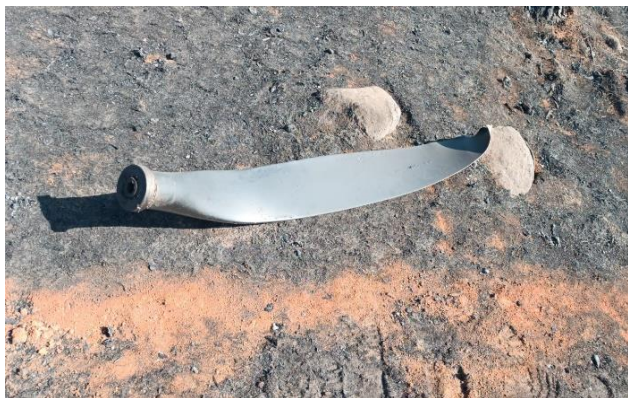
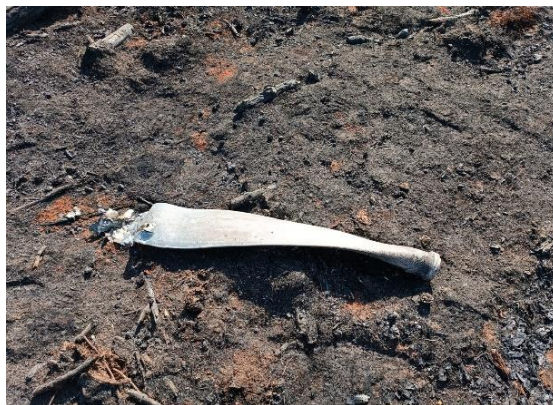
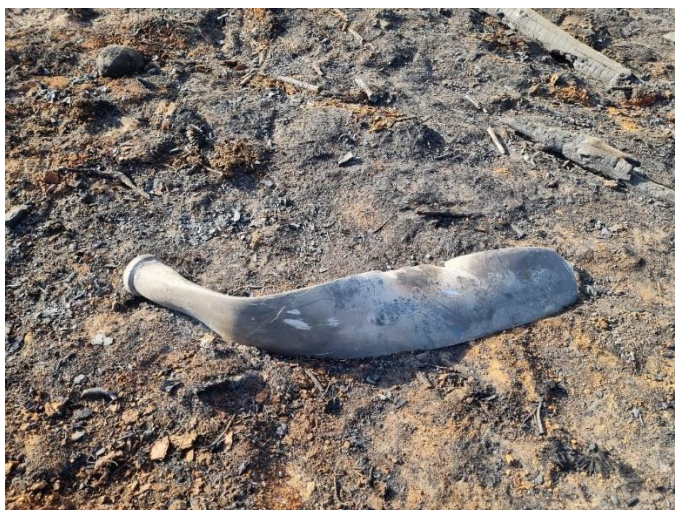
1.12.7 Parts of the aircraft separated and scattered in different directions, including the propeller blades. Only three (3) of the five (5) blades were recovered.

**Figures 15, 16 and 17:** Three of the five propeller blades that were recovered from the accident site.
