**PRELIMINARY ACCIDENT REPORT**

**Accident and Incident Investigations Division**

Accident  
- Preliminary Report -  
AIID Ref No: CA18/2/3/10376

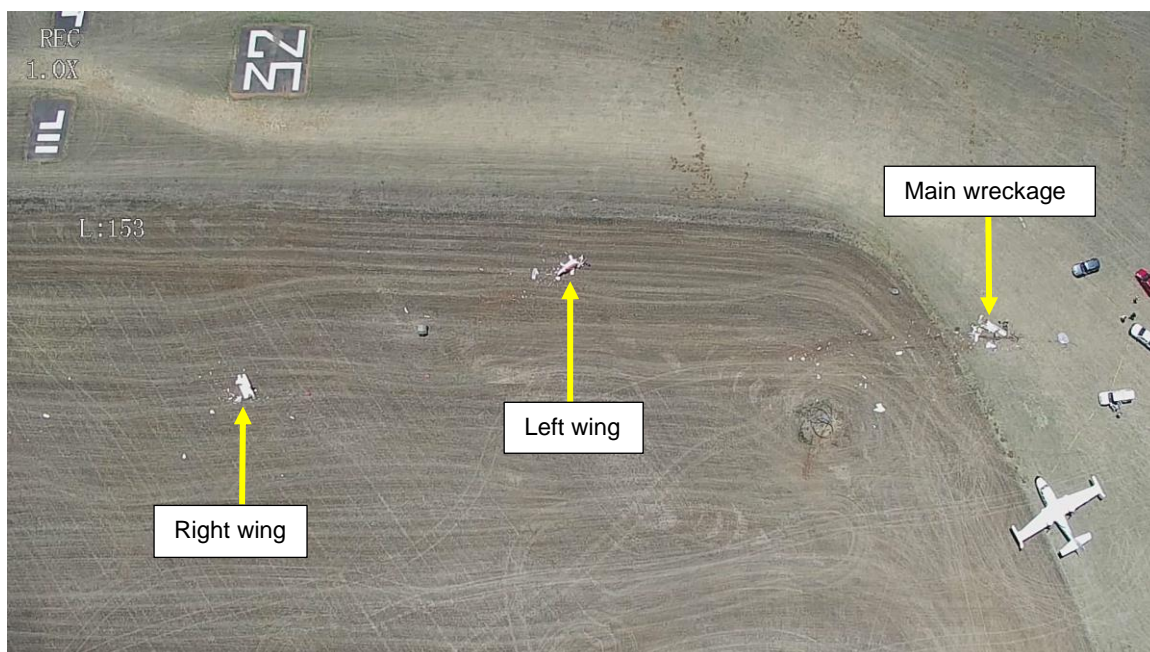
1.12.1 Following the in-flight structural failure, the wreckage was spread in a straight line on the grass surface on the right of Runway 14 at FASI. The right wing was the first structure in the sequence of break up, it was followed by the left wing and the main fuselage, empennage structure and the engine. The wreckage was spread over a distance of 98m.

**Figure 2:** Drone camera footage depicting the wreckage distribution. (Source: Drone Ops)

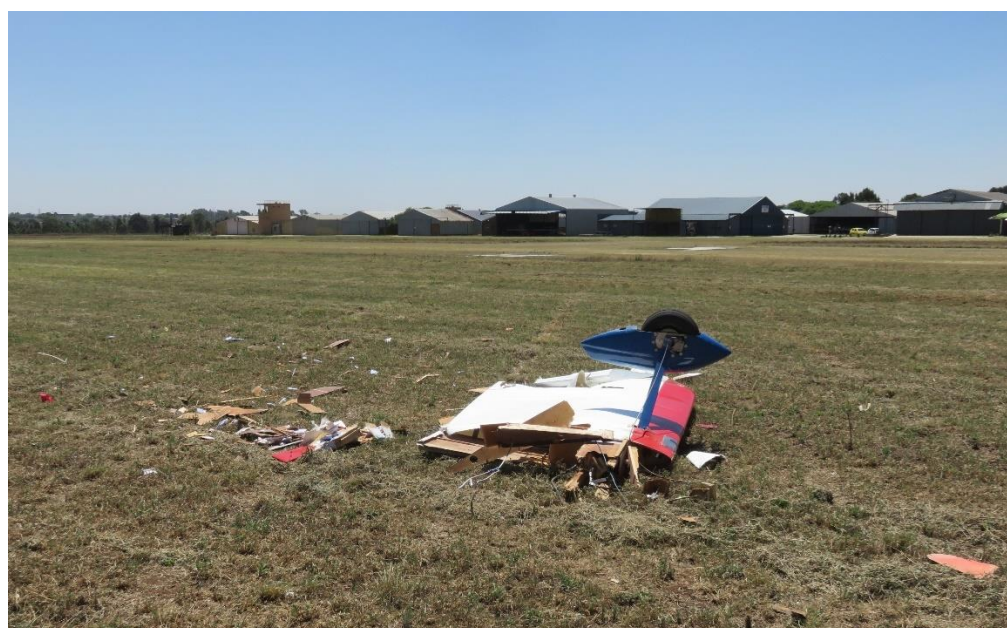
**Figure 3:** The right wing.

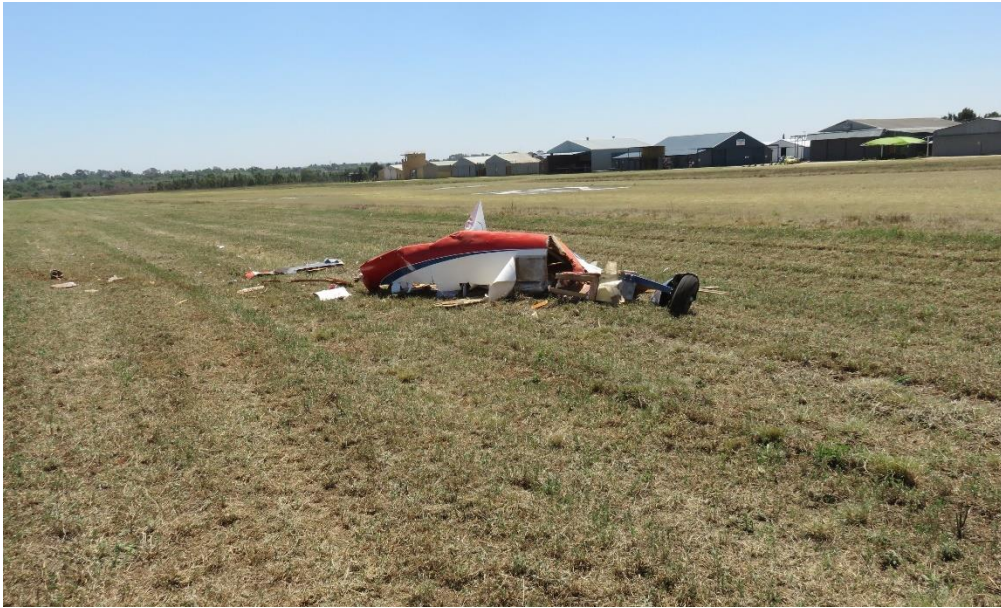
**Figure 4:** The left wing.

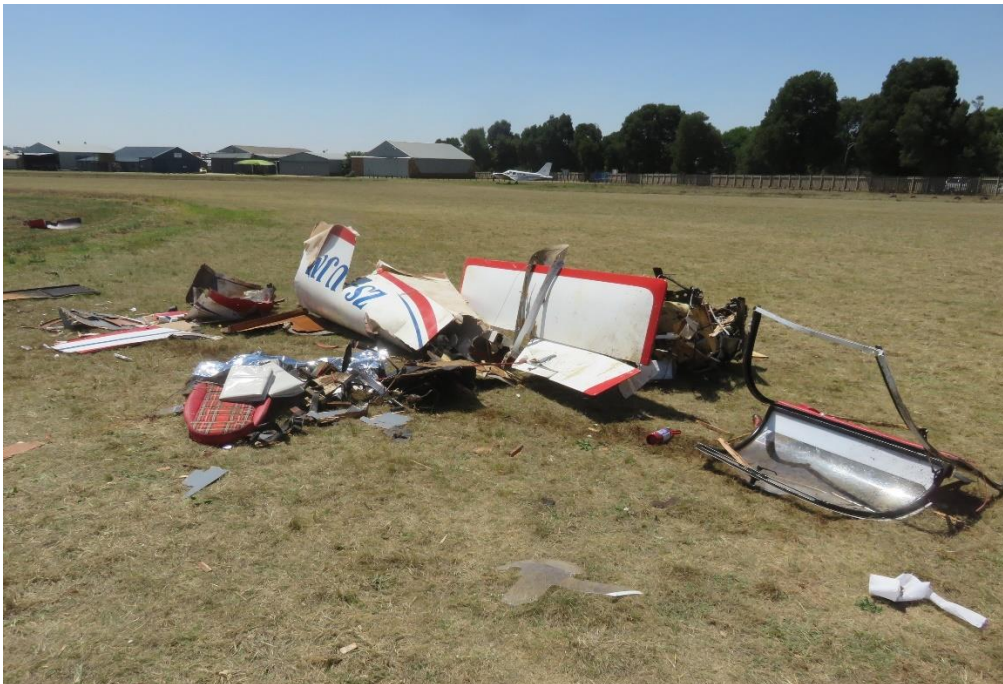
**Figure 5:** The main wreckage.

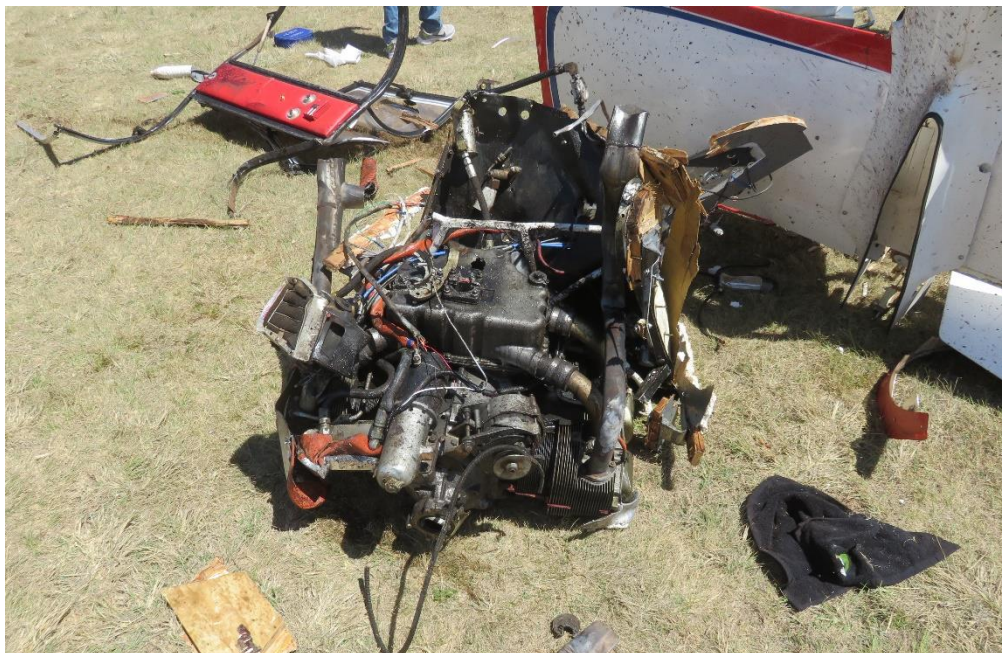
**Figure 6:** The engine in an inverted attitude with the propeller severed from the crankshaft.
