PRELIMINARY ACCIDENT REPORT

Accident and Incident Investigations Division

Accident
- Preliminary Report -
AIID Ref No: CA18/2/3/10287

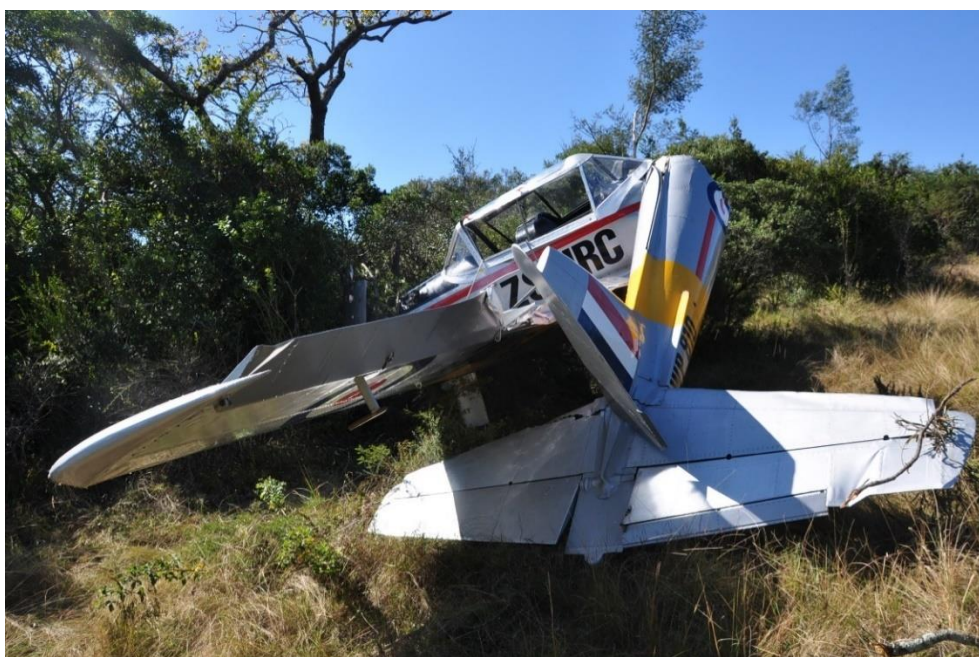
1.3.1 The aircraft sustained substantial damage.

Figure 6: The wreckage post-accident.

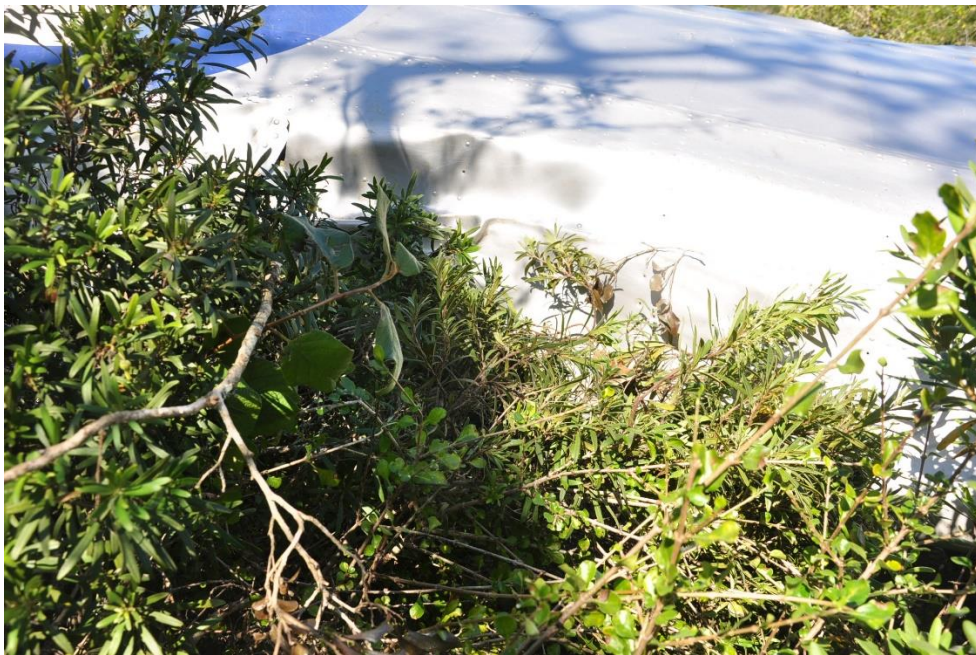
1.12.1 The aircraft impacted the trees whilst flying at an approximate heading of 003 degrees; the impact caused the aircraft to rest at a heading of 081 degrees. The right wing impacted the trees and the fuselage was torn as a result, which cause the empennage to fold and contact the left wing. The right wing sustained impact damage to the leading edge, flaps and ailerons. The left-wing flaps and ailerons were also damaged. The left horizontal stabiliser was torn due to impact forces. The rudder, horizontal stabiliser and aileron cables were checked and found to have continuity from the controls to the control surfaces. When the propeller struck the trees, the

Figure 8: Damage to the left wing.

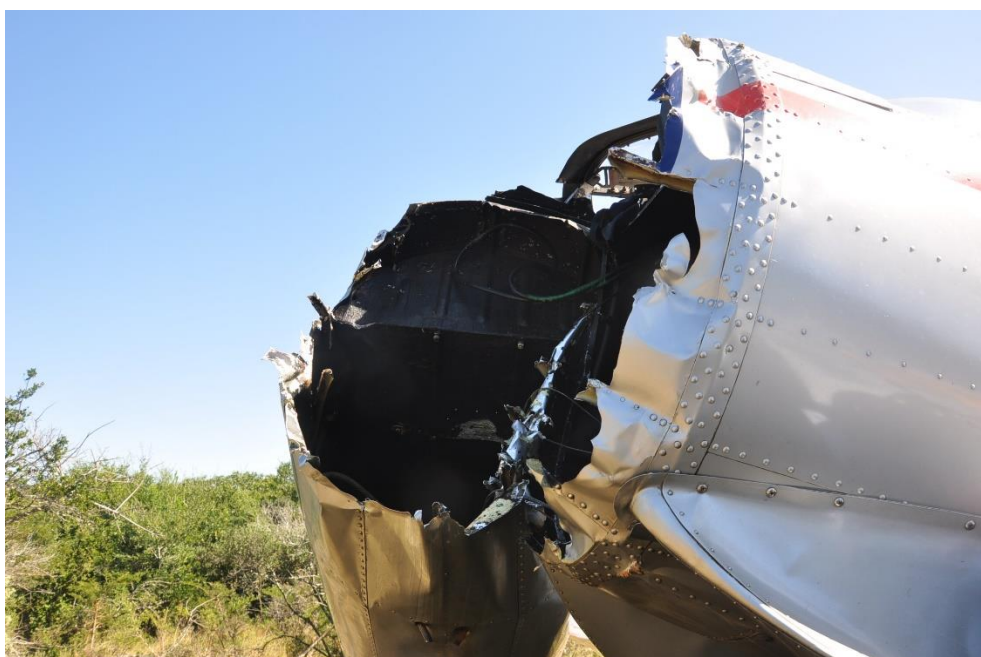
Figure 9. The torn empennage.

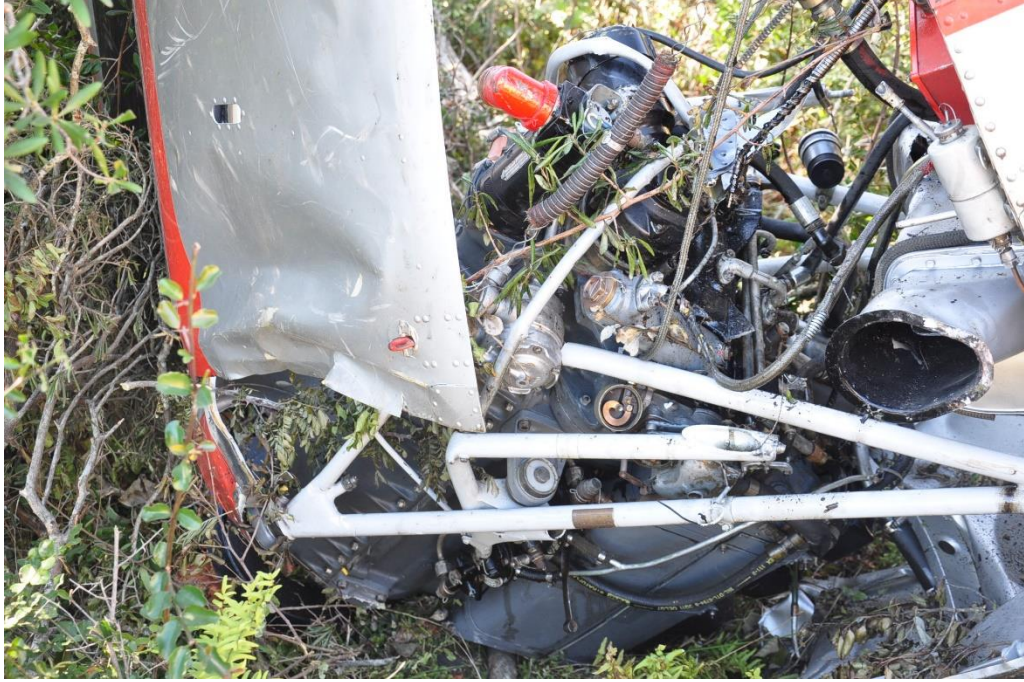
Figure 10: The engine did not separate completely from the aircraft.

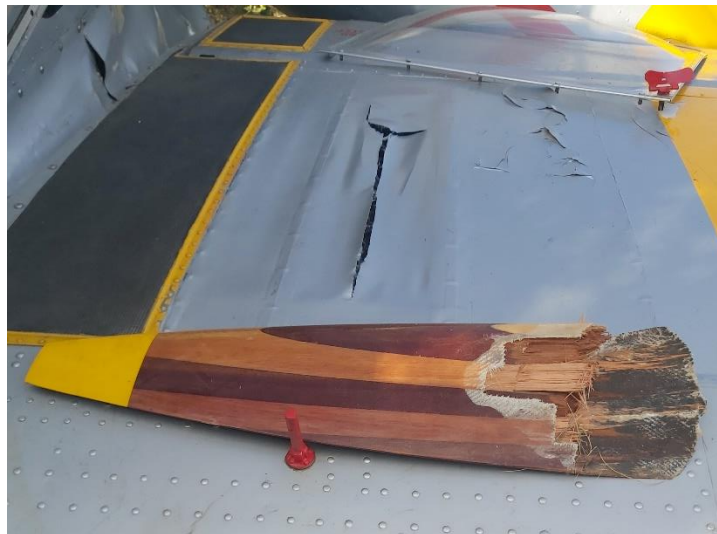
blades broke in half with one part remaining attached to the spinner. The canopy remained intact but could not be opened due to the bent rail. The pilot dislodged the Perspex glass to exit the cockpit. The pilot had also turned off all switches and levers before he made his exit.

Figure 11: The piece of the propeller that broke off.

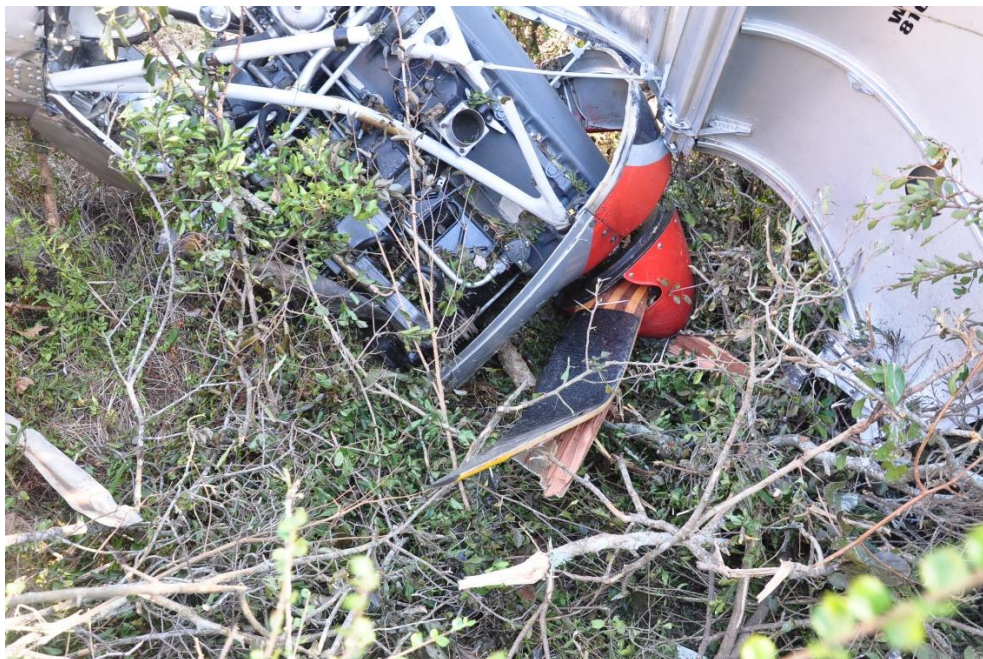
Figure 12: The piece of the propeller that remained attached to the spinner.

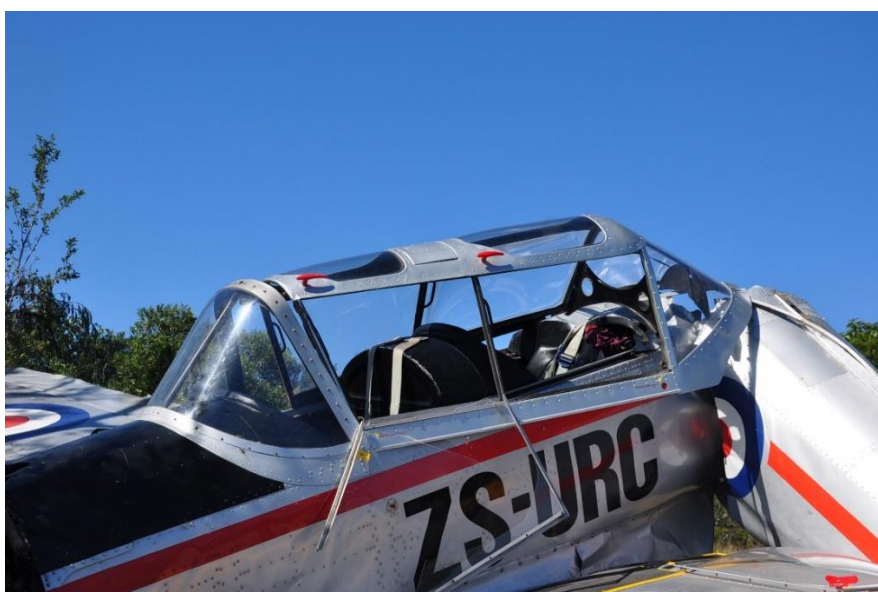
1.15.1 The accident was considered survivable because the cockpit structure was not deformed and the pilot had made use of the four-point safety harness.

Figure 13: The canopy and fuselage were still intact with only the bent canopy rail.

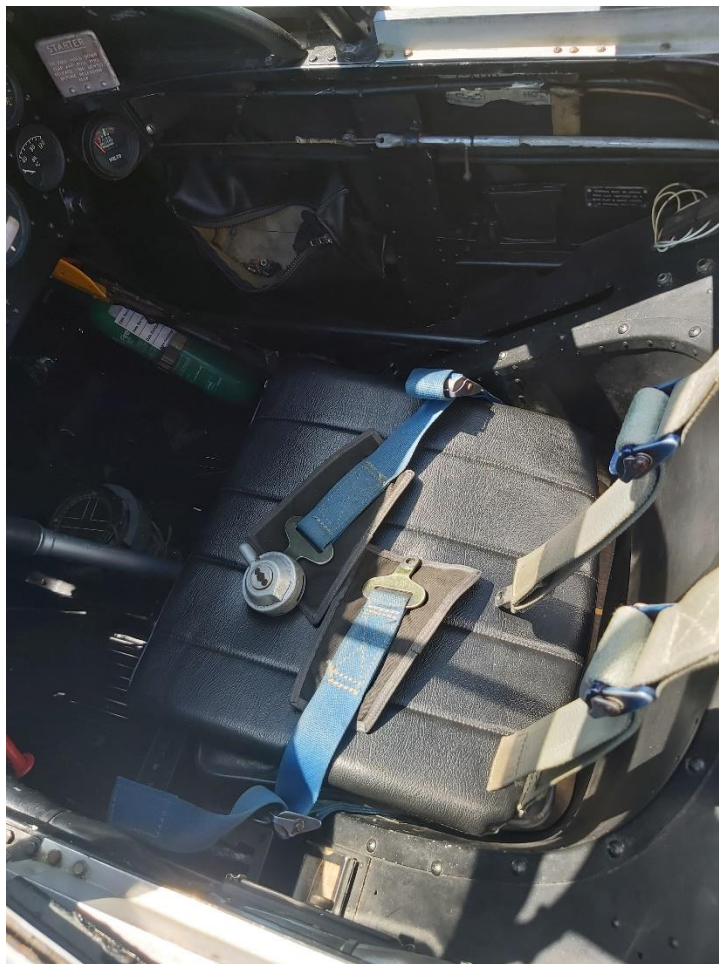
Figure 14: The four-point harness used by the pilot.
