PRELIMINARY SERIOUS INCIDENT REPORT

Serious Incident  
- Preliminary Report -  
AIID Ref No: CA18/3/2/1460

On Sunday, 27 October 2024, a Boeing 737-800 aircraft with registration ZS-ZWY was on a scheduled commercial flight SFR313 from Cape Town International Airport (FACT) in the Western Cape province to Lanseria International Airport (FALA) in Gauteng province. After landing at FALA during taxi, the right-side bearing stopped operating and the crew increased thrust to maintain taxi speed. The aircraft was brought to a stop in the parking bay. After a walk-around inspection at the parking bay, the aircraft maintenance engineer (AME) found that there was smoke which originated in the right main wheel assembly. Moreover, the right main wheel assembly showed signs of metal deposit. No person was injured during this serious incident.

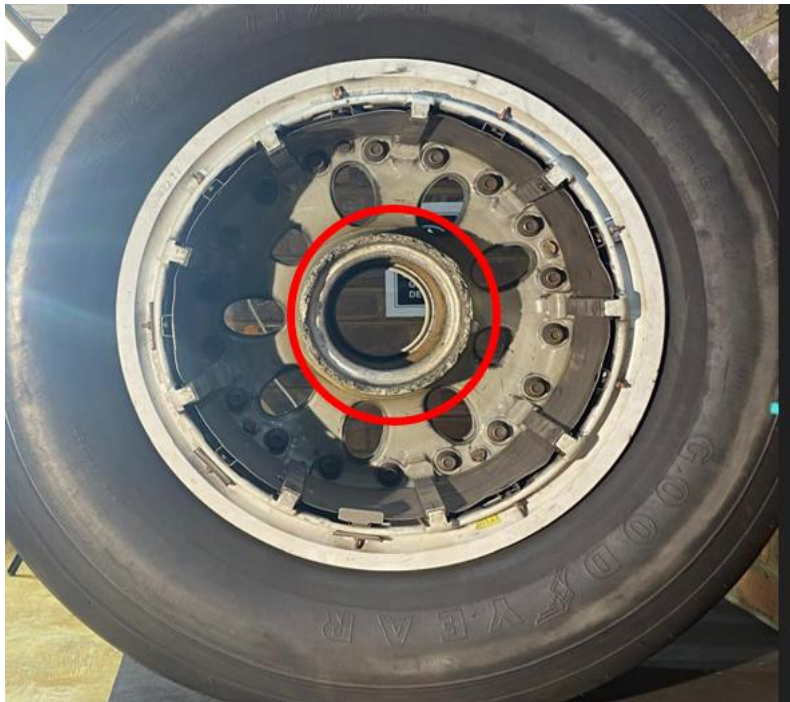
1.3.1 The Number 4 main wheel assembly's inboard hub and the bearing were damaged.

**Figure 3:** The red circle indicates the location of the damage.

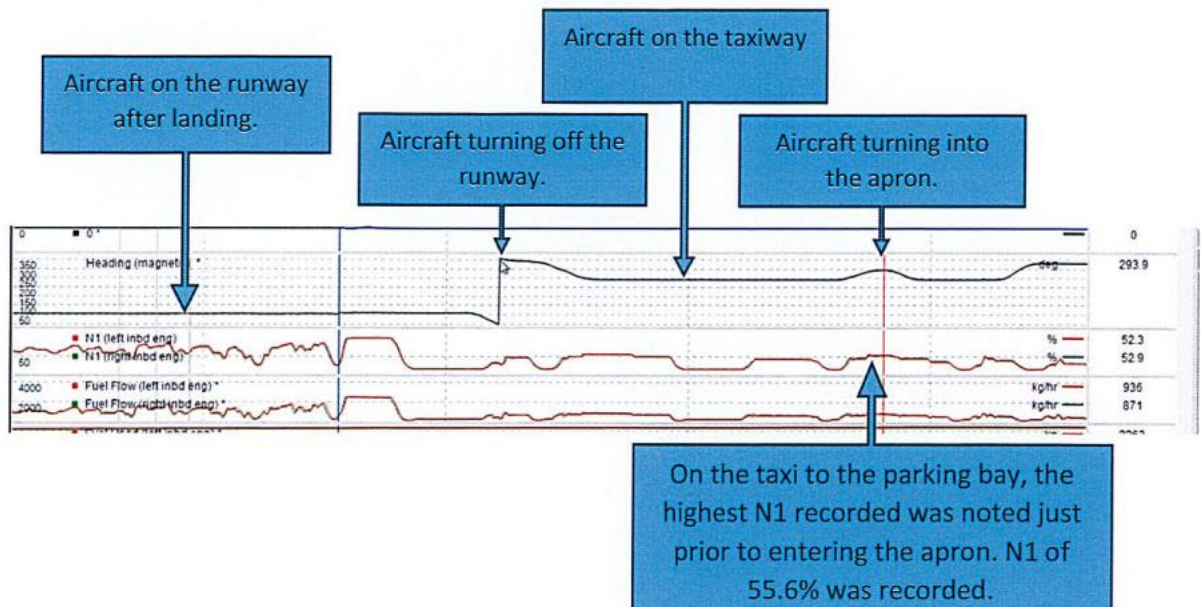
**Graph 1:** The downloaded QAR data.

Taxi N1- 36% to 56% - normal for undulated taxiway and turns to apron (see Graph 1).

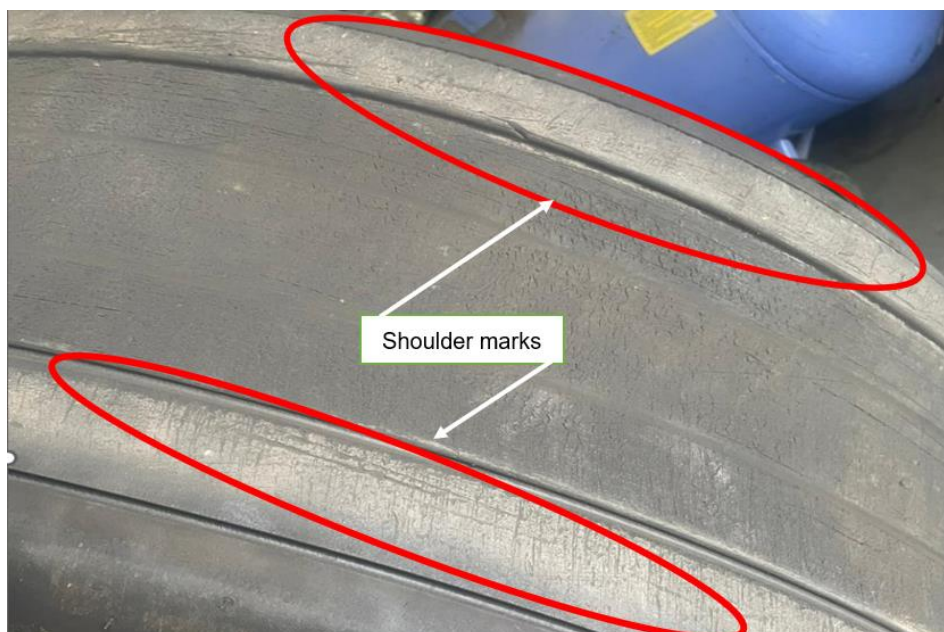
1.12.2 The Number 4 tyre exhibited signs of deflation.

**Figure 4:** The shoulder marks on the Number 4 main tyre shoulder.

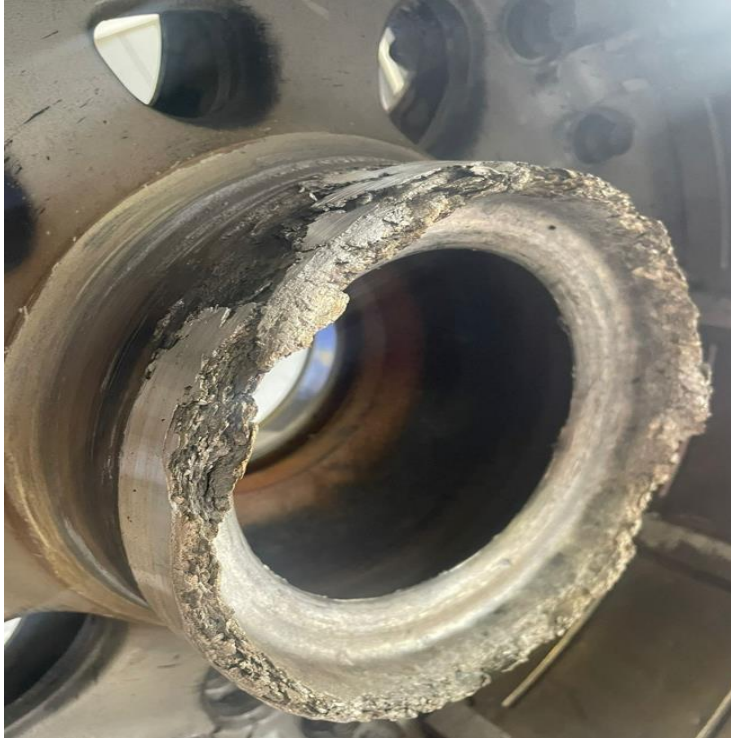
1.12.3 The Number 4 inboard hub exhibited multiple fractures and had a yellowish discoloration.

**Figure 5:** The fractured Number 4 hub.

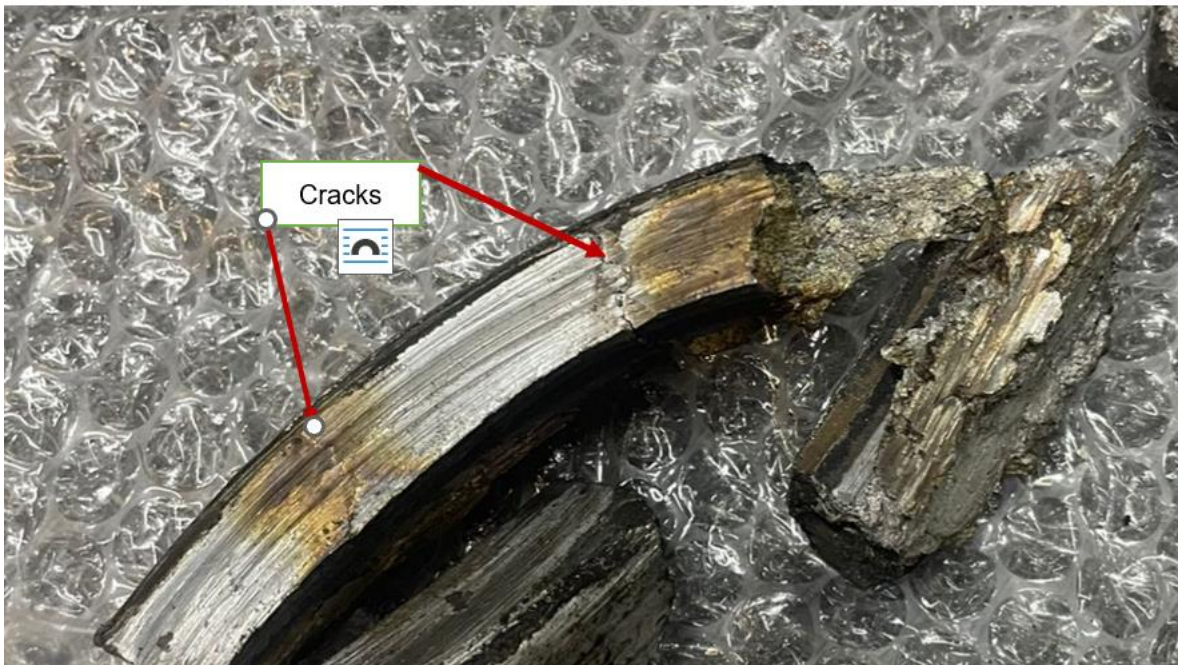
1.12.4 The broken hub pieces had cracks as well as a yellowish discoloration.

**Figure 6:** The fractured pieces of the hub.

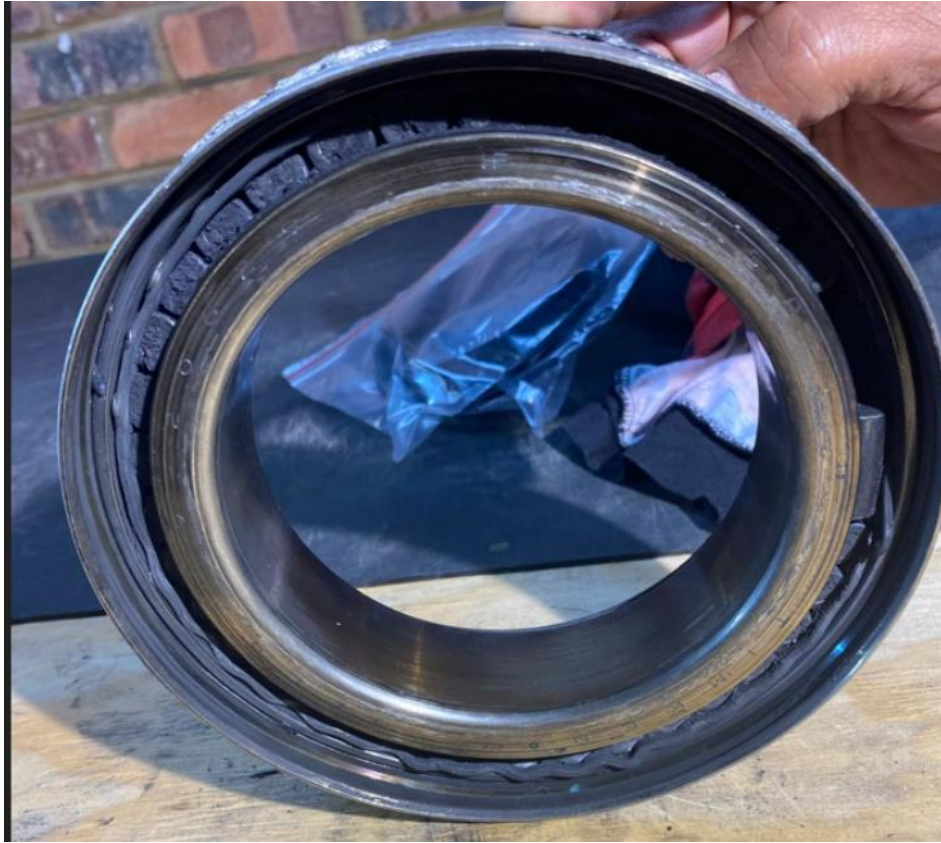
1.12.5 The Number 4 inner bearing exhibited signs of overheating which included discoloration and surface damage.

**Figure 7:** The number 4 inner bearing.

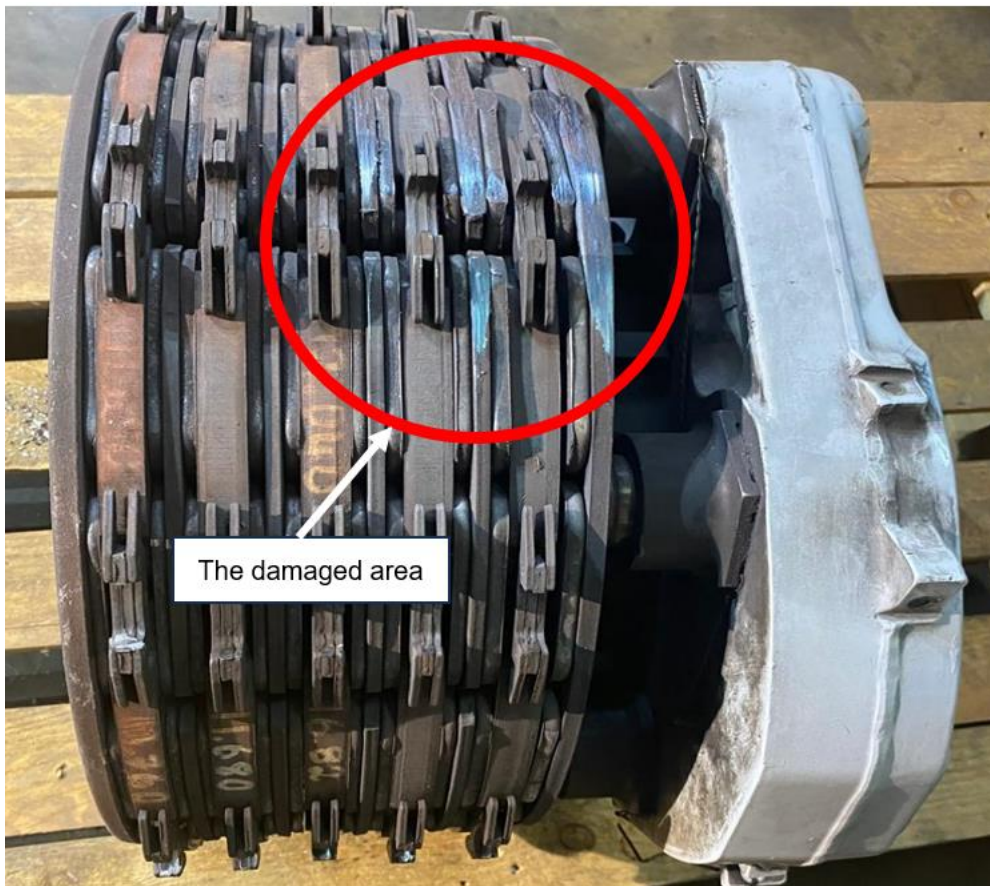
1.12.6 The Number 4 brake assembly showed signs of damage.

**Figure 8:** The Number 4 brake unit assembly.

2.2.13 The Number 4 main wheel assembly was damaged. The bearing was also damaged and had stopped operating; both the bearing's inner hub and the brake unit assembly were damaged as the main wheel assembly experienced difficulty during taxi.
