FACTUAL ACCIDENT REPORT

Accident
- Factual Report -
AIID Ref No: CA18/2/3/10380

Reference Number : CA18/2/3/10380
Occurrence Category : Category 1
Type of Operation : Private (Part 91)
Name of Operator : West Dunes Aviation (PTY) LTD
Helicopter Registration : ZT-RBU
Helicopter Make and Model : Robinson 44 Raven II
Nationality : South African
Place : Marataba Mountain Lodge, Limpopo Province
Date and Time : 26 October 2023 at 0356Z
Injuries : None
Damage : Substantial

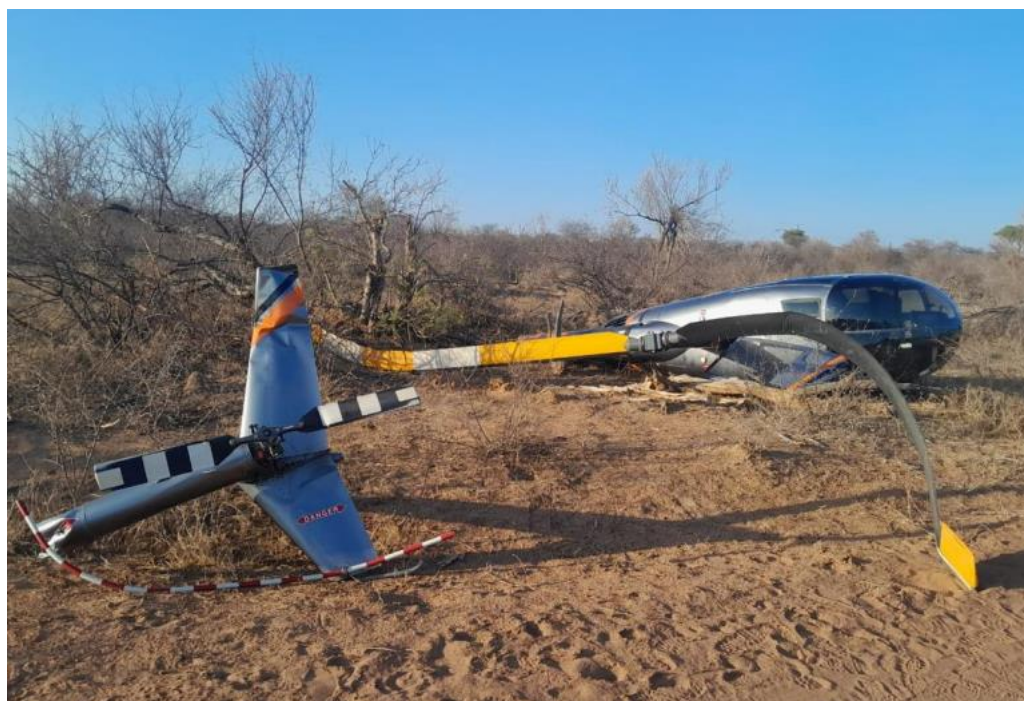
Figure 1: The helicopter after impact with the ground.

- 1.1.3 During the final approach phase at a height of approximately 50 feet above ground level (AGL) (*observed from the video footage of the last 8 seconds of the flight*), the engine failed and the low rotor revolutions per minute (RPM) warning light illuminated on the instrument panel, followed by the aural warning. The pilot entered an auto rotational flight at a height he had available, and performed a forced landing. The helicopter touched down hard on the ground. During impact with the ground, the skid gear broke off and the main rotor blades severed the tail boom; the helicopter flipped over and came to rest on its right side. The helicopter was substantially damaged, and the occupants were not injured.

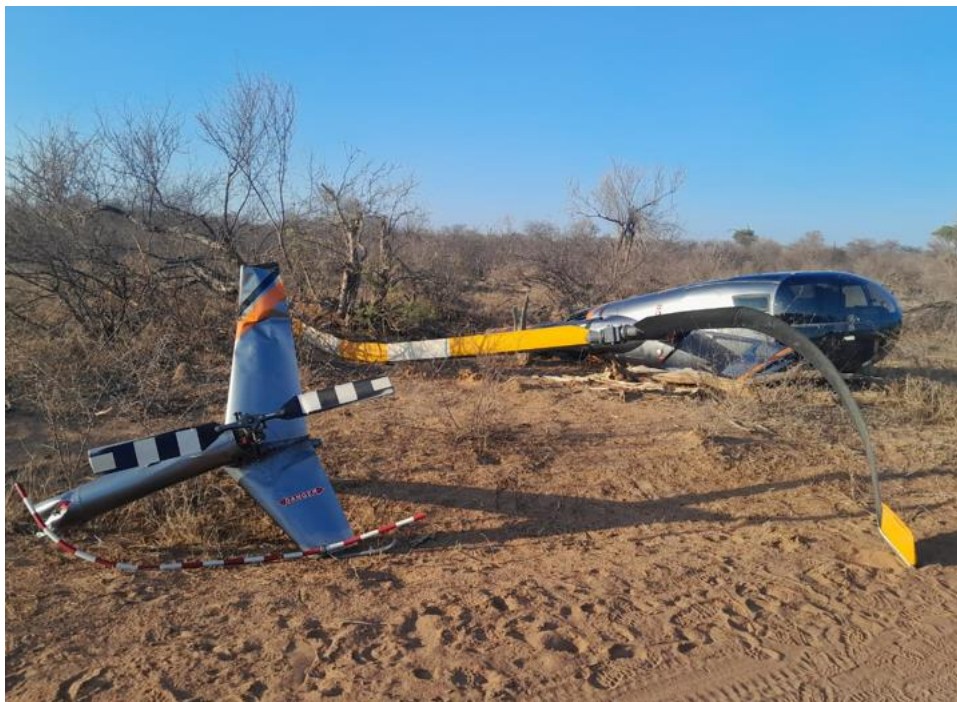
1.3.1 The helicopter sustained substantial damage.

Figure 3: The helicopter as it came to rest. (Source: Pilot)
