PRELIMINARY ACCIDENT REPORT

Accident and Incident Investigations Division

Accident
- Preliminary Report -
AIID Ref No: CA18/2/3/10633

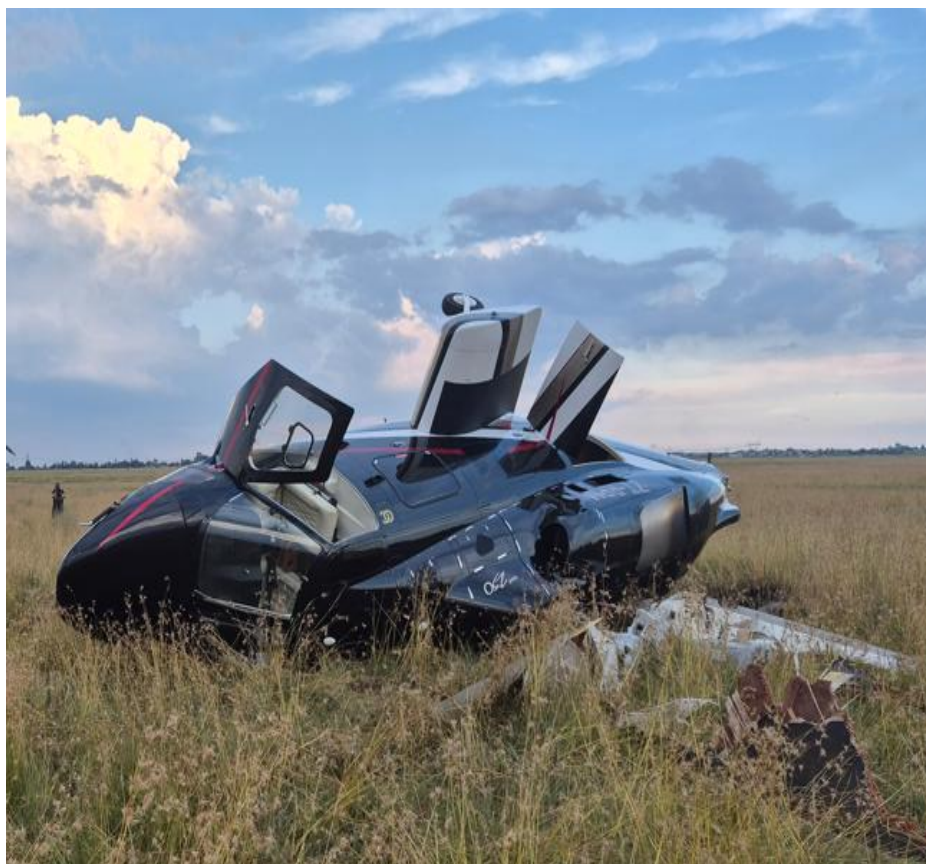
Figure 3: The helicopter at the accident site.

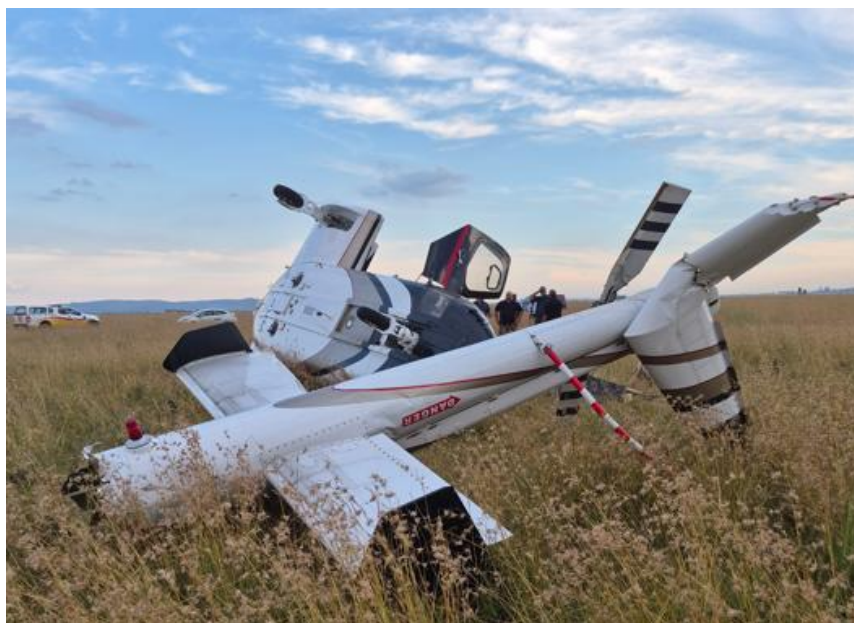
1.3.1. The helicopter was substantially damaged.

Figure 4: The helicopter with the broken tail boom.

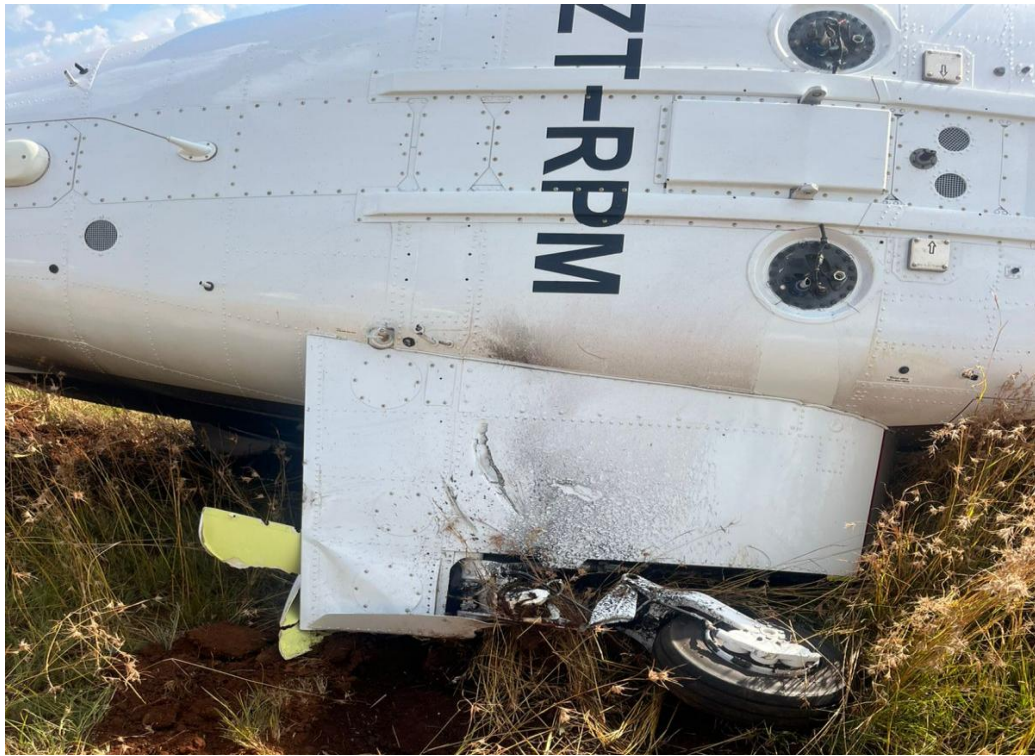
1.12.1 The accident occurred at the helicopter general flying area (GFA) near Alberton, approximately 1.3 kilometres from Panorama Airfield. All major components were present at the site, which indicated that nothing of significance had broken off from the helicopter prior to the first impact. The helicopter impacted the ground hard with the main landing gears/wheels and rolled to the left. The main landing gears were substantially damaged, and the propeller blades severed the tail boom. Both engines remained attached to the airframe; the cockpit cabin area and the windshield also remained intact. All doors remained attached to the airframe. The bladder fuel tanks contained sufficient Jet A1 fuel after the accident.

Figure 5: The damaged left main wheel.

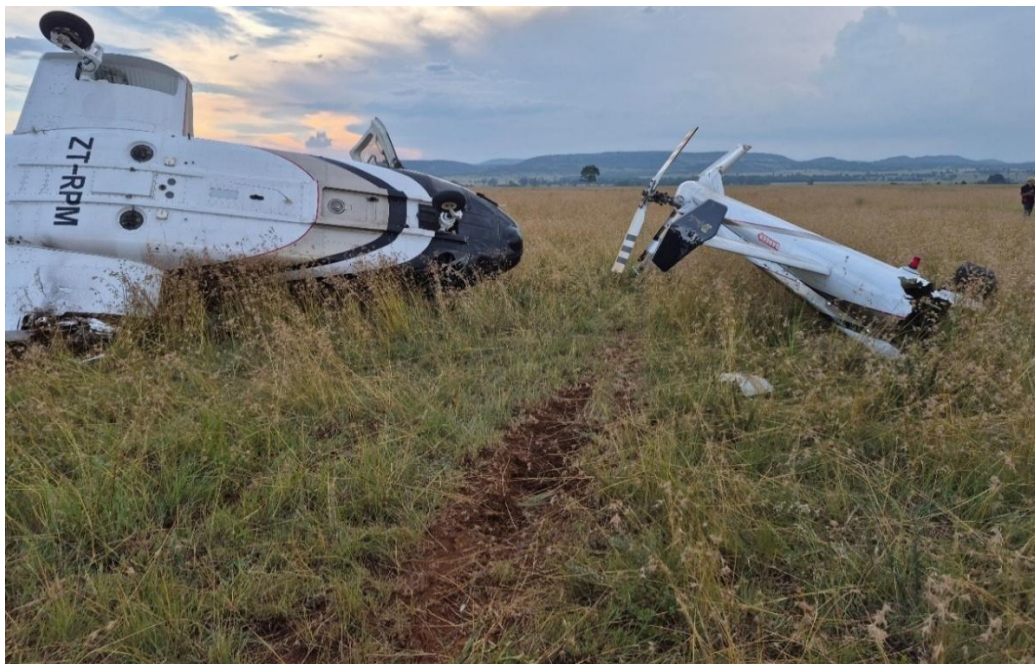
Figures 6: Witness marks impressed by the tail rotor.

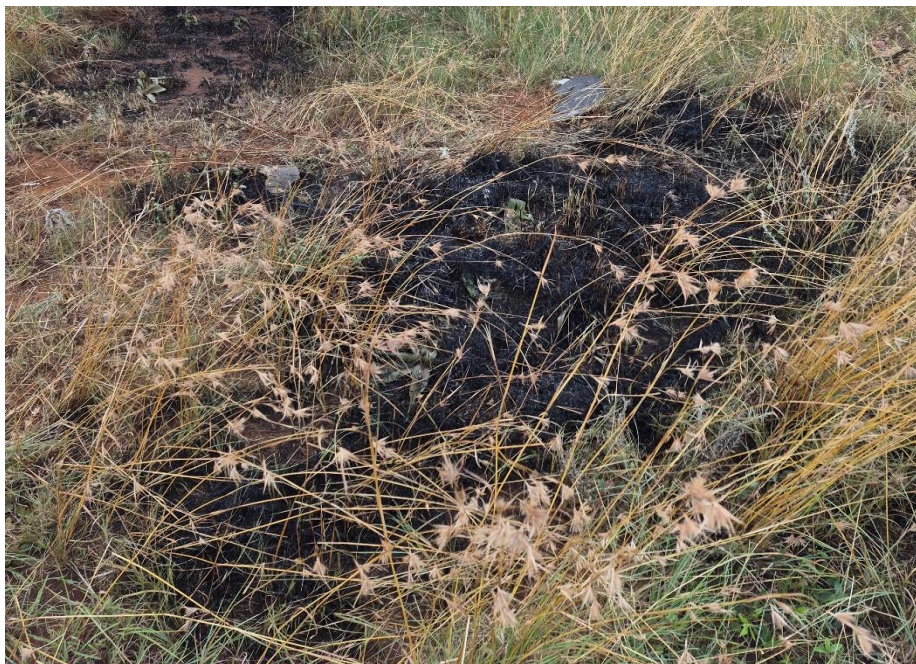
1.14.1 A post-impact fire ensued after the accident; the pilot used the helicopter's portable fire extinguisher to douse it.

Figures 7: Burnt vegetation at the accident site.
