PRELIMINARY ACCIDENT REPORT

Accident and Incident Investigations Division

Accident
- Preliminary Report -
AIID Ref No: CA18/2/3/10439

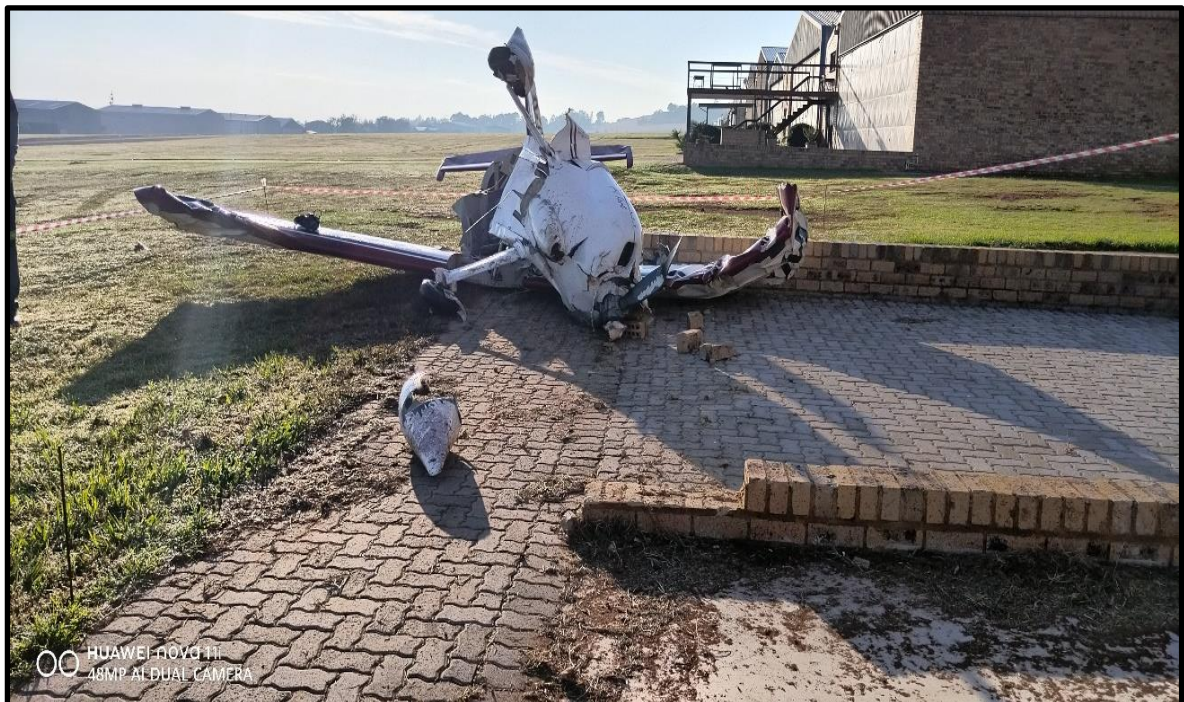
- 1.3.1 The fuselage was cut open at the pilot's cockpit side to rescue the pilot as he was trapped inside.

Figure 3: The aircraft after the accident.

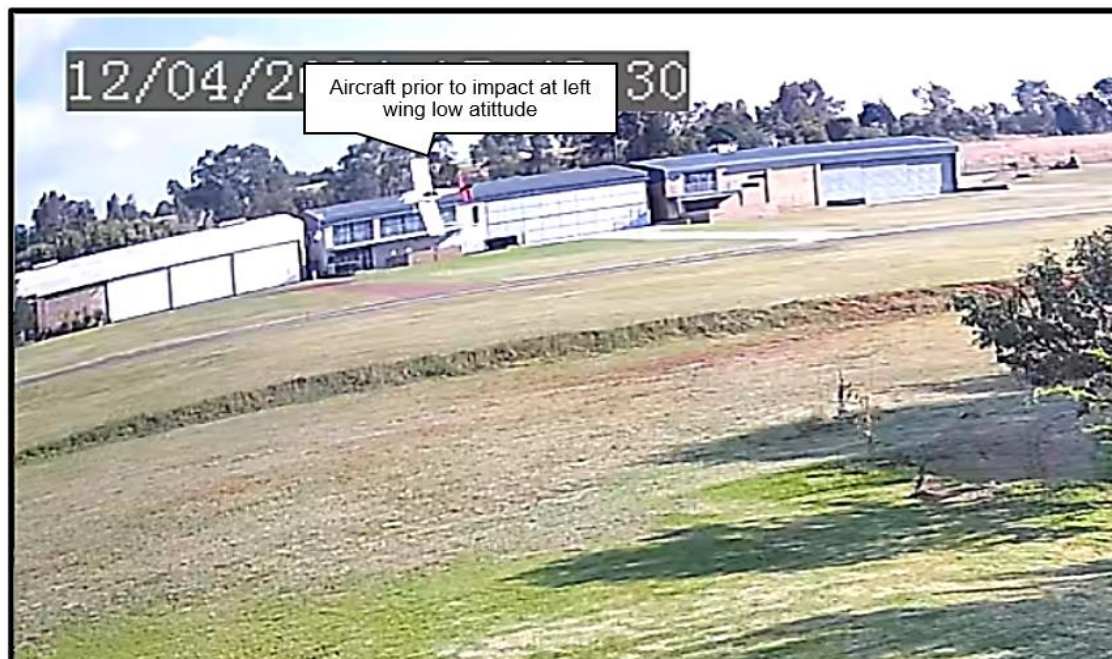
Figure 4: The aircraft before impact. (Source: Aerodrome video footage)

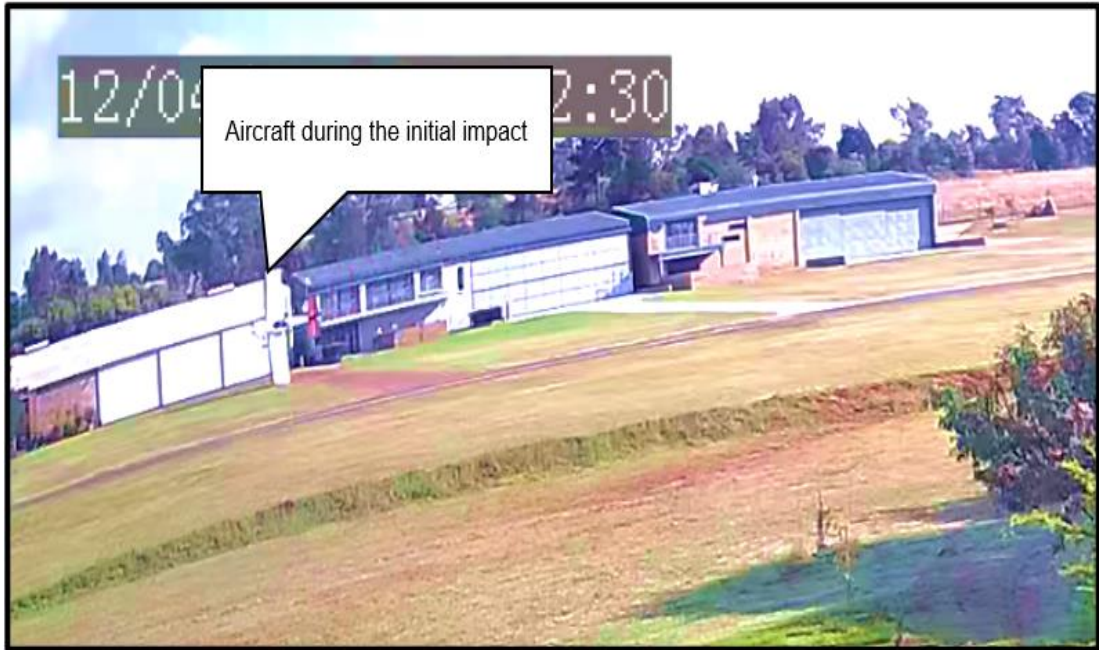
- The aircraft's initial impact was on a paved surface. The first impact was with the left-wing tip fairing as it was in a left-wing low and a slightly nose-down attitude. After impact, the aircraft tumbled forward which caused the propeller and the nose to impact the ground.

Figure 5: The aircraft as it impacted the ground with the left wing.
(Source: Aerodrome video footage)

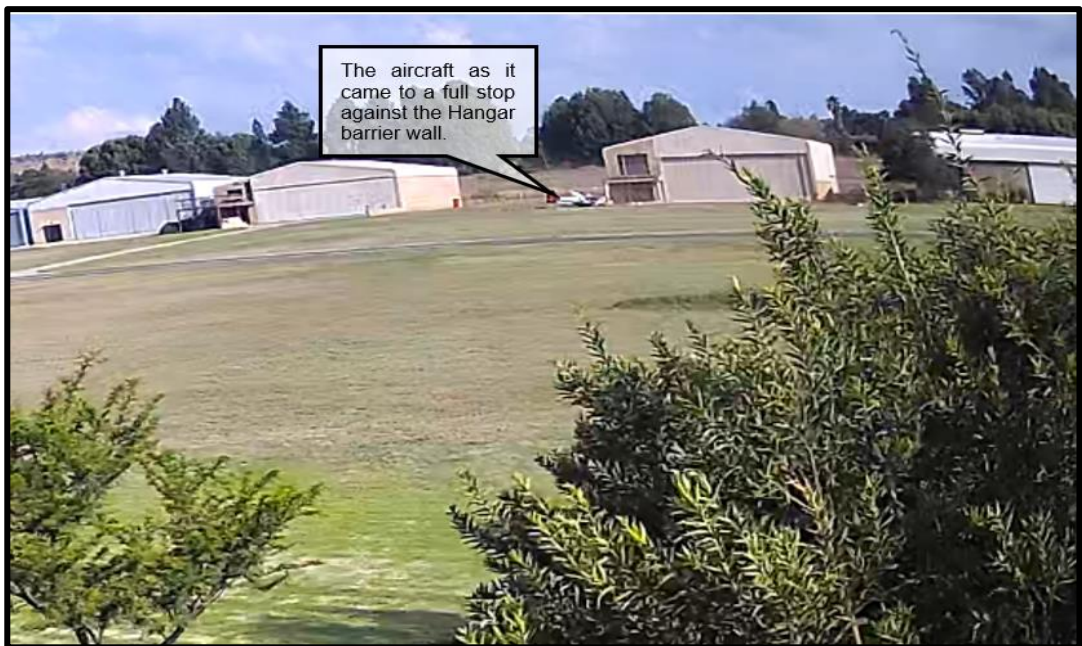
Figure 6: The aircraft against the hangar barrier, facing the opposite direction from which it had approached. (Source: Aerodrome video footage)

- The aircraft's tail turned 180° which caused the aircraft to face the opposite direction of approach; it skidded on the ground before it came to rest against the hangar's extended barrier.

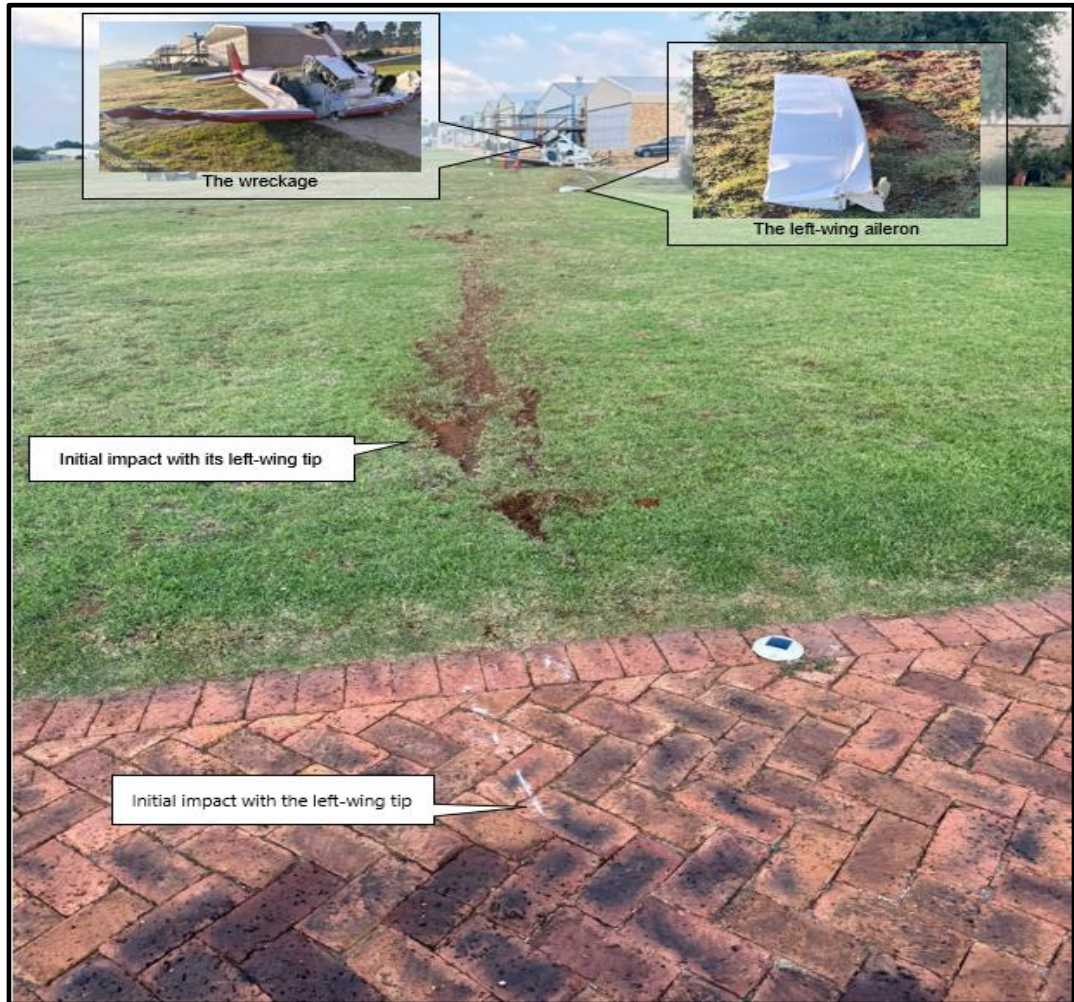
Figure 7: Wreckage impact marks and distribution.

- The impact marks on Figure 7 indicated that the aircraft initially impacted the paved area lightly with its left-wing tip which created folds due to the aircraft's weight. The aircraft tumbled forward, and as the nose got closer to the ground, the propeller impacted the ground three times, confirming that the engine was delivering a substantial amount of power at the time of impact.

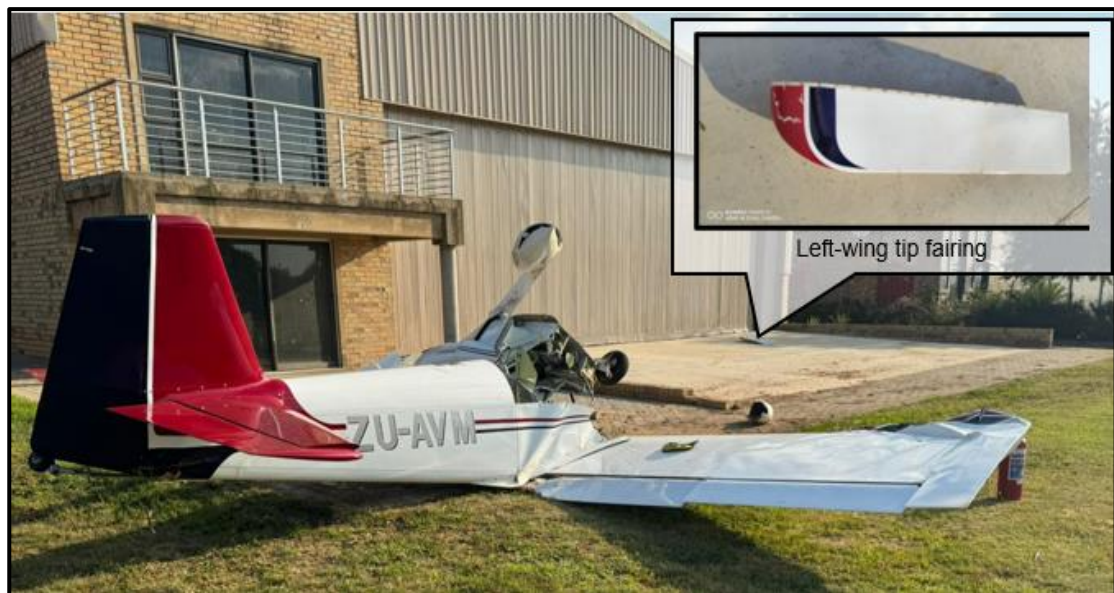
Figure 8: The wreckage after the pilot was rescued.

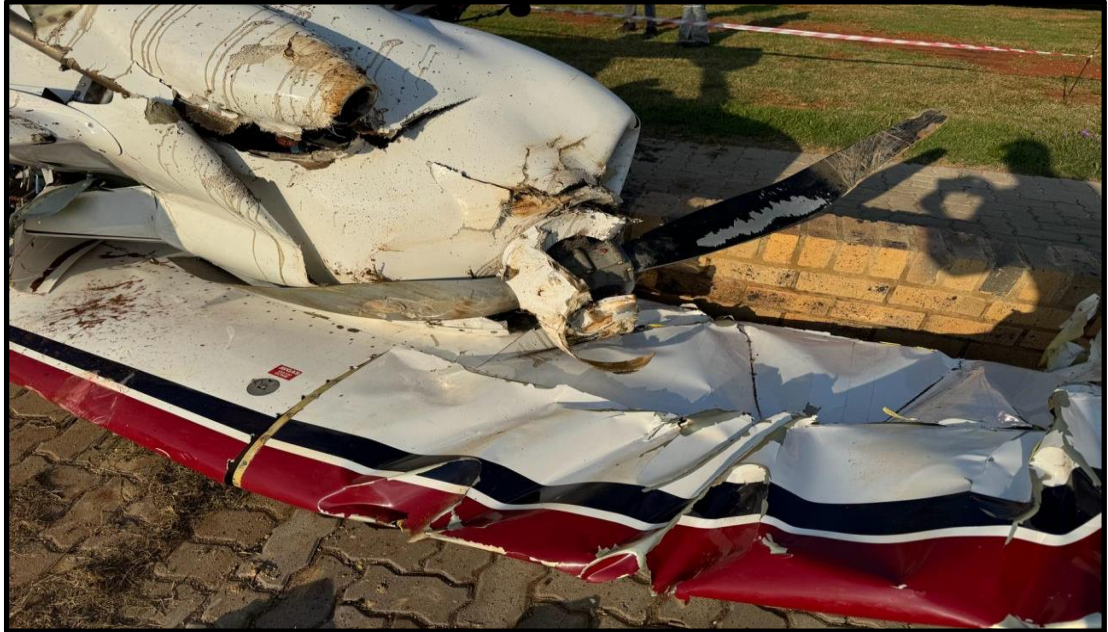
1.12.2 The right-wing leading edge was damaged; however, it remained intact. The aircraft's wing tanks were intact, but the fuel transfer pipelines were severed during the accident sequence; this caused fuel to leak. The propeller blades had signs of impact damage as they were turning with rotational energy at the time of the accident. The cockpit section was cut during rescue of the pilot. Both wings were damaged; the left wing was extensively damaged as it had folds after the initial impact; both ailerons, flap and wing-tip fairing separated from the fuselage.

Figure 9: The damaged propeller and left wing.
