**PRELIMINARY ACCIDENT REPORT**

**Accident and Incident Investigations Division**

Accident  
- Preliminary Report -  
AIID Ref No: CA18/2/3/10450

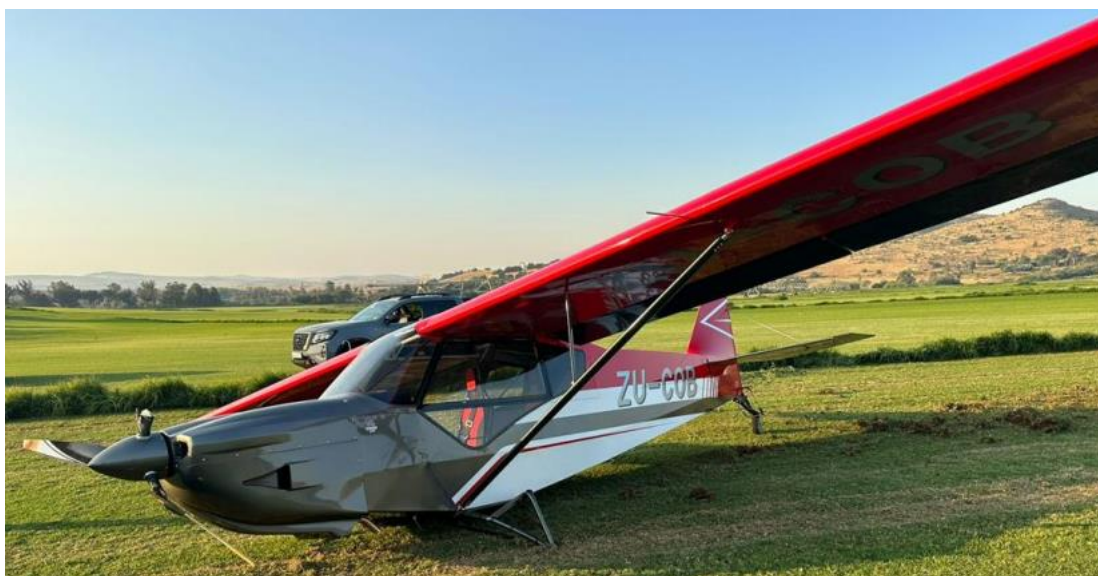
- 1.1.5. During the landing roll, the left main landing gear rolled over a trench and broke off. Moreover, one of the wooden propeller blades also broke off.

1.12.1. As the pilot rolled the aircraft out of a turn, the engine stopped; he attempted to restart the engine but was unsuccessful. He conducted a precautionary landing on the farm approximately 2km north of FAKR after deducing that he would not make it to the aerodrome. During the landing roll, the left main landing gear rolled over a trench and broke off. One of the wooden propeller blades broke off.

**Figure 3:** The aircraft at the accident site. (Source: Operator)
