PRELIMINARY ACCIDENT REPORT

Accident and Incident Investigations Division

Accident
- Preliminary Report -
AIID Ref No: CA18/2/3/10462

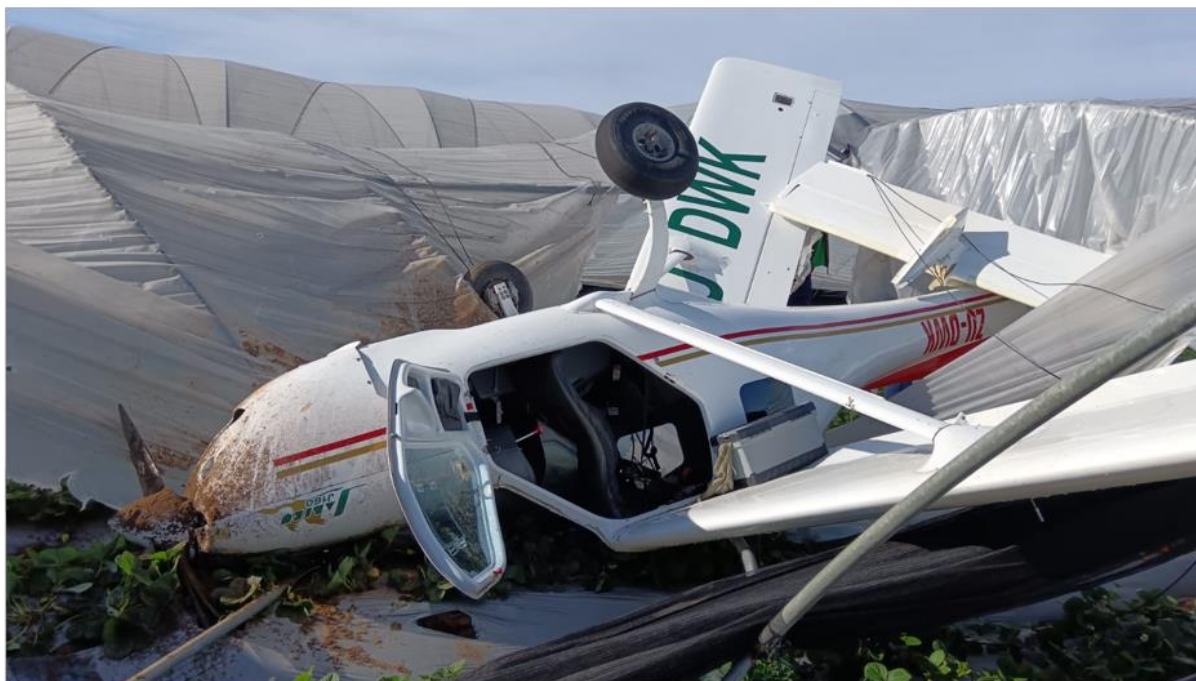
- 1.3.1. The aircraft sustained substantial damage to the fuselage, wings, landing gears and the propeller due to the impact force. The horizontal and the vertical stabilisers were also damaged on impact with the ground.

Figure 3: The aircraft's resting position after the accident. (Source: Pilot)

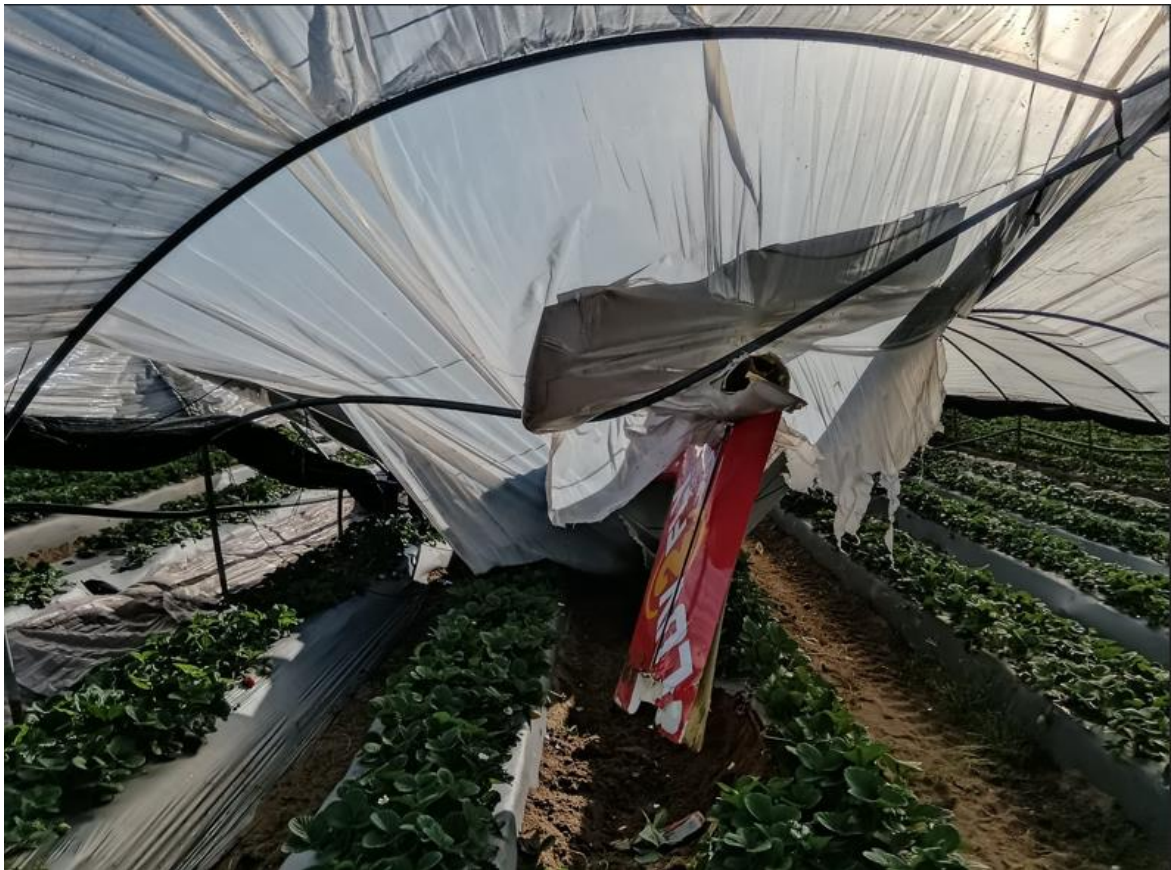
- 1.4.1. The strawberry crops and the cover material were damaged during the accident sequence.

Figure 4: The torn strawberry cover material. (Source: Pilot)

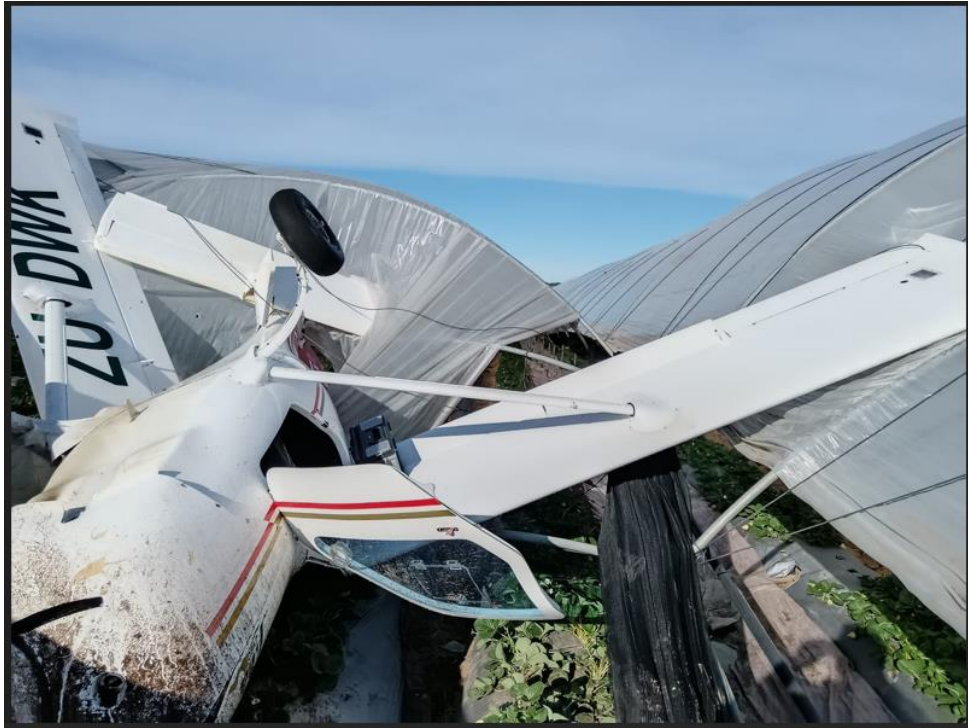
1.12.1. During the initial climb from Runway 01, the aircraft lost engine power and the pilot forced landed the aircraft. However, it landed on a strawberry farm and damaged the crops and the cover that protected the strawberries. The aircraft sustained damage to the fuselage, wings, landing gears and the propeller due to the impact force. The horizontal and the vertical stabilisers were also damaged on impact with the ground.

Figure 5: The damaged fuselage and wings. (Source: Pilot)

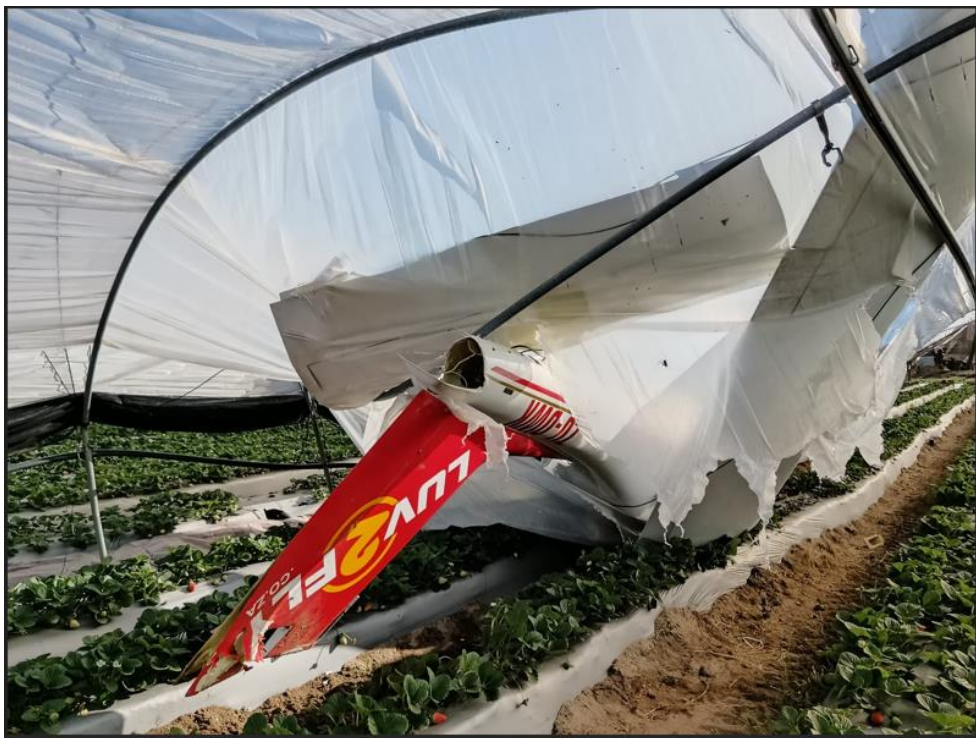
Figure 6: The damaged vertical and horizontal stabilisers. (Source: Pilot)

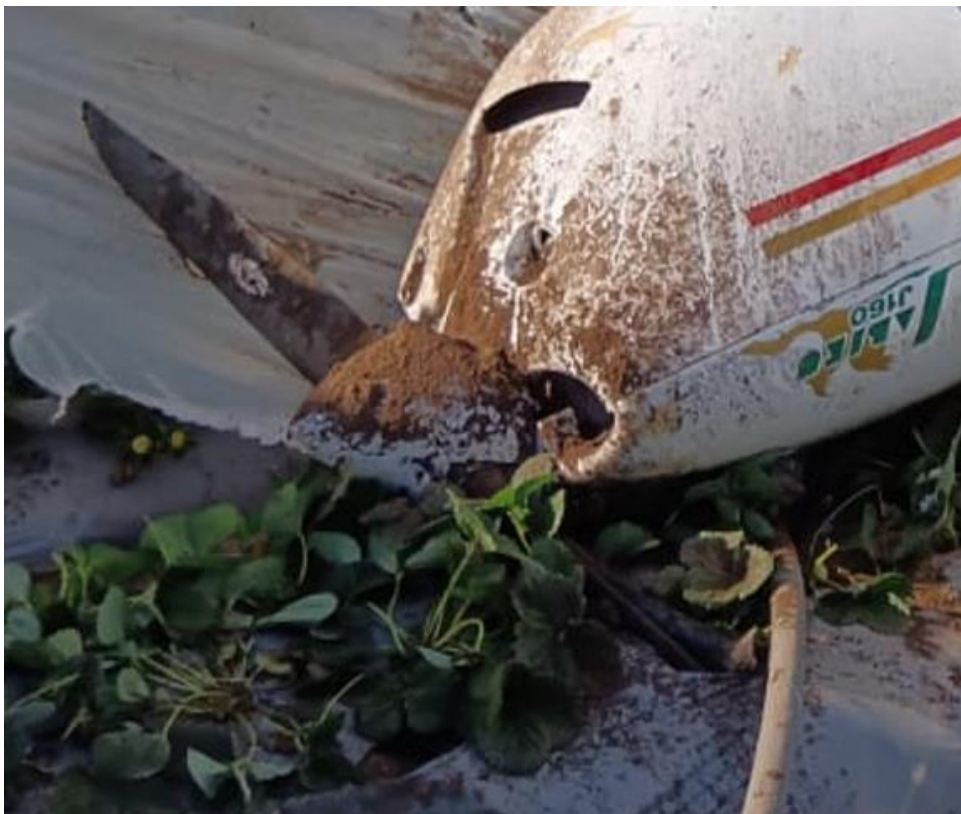
Figure 7: The position of the propeller indicates that the engine was not turning when it impacted the ground. (Source: Pilot)

- 2.2.9 The engine revolutions per minute (RPM) had decreased from 2960 to 1390 during the initial climb, and the engine power decreased.
