PRELIMINARY ACCIDENT REPORT

Accident and Incident Investigations Division

Accident
- Preliminary Report -
AIID Ref No: CA18/2/3/10533

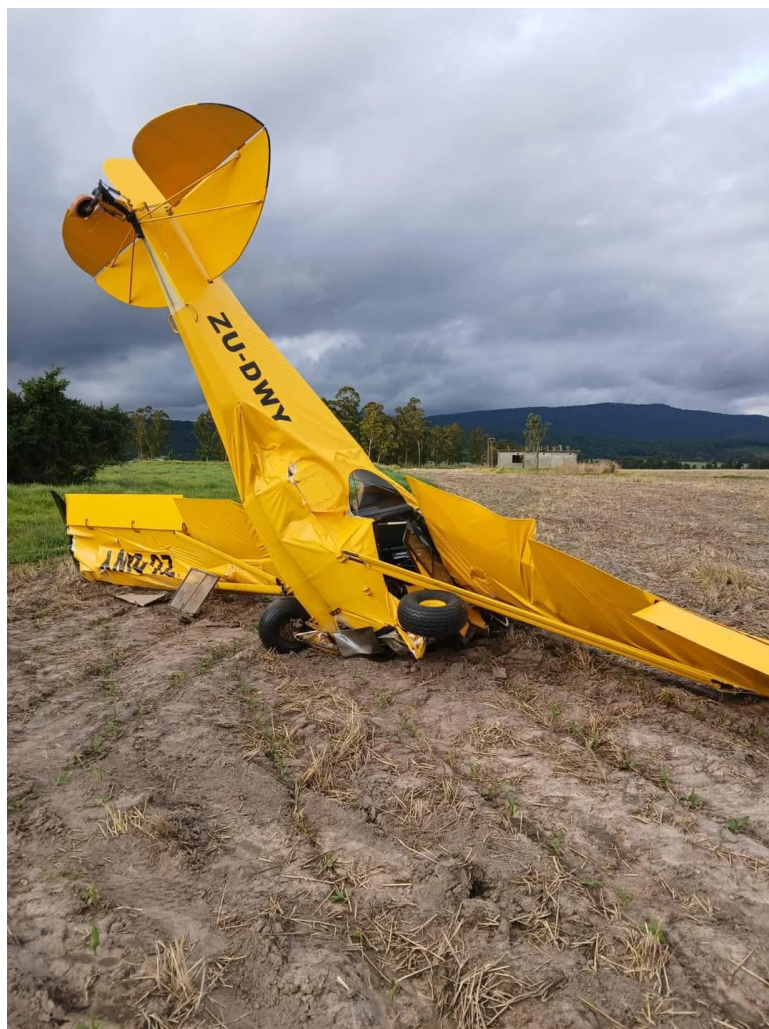
Figure 1: The aircraft after the accident. (Source: Operator)

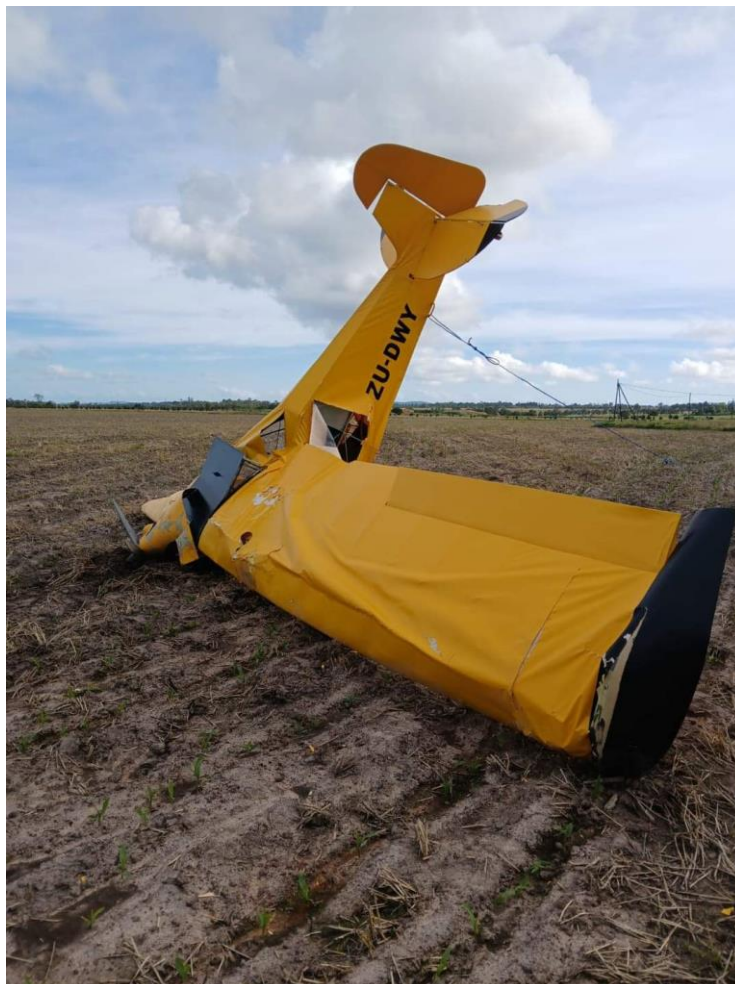
1.3.1 The aircraft sustained substantial damage during impact with the ground.

Figure 3: The aircraft in its resting position after the accident.

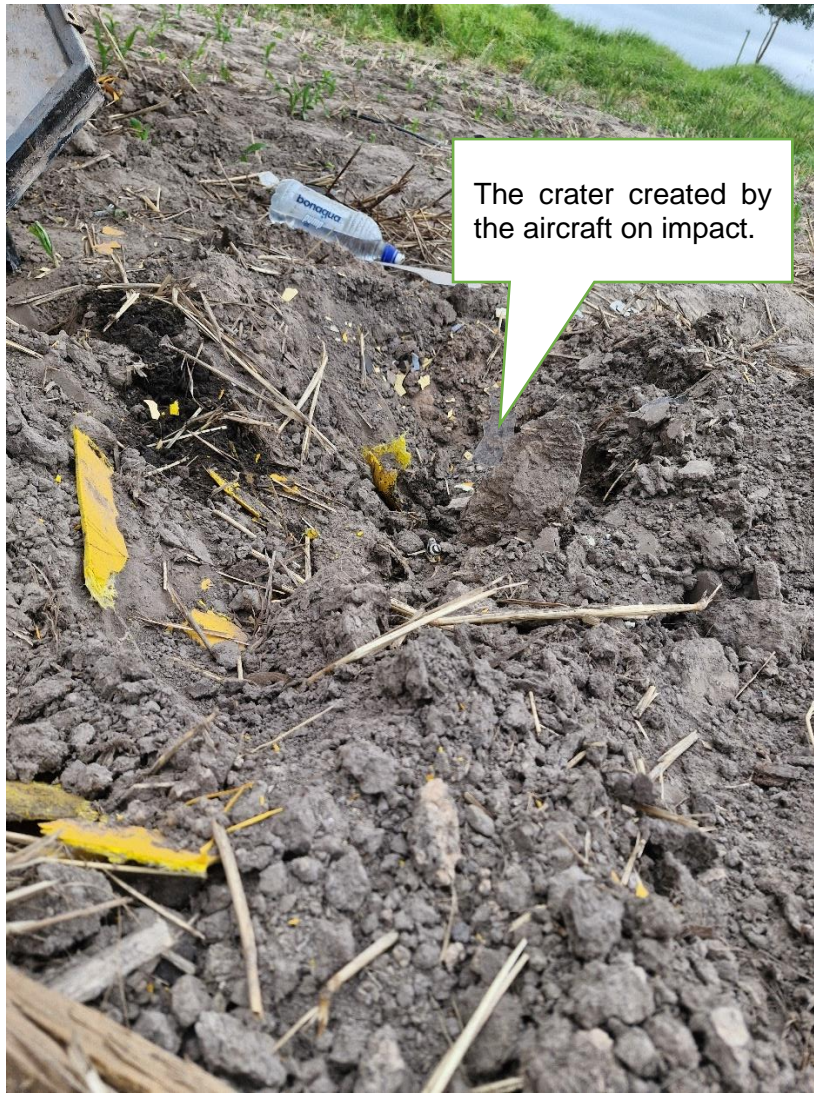
1.12.1 The aircraft impacted the ground in a nose-down attitude; it faced east. It remained in a nose-down attitude after the crash. One of the propeller blades was bent.

Figure 4: The aircraft's impact point.

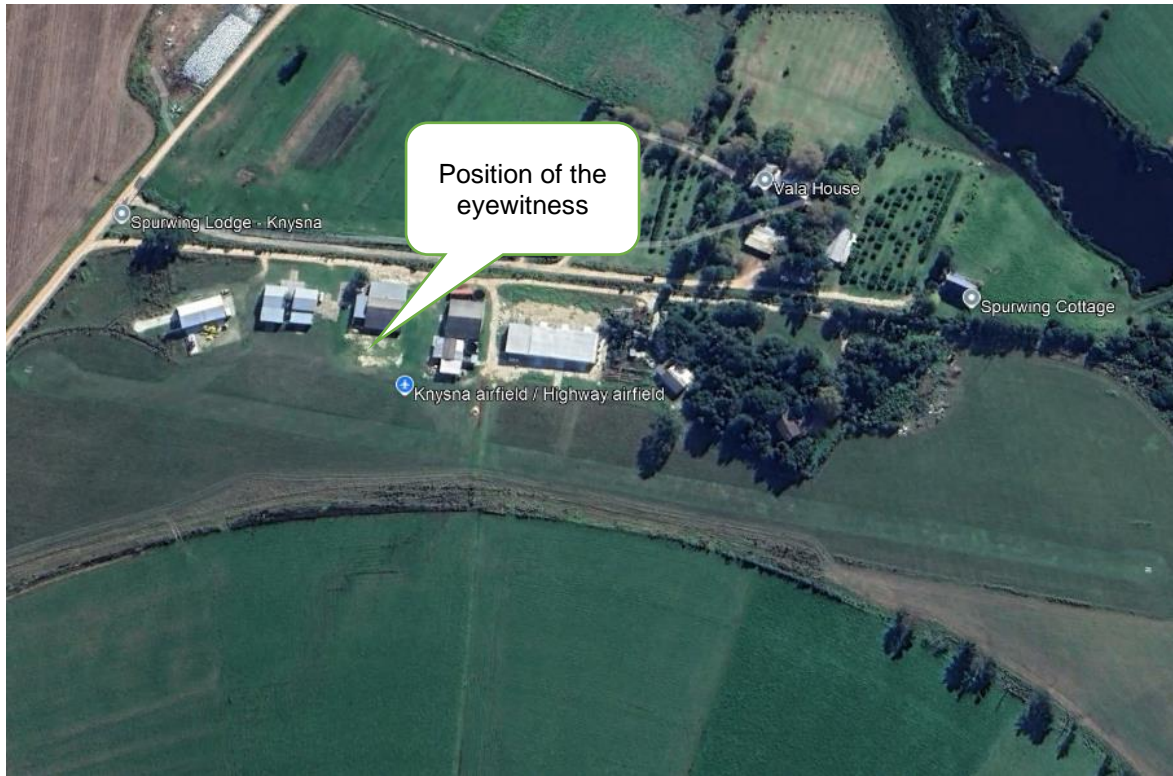
Figure 5: The eyewitness position.
