PRELIMINARY ACCIDENT REPORT

Accident
- Preliminary Report -
AIID Ref No: CA18/2/3/10221

On 30 November 2022, a pilot and a passenger on-board a Gyrocopter ELA 08 with registration ZU-DYV were engaged in circuit flying on Runway (RWY) 03 at Springs Aerodrome (FASI) in Gauteng province. During a late right base leg whilst the gyrocopter was airborne for approximately 45 minutes and overhead the quarry in Brakpan, the engine stopped without warning. The pilot decided to perform a forced landing on the road adjacent to the quarry. During the landing roll, the main rotor blades struck the trees and one of the blades separated from the hub. This resulted in the gyrocopter rolling over twice along its lateral axis before coming to rest on its left side. Both occupants were injured during the accident sequence—the pilot was airlifted to the hospital whilst the passenger was transported by ambulance.

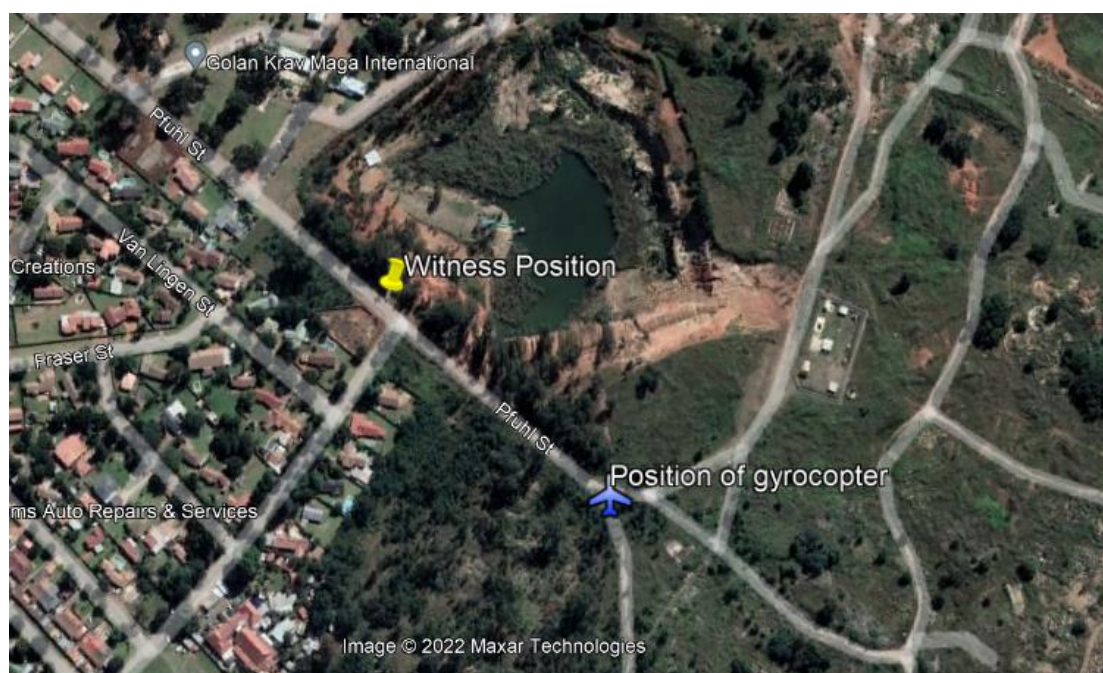
1.1.5. The accident occurred at Global Positioning System (GPS) determined to be 26°13'03.8" South and 28°23'11.5" East, at an elevation of 5 268 feet (ft).

Figure 2: An overview of the accident site. (Source: Google Earth overlay)

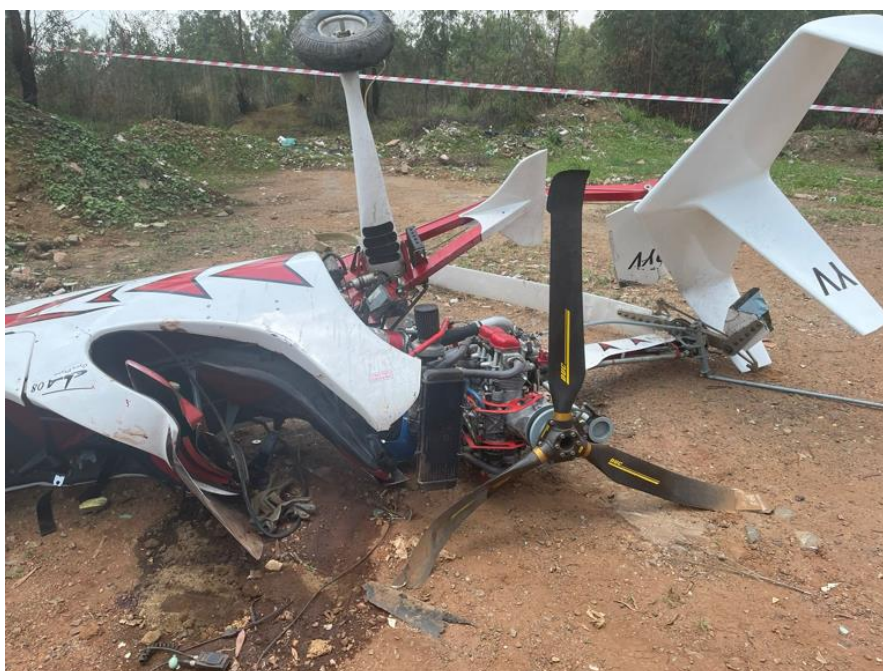
1.3.1. The gyrocopter was substantially damaged.

Figure 3: The gyrocopter post-accident.

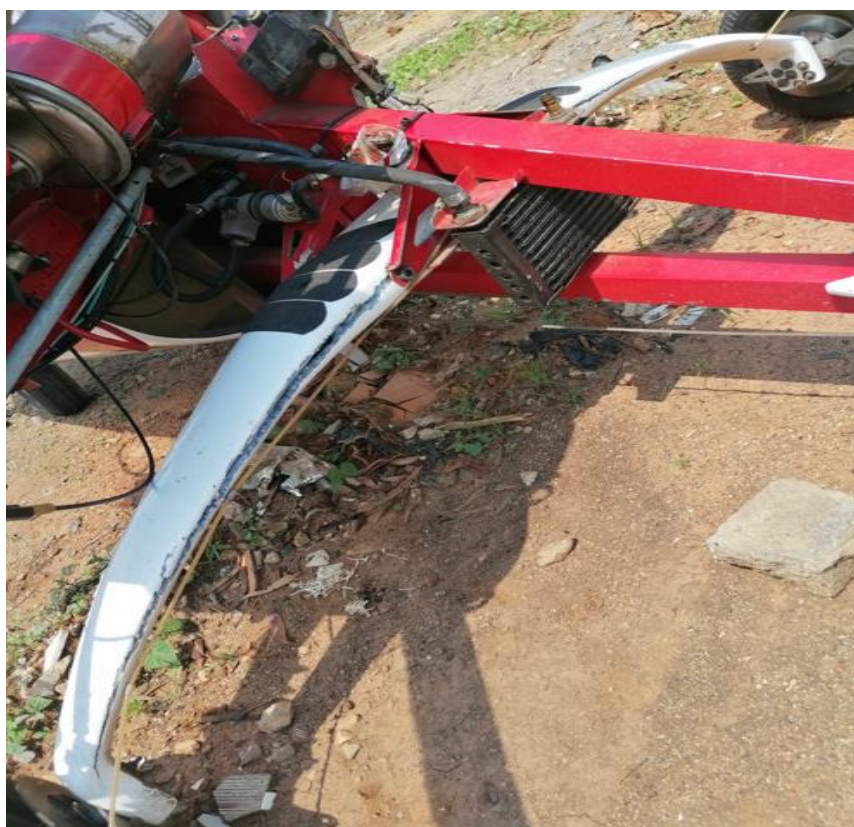
1.12.2. The landing gear strut was still intact; however, evidence of fracture down the middle was visible. Both main tyres were still attached to the axle. The nose gear had collapsed into the wheel well.

Figure 4: The landing gear strut.

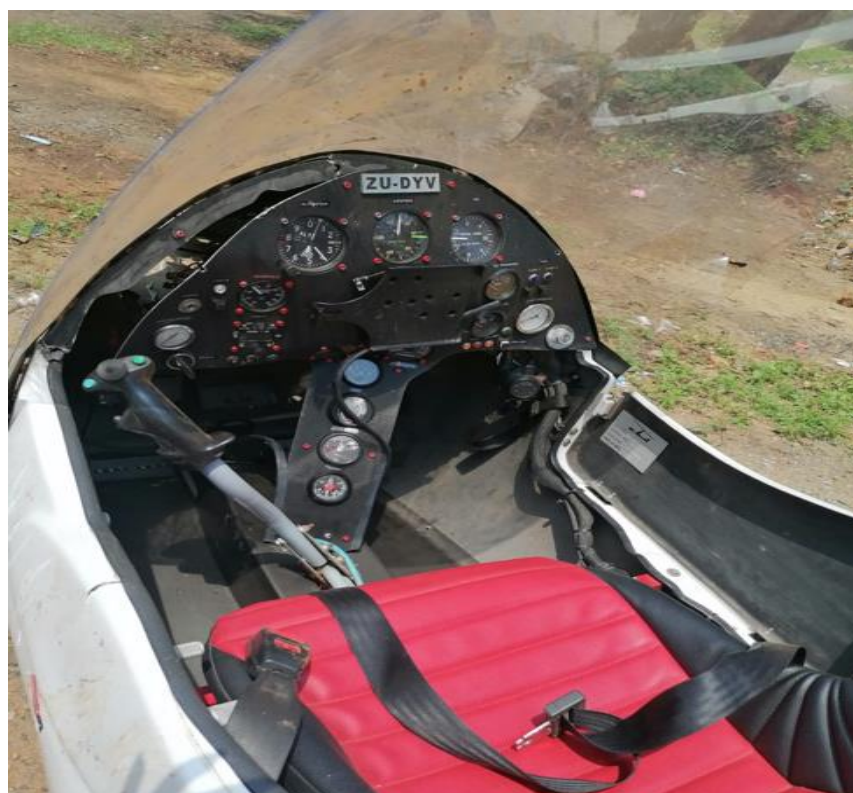
using a sharp object when the occupant was helped out by the eyewitnesses. Both controls were still secured in their respective positions. The throttle arm levers were still in place; the cable was checked for functionality and it corresponded with the movement of the throttle. All instruments in the panel were still secured.

Figure 6: the instrument panel.

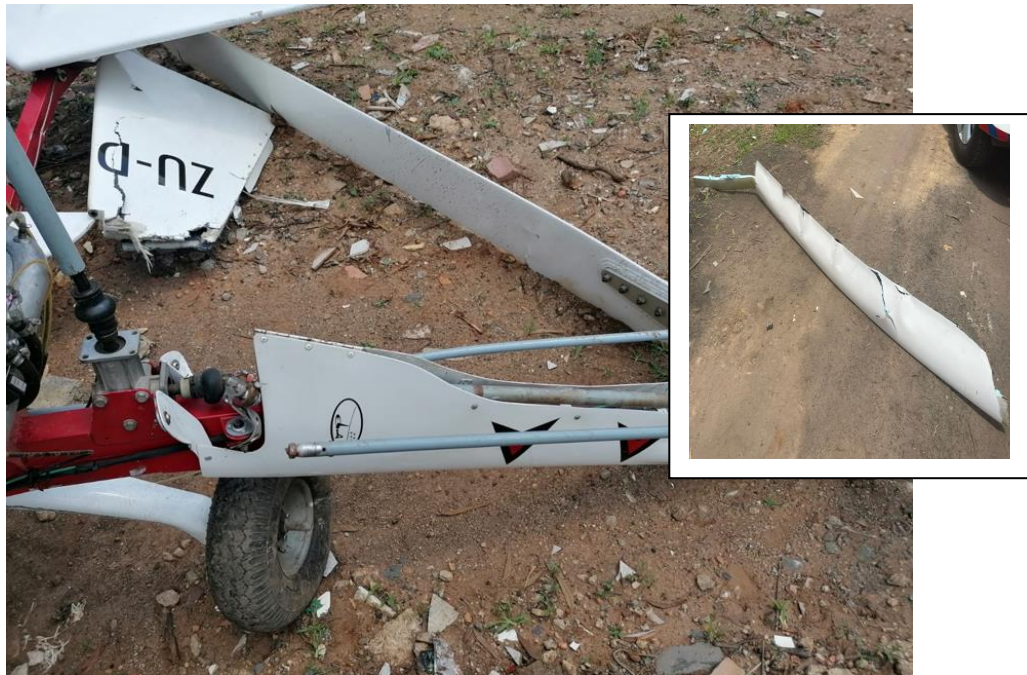
1.12.4. The mast was severed and was found hanging by the wire harness, indicative of impact fracture. Both the control tubes were severed at the bottom. The pre-rotating gearbox and its associated hardware were still intact. The drivebelt was still attached to the pulley. One of the main rotor blades detached from the hub and was found 7.8 metres from the other blades which were still attached to the hub. The detached main rotor blade had evidence of fracture on the tip and in the middle section.

Figure 6: The main rotor mast and (inset) the severed blade.

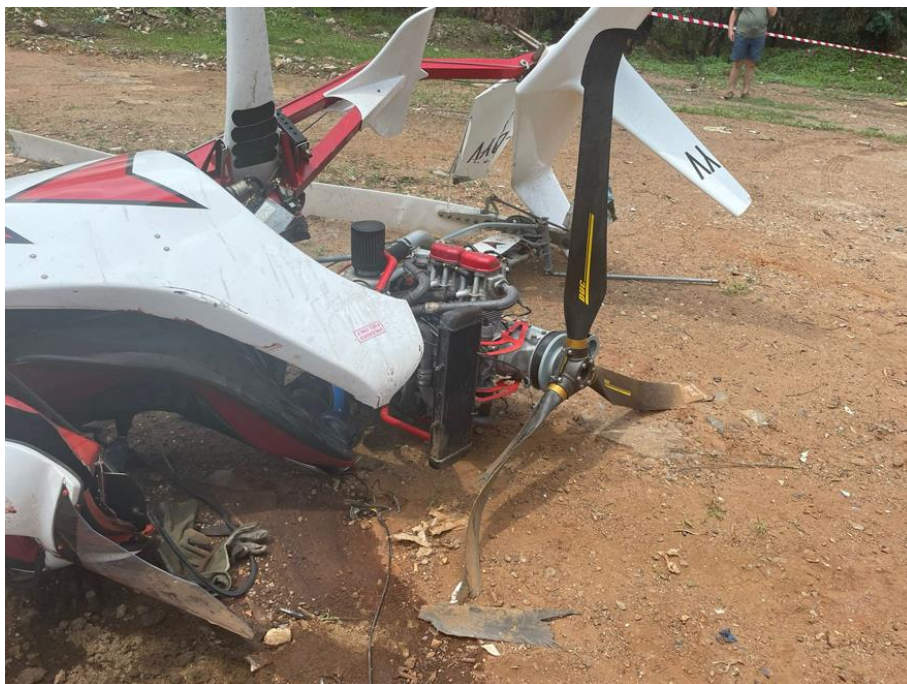
1.12.5. The condition of the exterior of the engine was good. The engine was still attached to the cradle. There were no visible signs of oil or fuel leak. The wiring harness was still intact. All three propeller blades were still attached to the hub, however, one of the blades was damage with dirt on the washout. The exhaust muffler was still intact and there was no visible oil leak on the turbo assembly.

Figure 7: The damaged propeller blades.
