**PRELIMINARY ACCIDENT REPORT**

Accident  
- Preliminary Report -  
AIID Ref No: CA18/2/3/10361

**Reference Number** : CA18/2/3/10361  
**Occurrence Category** : Accident (Category 1)  
**Type of Operation** : Private (Part 94)  
**Name of Operator** : Private Flight  
**Aircraft Registration** : ZU-EIB  
**Aircraft Make and Model** : Micro Wings Cubby, Tri Cubby  
**Nationality** : South African  
**Place** : Ridgemont Farm, Robertson District, Western Cape Province  
**Date and Time** : 29 August 2023 at 1055Z  
**Injuries** : Fatal  
**Damage** : Destroyed

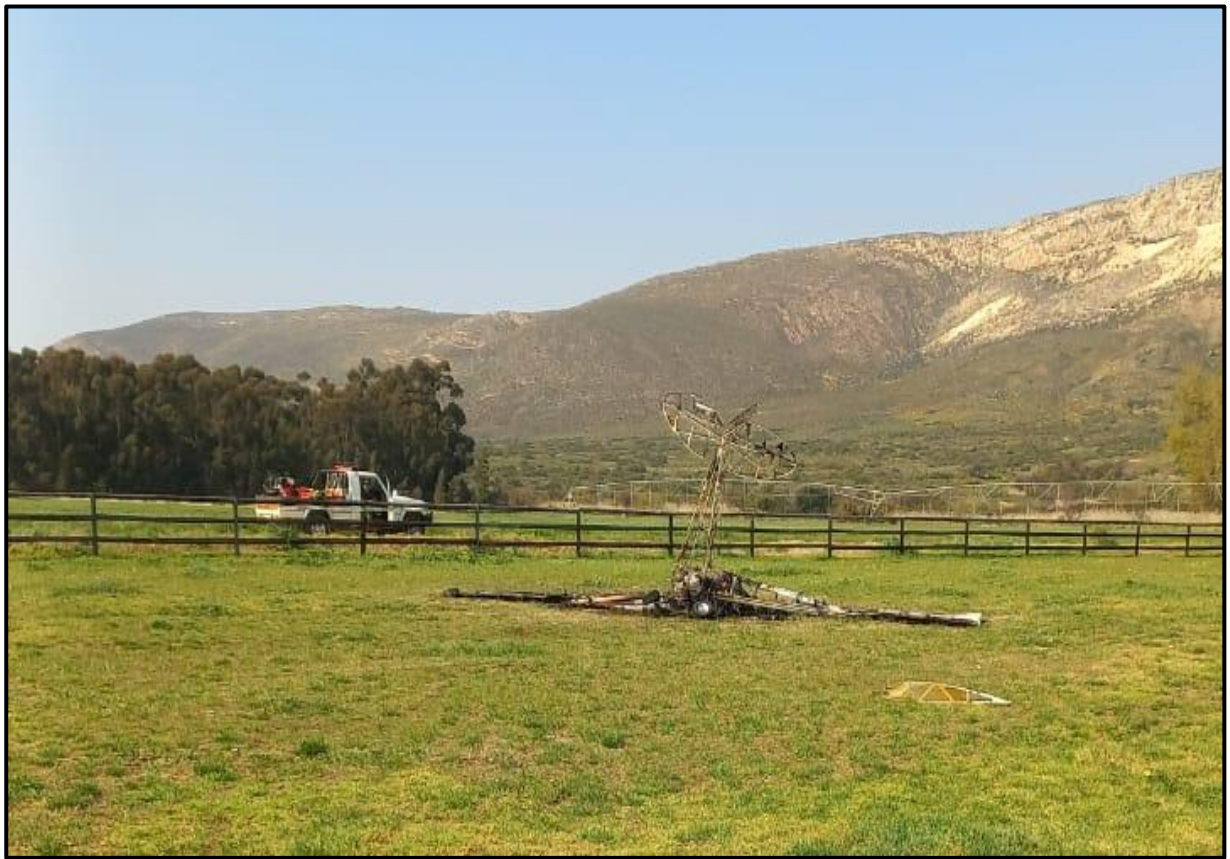
1.12.1 The aircraft impacted the ground in a high-speed nose-down attitude in a south-easterly direction, which was the opposite direction to which the aircraft was flying. There were no skid marks or any other damage apart from the aircraft being consumed by the post-impact fuel-fed fire. The aircraft wreckage remained in a nose-down attitude (tail in the air). Emergency personnel had to cut several structural beams to retrieve the deceased. During the on-site investigation by the AIID team, the EMS team availed themselves to point out the areas and parts they had to cut.

**Figure 5:** The aircraft as it came to rest.

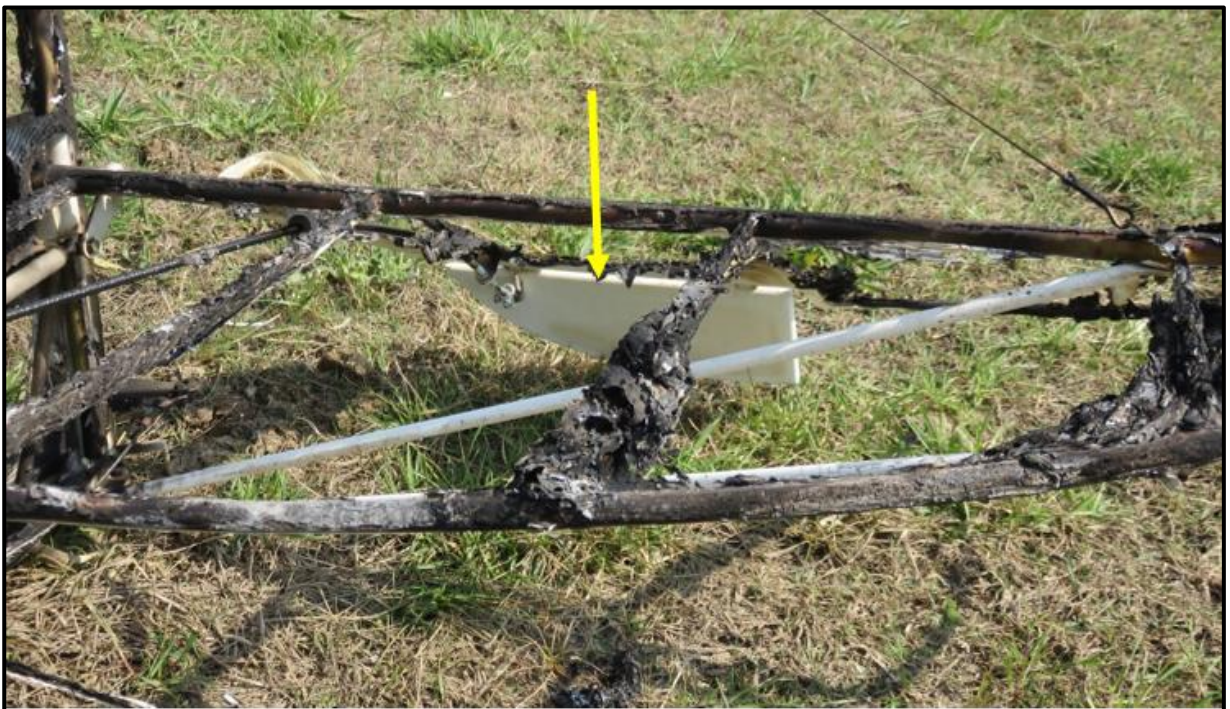
1.12.2 No evidence could be found that the structural integrity of the aircraft was compromised, and all the flight controls were accounted for. The elevator trim was found in the full nose-up position (see Figure 6). The two rudder cables that were replaced prior to the accident flight were found intact and securely connected (see Figure 7). The right rudder cable was, however, cut by the EMS personnel and this was pointed out to the investigation team.

**Figure 6:** The elevator trim tab in the full nose-up position.

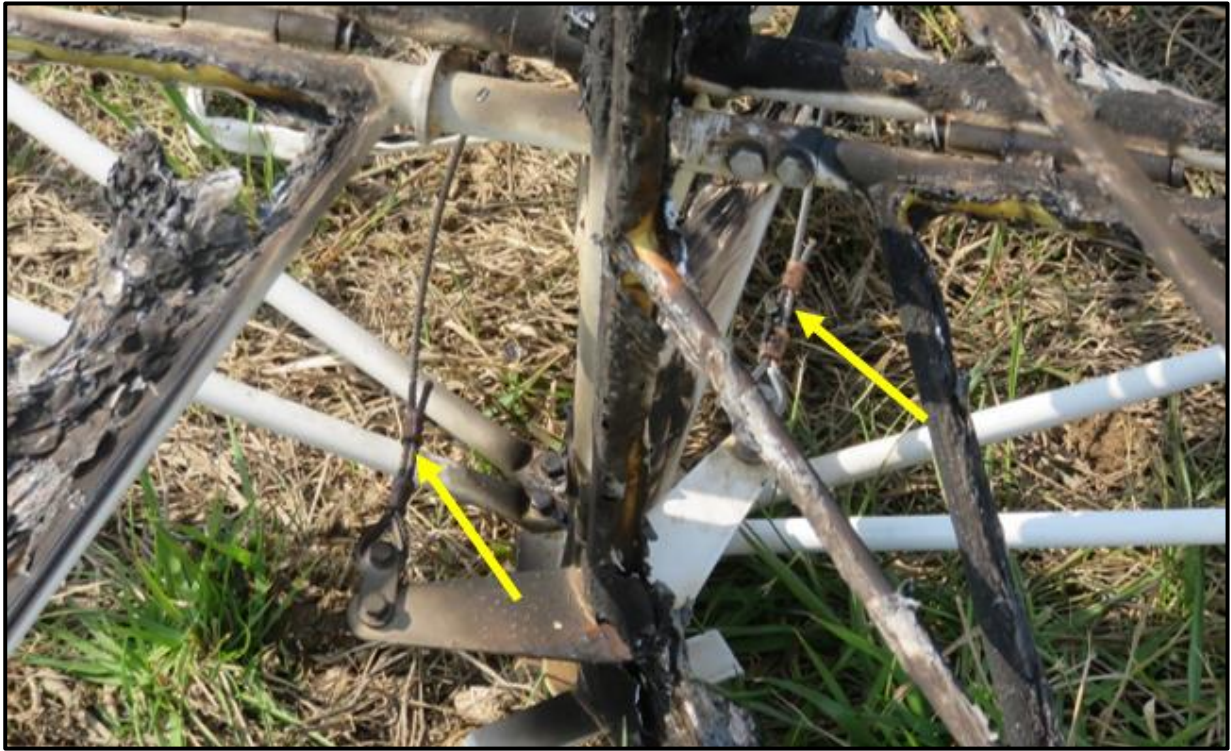
**Figure 7:** The two rudder cables were secured on both sides of the rudder attachments.
