**LIMITED OCCURRENCE INVESTIGATION REPORT – FINAL**

<b>Reference Number</b>	CA18/2/3/10173							
<b>Classification</b>	Accident	<b>Date</b>	16 June 2022		<b>Time</b>	1200Z		
<b>Type of Operation</b>	Training (Part 141)							
<b>Location</b>								
Place of Departure	Klipriver Airfield, Gauteng Province			Place of Intended Landing	Klipriver Airfield, Gauteng Province			
Place of Occurrence	Klipriver Airfield							
GPS Co-ordinates	Latitude	S 26°28'52.7"	Longitude	28°06'41.41"	Elevation	5000ft		
<b>Aircraft Information</b>								
Registration	ZU-EZJ							
Make; Model; S/N	Bush Cat; Z194 (Serial Number: CH 081)							
Damage to Aircraft	Substantial			Total Aircraft Hours	486.7			
<b>Pilot-in-command</b>								
Licence Type	National Pilot Licence (Aeroplane)			Gender	Male		Age	67
Licence Valid	Yes	Total Hours	4486		Total Hours on Type	1000		
Total Hours 30 Days	2.6			Total Flying on Type Past 90 Days	7.9			
<b>People On-board</b>	1 + 1	<b>Injuries</b>	0	<b>Fatalities</b>	0	<b>Other (on ground)</b>	0

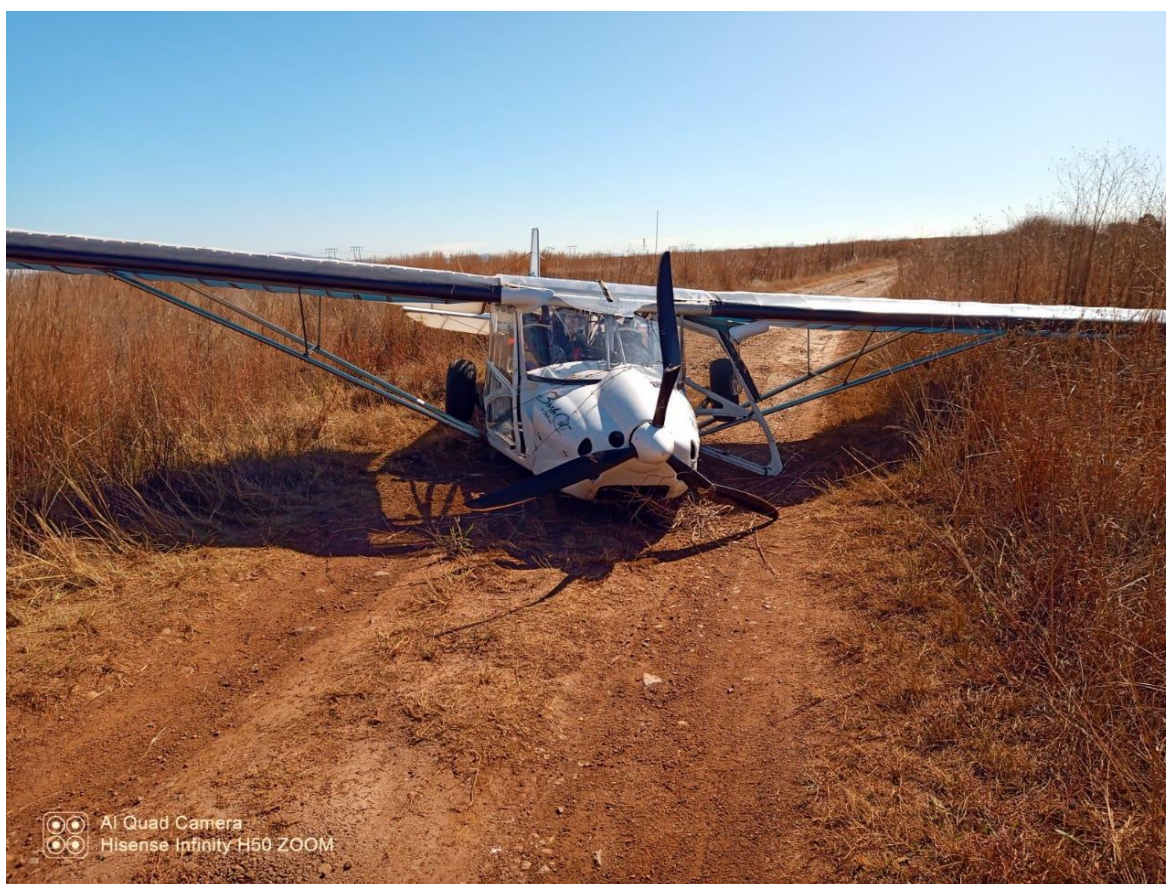
The aircraft sustained substantial damage, however, the flight instructor and the student pilot were unharmed.

**Figure 1:** The aircraft as it came to rest. (Source: Pilot)

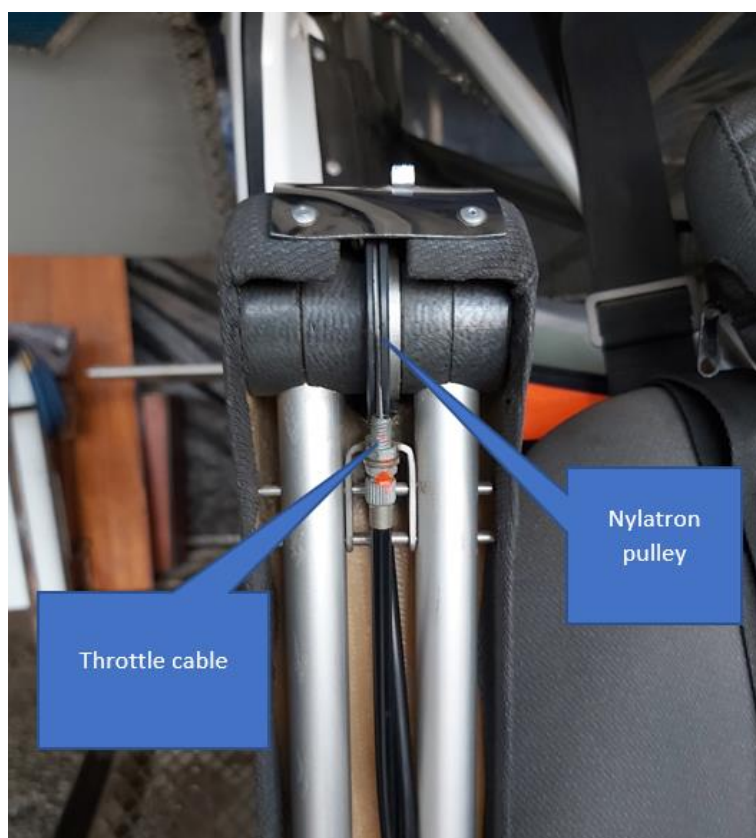
- The aircraft was recovered to the Approved Training Organisation (ATO) hangar. The investigator visited the aircraft maintenance organisation (AMO) where the aircraft was kept. He established that, indeed, both throttle levers were stuck (jammed) after his examination.

- It was discovered that the Nylatron pulley was worn out and the Nico press sleeve on the cable had damaged the groove of the pulley, causing it to get stuck in the groove and disabling the movement of the cable.

**Figure 2:** Defective throttle.

The throttle lever got stuck (jammed) due to restriction of the throttle cable which was above idle, and the resultant loss of engine power and height led to the unsuccessful forced landing.

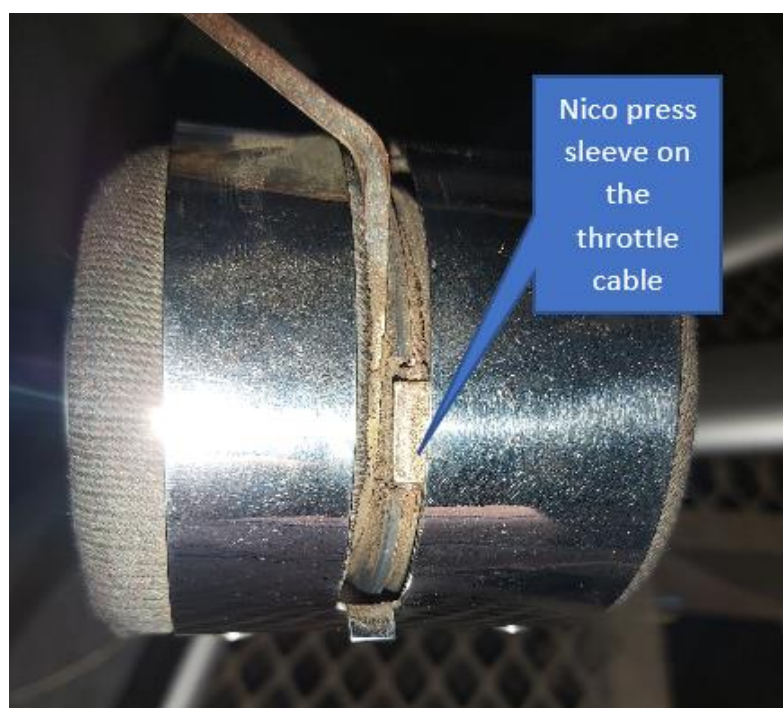
**Figure 3:** Throttle showing Nico press sleeve on the cable.

The Nico press sleeve moved into the pulley groove, restricting further movement of the throttle cable.

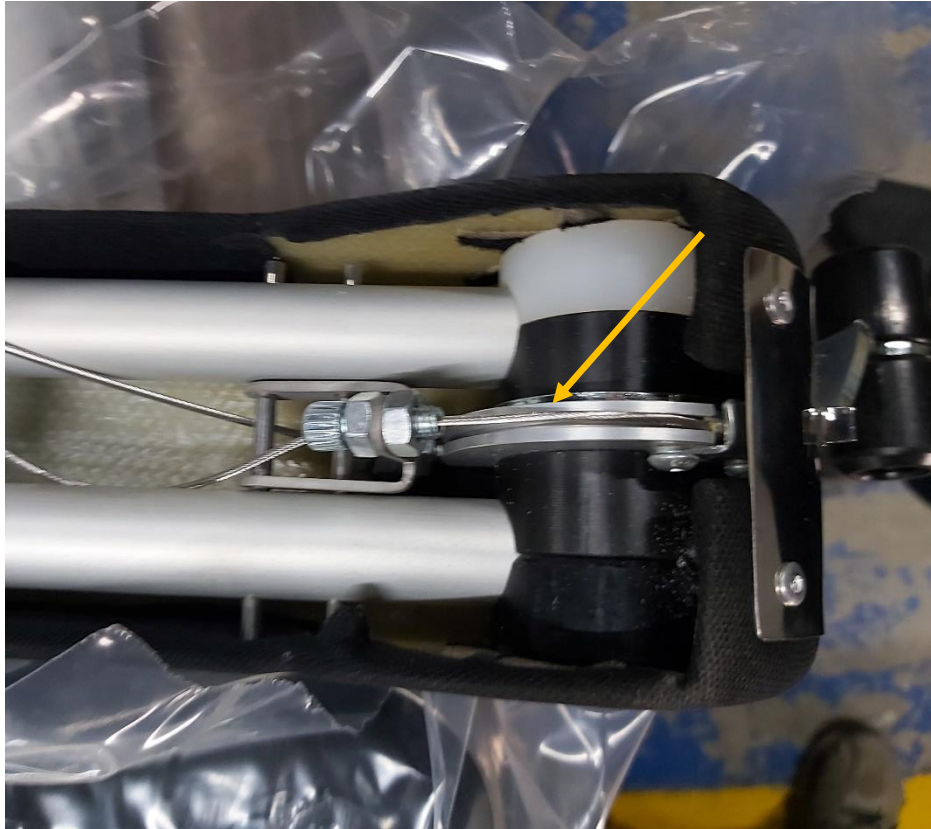
**Figure 4:** New pulley made of aluminium (sealed item before installation on the aircraft).

Following the incident, the manufacturer issued an advisory Service Bulletin (SB) CH 017-07-2022 effective 22 July 2022 to inform owners of the new throttle system. The manufacture has since issued a mandatory Service Bulletin (SB) CH 018-10-2022 effective 14 October 2022 which supersedes CH 017-07-2022.
