PRELIMINARY ACCIDENT REPORT

Accident and Incident Investigations Division

Accident
- Preliminary Report -
AIID Ref No: CA18/2/3/10621

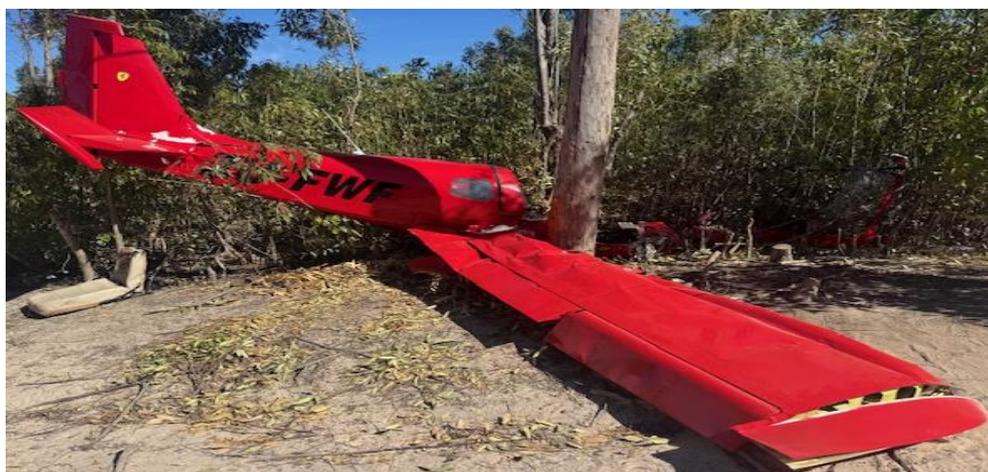
1.3.1. The aircraft was destroyed during the accident sequence.

Figure 3: The aircraft at the accident site.

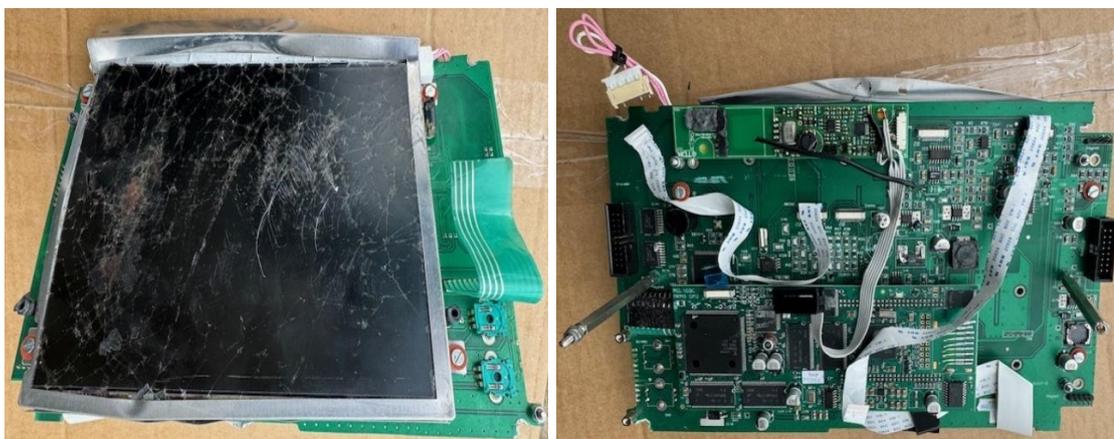
1.11.2. The aircraft was equipped with an old model MGL Avionics Stratomaster Voyager EFIS unit. The unit sustained impact damage during the accident sequence. The Secure Digital (SD) card was ejected during the accident; however, it was found intact. The SD card that was recovered from the aircraft contained no data of the last two flights. The unit did not have internal data recording capabilities; it could only record with the external SD card that was set up and used by the pilot.

Figures 5 and 6: The EFIS unit (back and front) after it was removed from the cockpit.

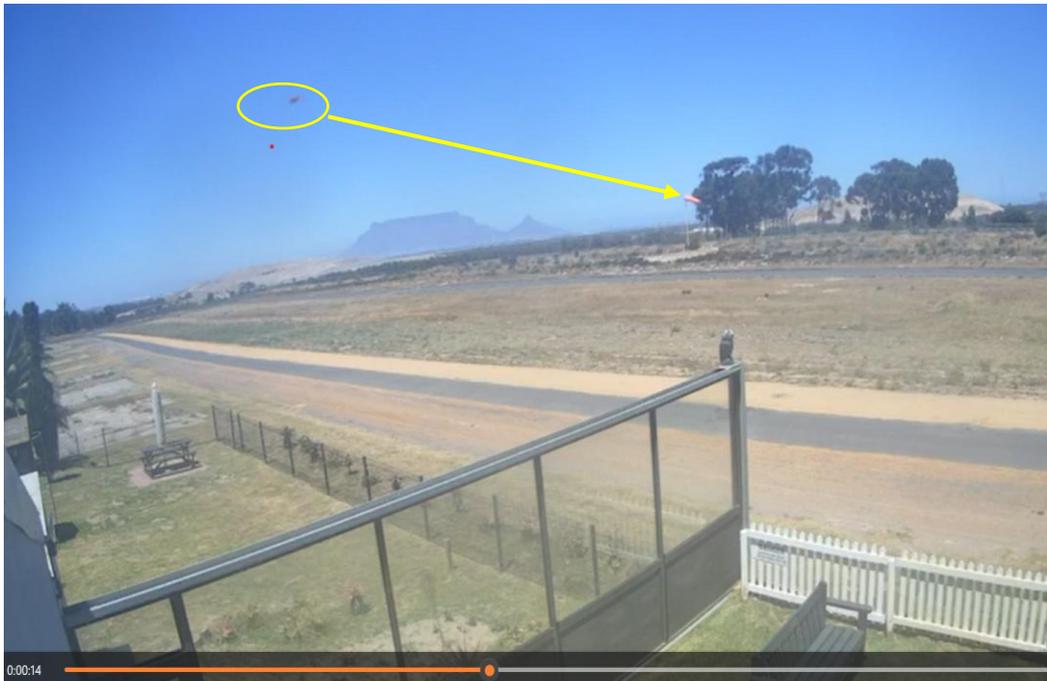
1.12.1. A video footage downloaded from the close-circuit television (CCTV) camera that was mounted on the roof of the clubhouse at Morningstar Airfield showed the aircraft as it climbed in a southerly direction after take-off from Runway 20. The footage showed the windsock indicating a strong headwind.

Figure 7: The video footage snapshot showing the aircraft in a climb (yellow circle), and the windsock indicating a strong headwind (yellow arrow).

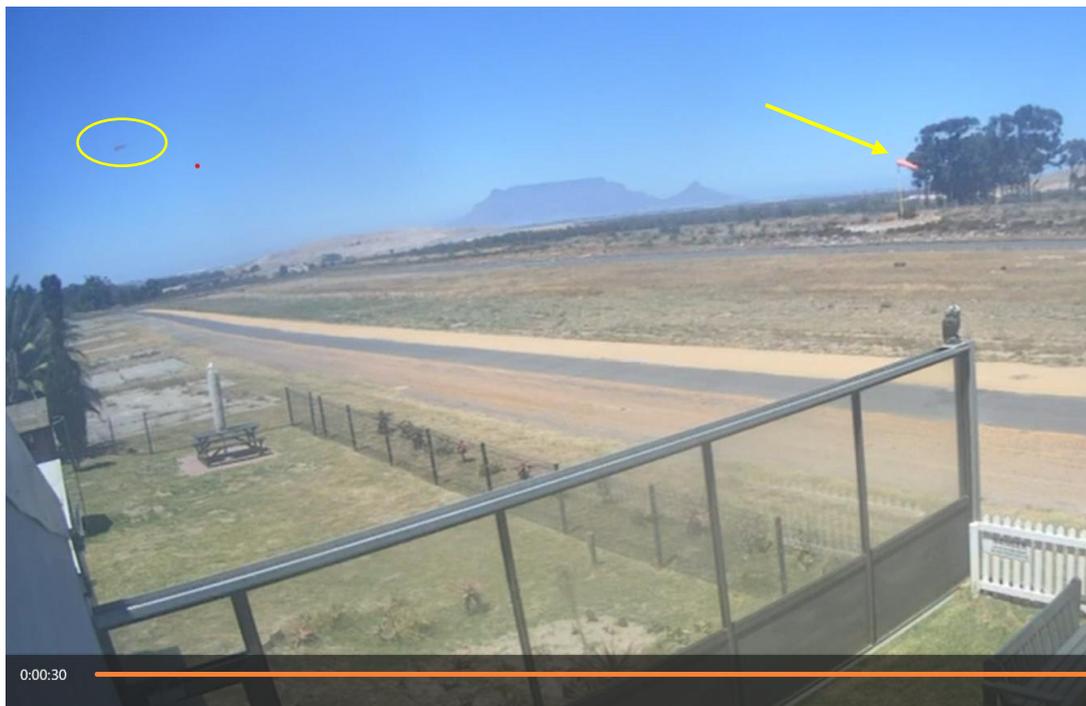
1.12.2. At approximately 250 AGL, the aircraft was observed executing a left turn followed by a nose-down attitude whilst in descent; it then disappeared from the CCTV camera coverage. The aircraft crashed on a bush-type terrain near Van Schoorsdrift Road, approximately 150m south-east of Morningstar Airfield.

Figure 8: The video footage snapshot showing the aircraft executing a left turn (yellow circle).

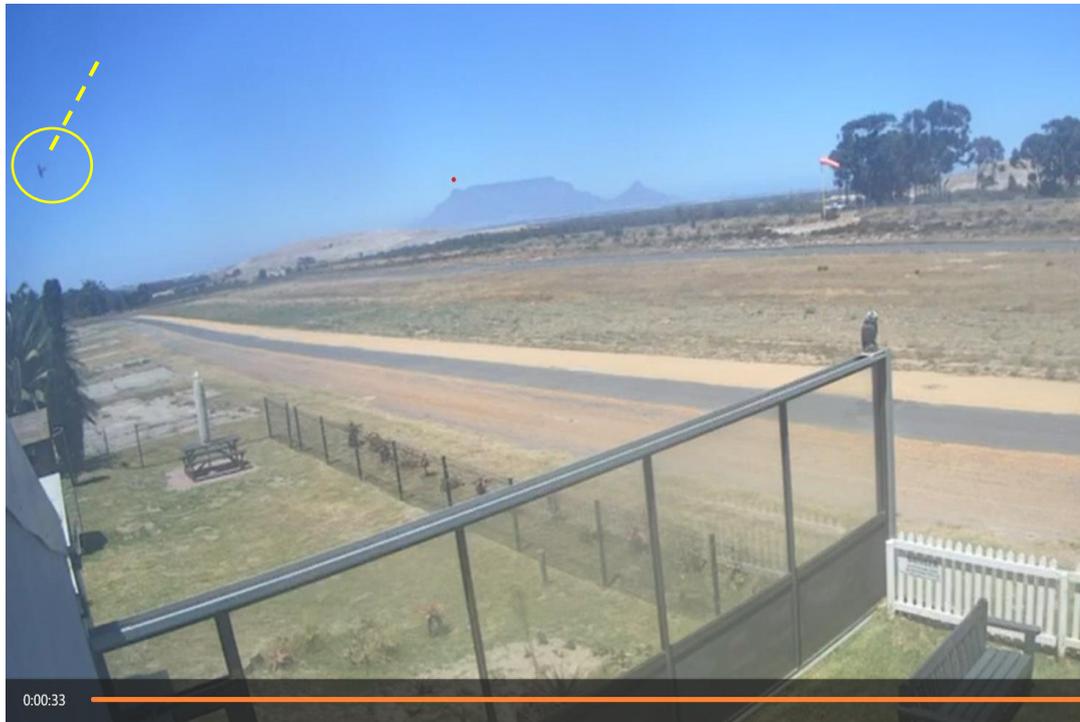
Figure 9: The video footage snapshot showing the aircraft in a nose-down attitude.

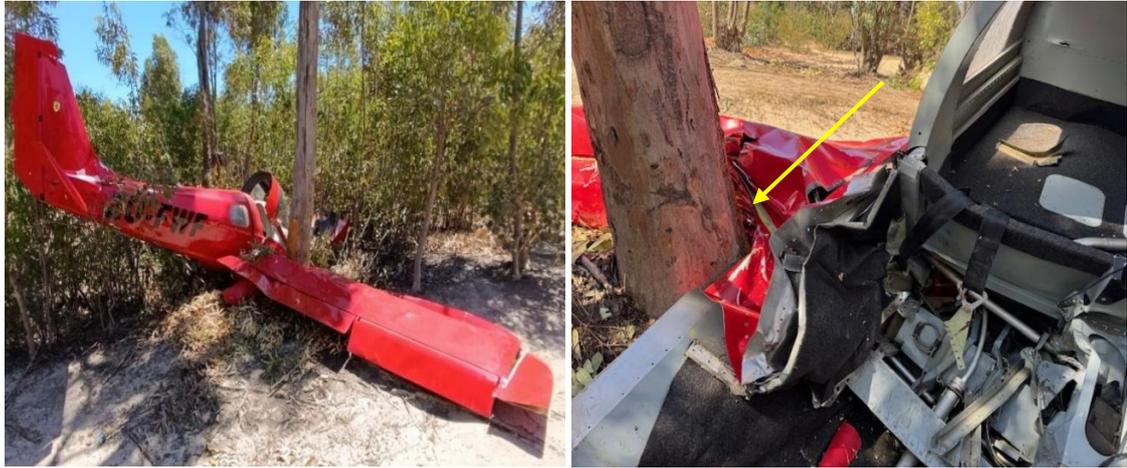
1.12.4. Evidence indicated that the aircraft was in a nose-down attitude on impact and the flaps were retracted (up position). The right-wing root leading edge impacted the stem of a large tree which caused the wing tanks to rupture. The aircraft had an estimated 57L Mogas remaining in the tanks at the time of impact. There was a strong smell of fuel at the accident scene. The nose gear strut was found broken due to overload, and the spring-loaded main landing gear struts were stretched backward. The main wheel assemblies (tyres) remained intact and inflated. The propeller had struck the soft ground and one of the blades broke off. Examination of the remaining two composite blades indicated that the engine was not delivering power at the time of impact.

Figures 10 and 11: The aircraft's right-wing root against the tree stem. The yellow arrow indicates the direction of travel.

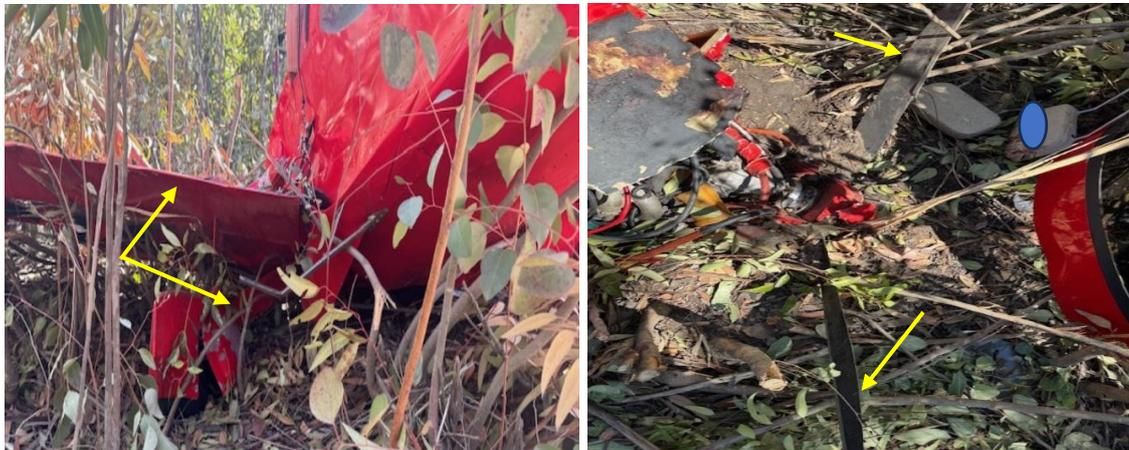
Figures 12 and 13: The left wing with the flaps in a retracted (up) position and the left main gear strut strained backward (yellow arrows on the left picture). The engine nose section is buried under the soft ground and the remaining two blades are still intact (yellow arrows on the right picture).

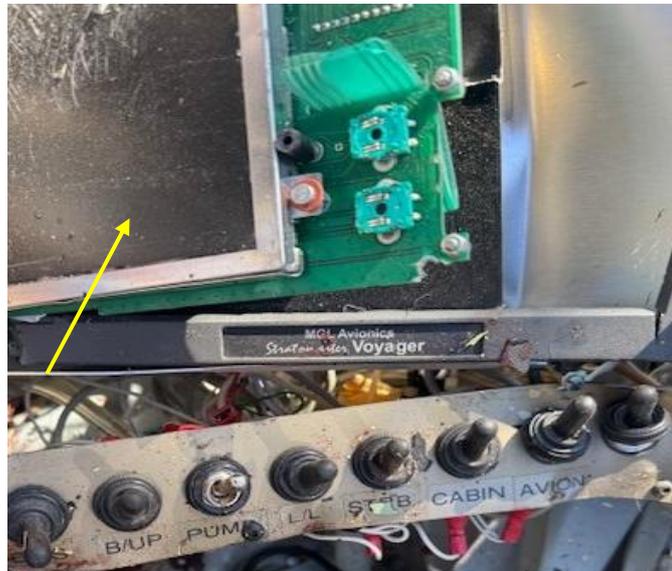
1.12.5. The engine was pushed back towards the firewall; the engine mounts and the firewall were severely damaged. External examination of the engine revealed a clean air filter; the exhaust system was damaged but no anomalies were noted; the cooling system was intact. The oil reservoir cap was missing, however, there was oil spillage/sputter on the inside engine cowling (compartment), suggesting that it was not in place during impact. Examination of the cockpit area revealed that both control columns had broken off. The throttle lever was in a full forward position (maximum power), and the fuel selector in the middle console was selected to the right tank. The EFIS screen was crushed, however, the SD card had ejected. The circuit breakers (CBs) on the instrument panel were firmly secured to the mounting panel and were pressed in; all the switches including those of the fuel pumps were on.

Figure 14: An enlarged view of the EFIS (yellow arrow) unit in the cockpit with the switches in 'on' position.
