PRELIMINARY ACCIDENT REPORT

Accident
- Preliminary Report -
AIID Ref No: CA18/2/3/10522

Reference Number	: CA18/2/3/10522
Occurrence Category	: Accident (Category 1)
Type of Operation	: Training (Part 141)
Name of Operator	: Legend Sky
Aircraft Registration	: ZU-IBE
Aircraft Make and Model	: Jabiru J170
Nationality	: South African
Place	: Carlsruhe Private Game Reserve
Date and Time	: 1 November 2024 at 1747Z
Injuries	: Two fatalities
Damage	: Destroyed

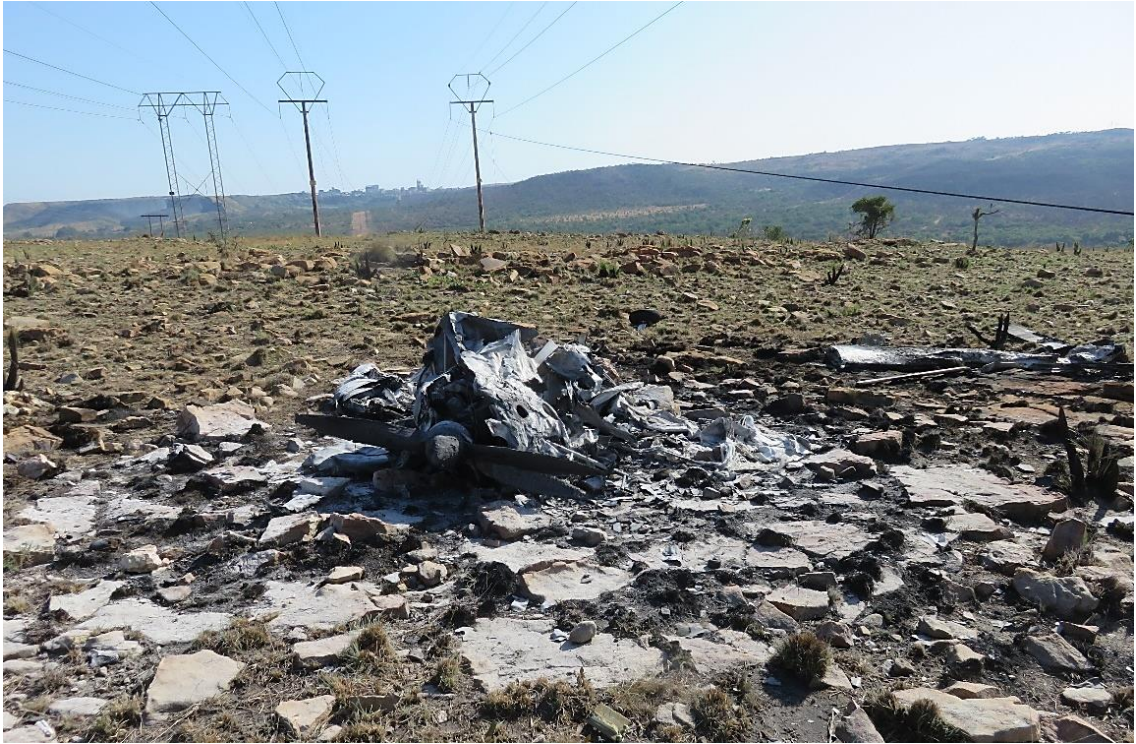
1.3.1 The aircraft was destroyed by post-impact fuel-fed fire.

Figure 3: The wreckage post-accident.

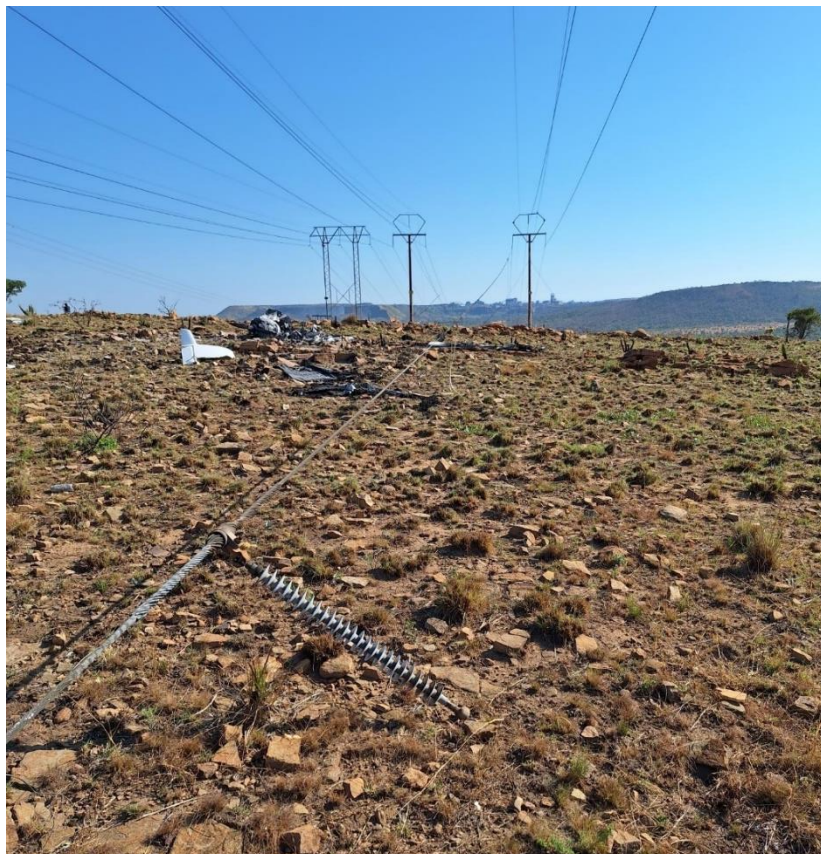
- 1.4.1 Several Eskom powerline pylons and conductors were damaged after impact with the aircraft. There was power failure in some parts of Cullinan after the accident.
- 1.4.2 The local fire services responded to the scene and doused the post-impact fire that erupted.

Figure 4: One of the high-tension cables that snapped from the pylon during the accident.

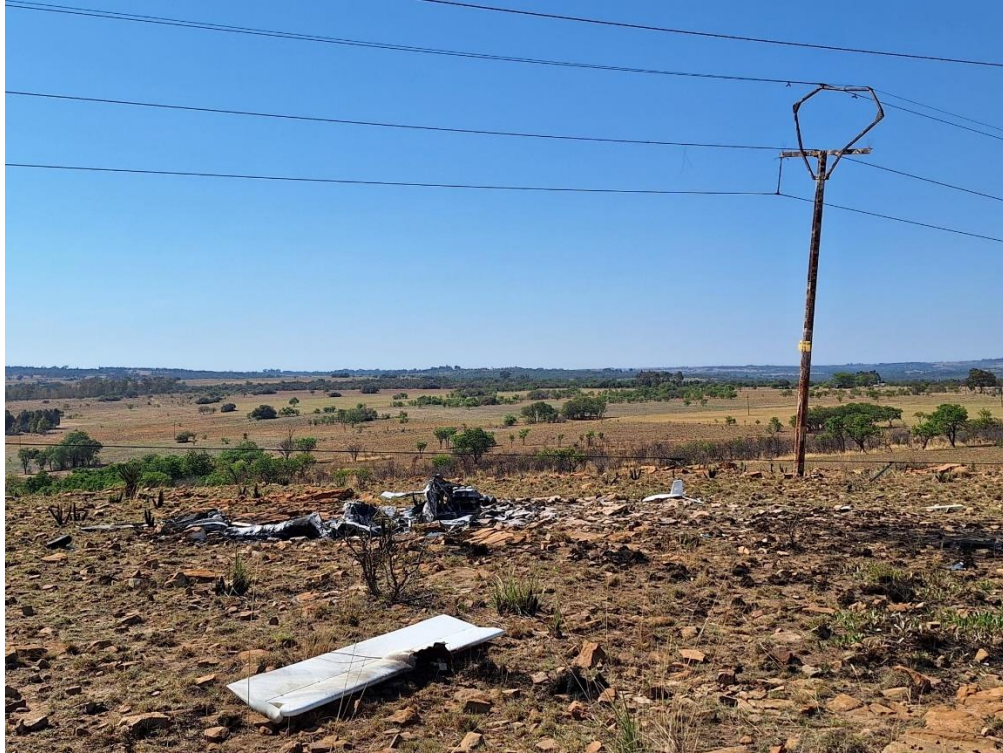
1.12.1 The aircraft impacted high-tension powerlines whilst flying in a north north-westerly direction. The wreckage distribution covered an approximately 30m radius and the fuselage was consumed by post-impact fire that erupted. Aircraft parts that were not destroyed displayed evidence of being scorched.

Figure 5: The accident site.

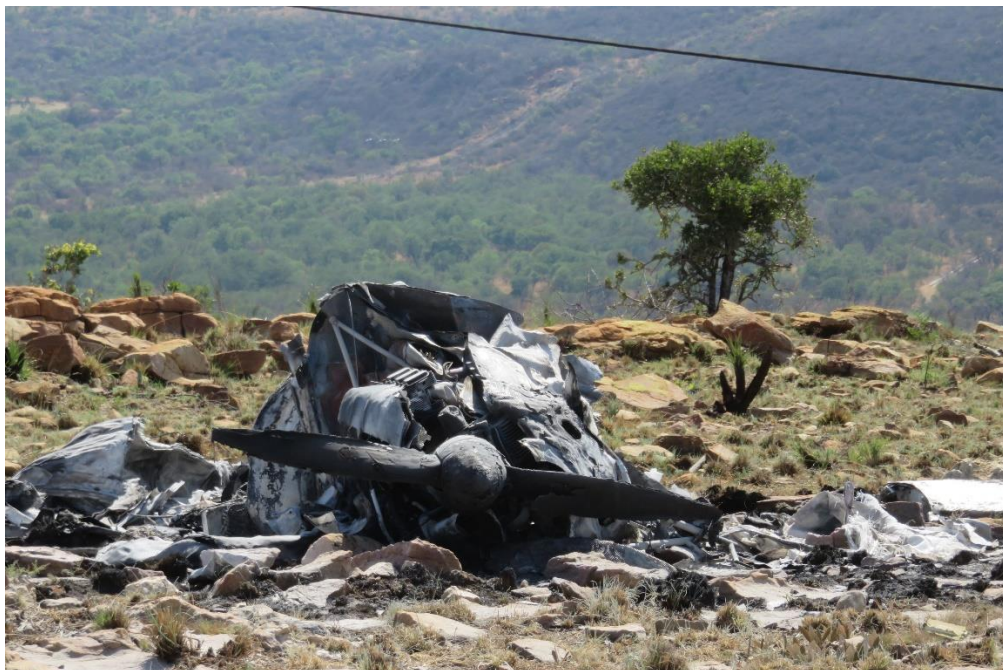
Figure 6: The fuselage of the aircraft.

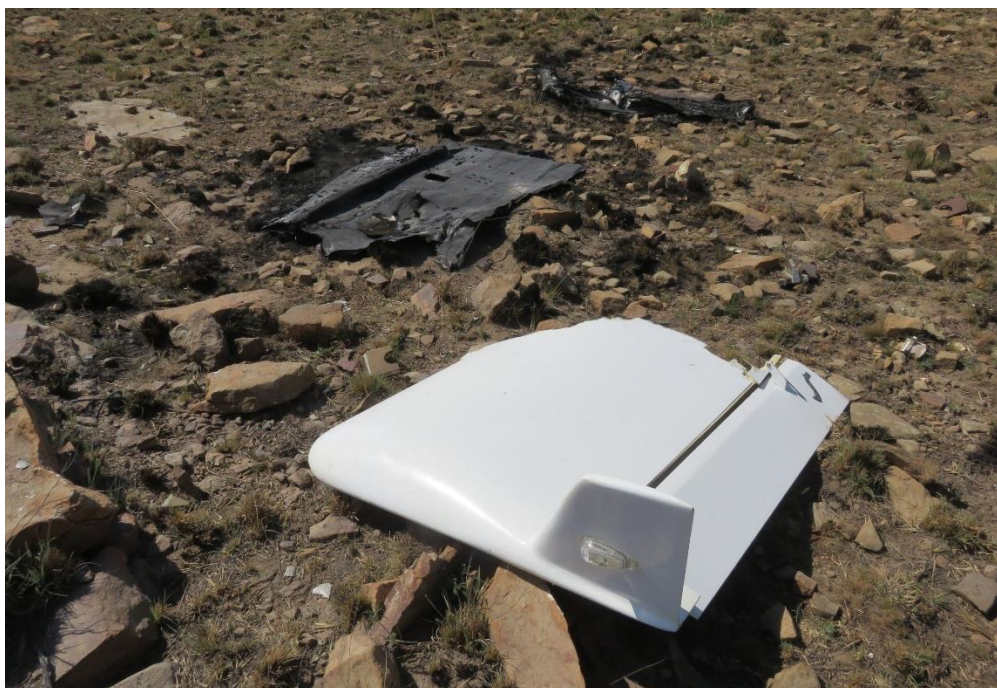
Figure 7: A section of the left outer wing.

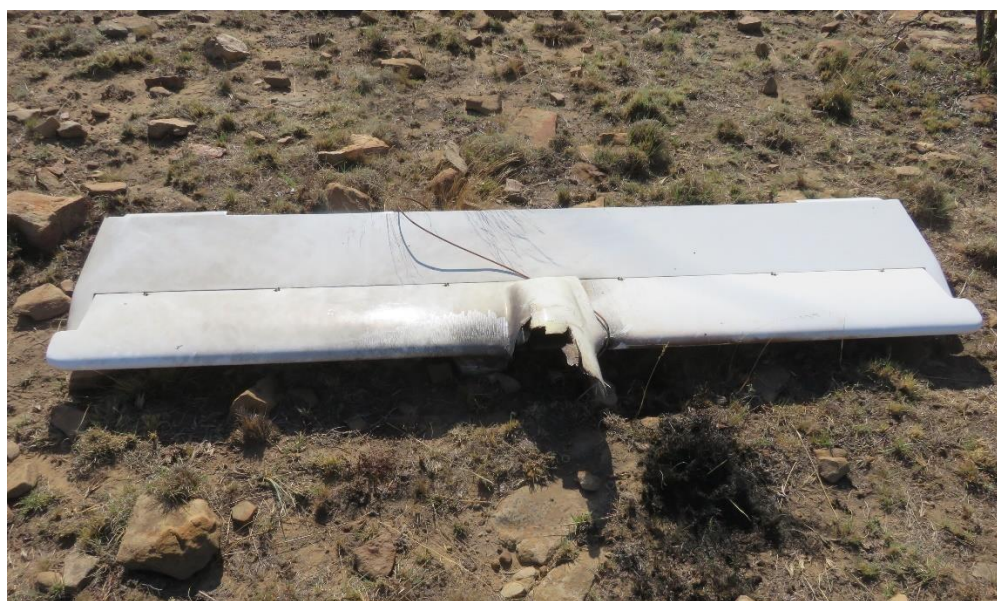
Figure 8: The horizontal plane with the vertical fin ripped off.

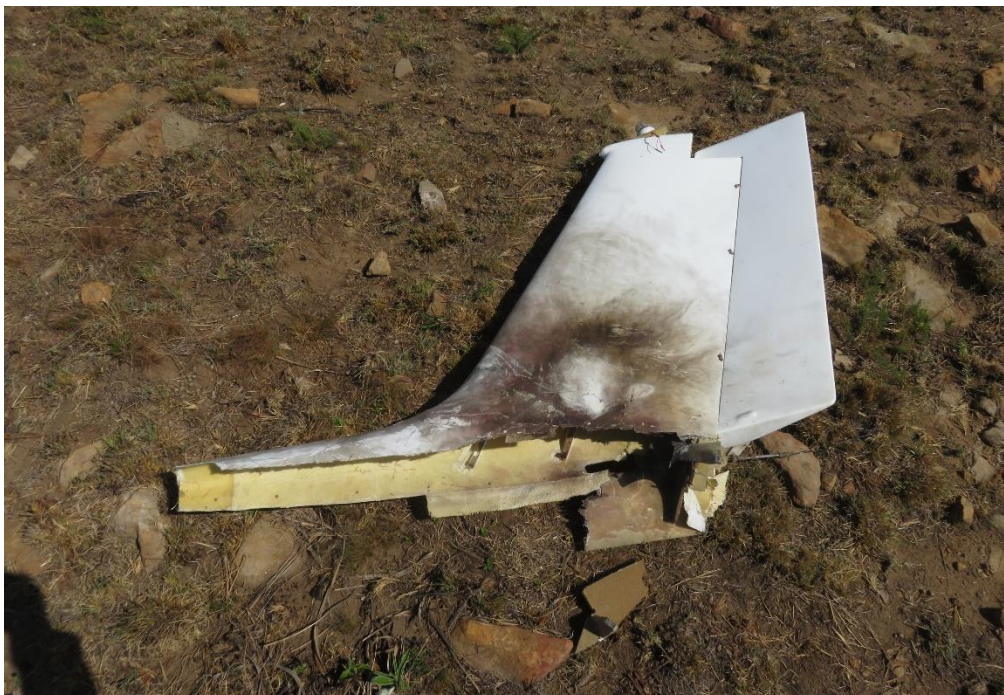
Figure 9: The vertical fin with the rudder still attached.
